Lake Wallkill Dam (NJ-00032)
Hudson River Basin, Wallkill River,
Tributary, Sussex County, New Jersey
Phase 1 Inspection Report.

LAKE WALLKILL DAM (NJ00032)

PHASE I REPORT
NATIONAL DAM INSPECTION PROGRAM

PHASE I INSPECTION REPORT
NATIONAL DAM INSPECTION PROGRAM
NAME OF DAM: LAKE WALLKILL DAM FED # NJ00032 AND
NJ ID # 599

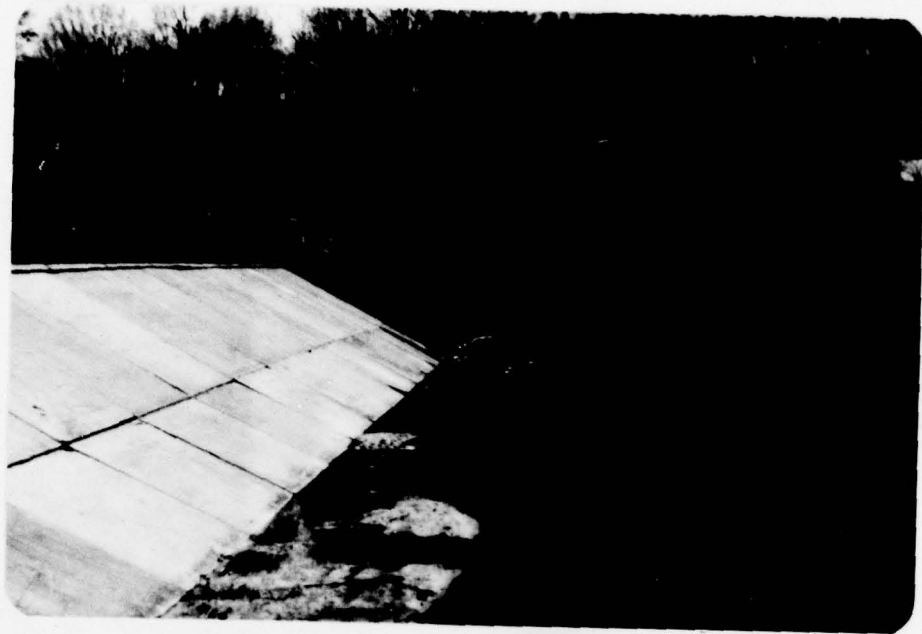
View of Primary Spillway Outlet

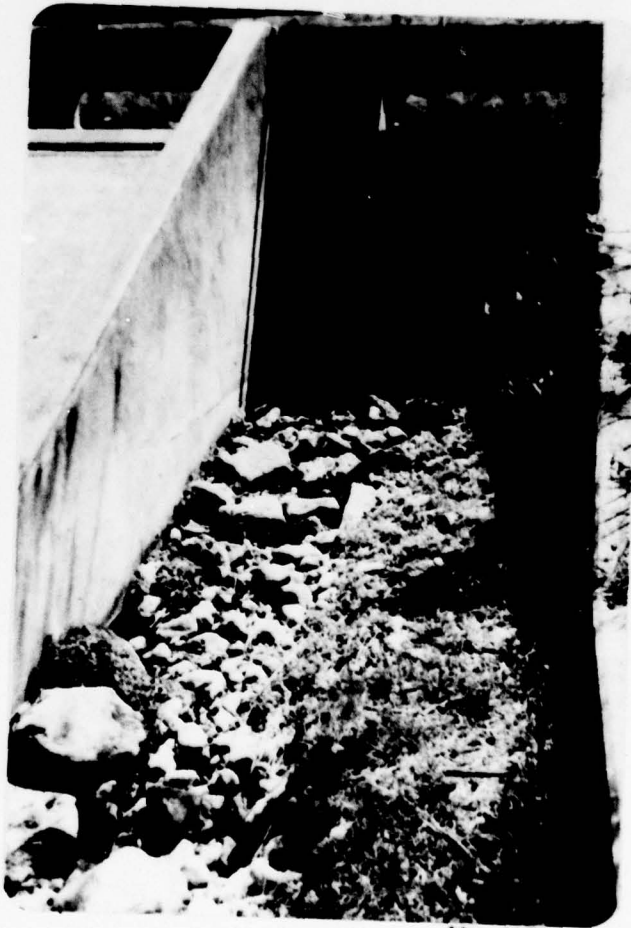
View of Sluiceway Outlet Channel
