**STONY BROOK DAM NO. 4**

**NJ 00390**

**PHASE 1 INSPECTION REPORT  
NATIONAL DAM SAFETY PROGRAM**

June, 1979

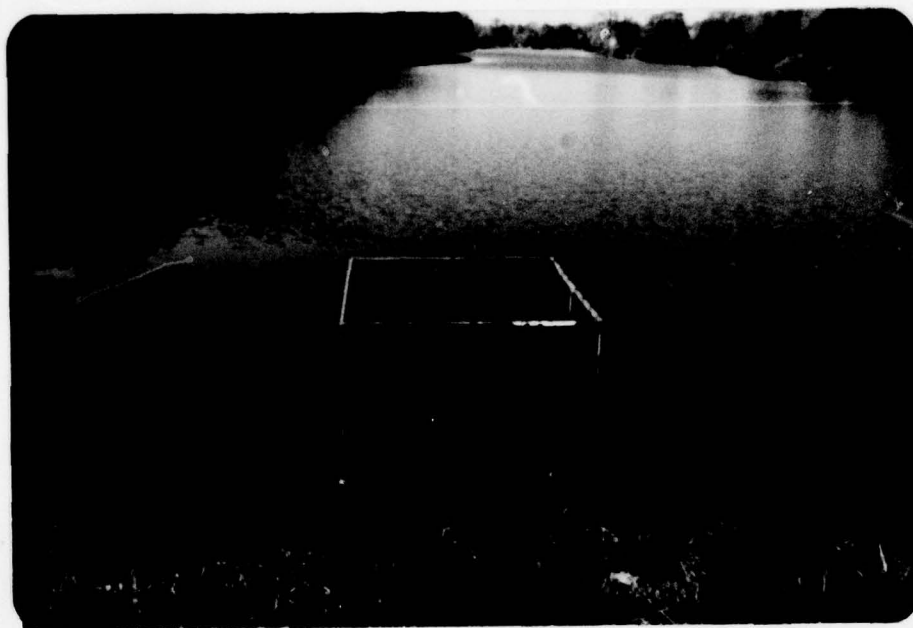
View of Intake Structure

The algae-covered, concrete inlet riser appears to be in satisfactory condition although some light spalling was noted on the outer edges. A long timber has fallen into the riser and is now protruding above the trash bars. The trash rack itself appears to consist of only a single pipe railing around the inlet and is of little use in preventing debris from entering the box

riser. The gate wheel for the low level drain is missing which precludes the possibility of lowering the lake in an emergency situation. The 78-inch diameter discharge conduit and headwall appear in satisfactory condition although there is light erosion around the pipe exit. The rock drain along the downstream toe is no longer uniform in appearance but seems to be functioning as designed since no seepage or moisture was noted beyond the toe.

| VISUAL EXAMINATION OF | OBSERVATIONS | REMARKS OR RECOMMENDATIONS |
|---|---|---|
| INTAKE STRUCTURE | Satisfactory although trash gates gone, timber debris in riser, grass impinging on edges of riser. | Trash racks are only 2" dia. pipe railing.<br>Some concrete deterioration. |

- Clear the debris which has collected in and around the intake riser;
- Study the feasibility of installing a cover screen on the trash bars;
- Replace and lock the wheel for the gate stem which operates the low level drain;
- Seed or protect with small stone the eroded areas on the upstream berm and area surrounding the outlet structure; and
- Fill the animal burrows.
