PASSAIC RIVER BASIN  
DEN BROOK, MORRIS COUNTY  
NEW JERSEY

**LEVEL II**  
**LAKE ESTLING DAM**  
**NJ 00184**

**PHASE 1 INSPECTION REPORT**  
**NATIONAL DAM SAFETY PROGRAM**

August, 1979

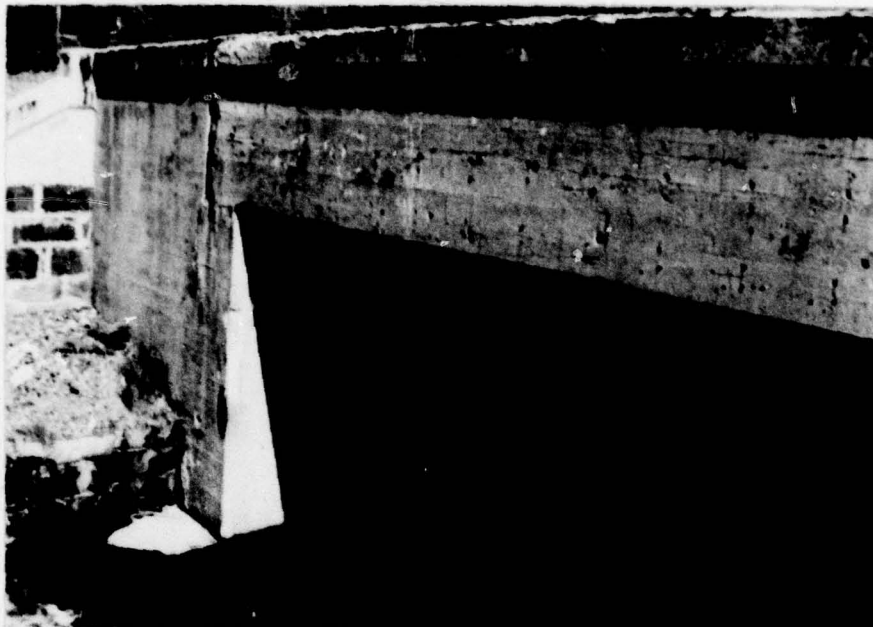
VIEW OF DOWNSTREAM CULVERT THROUGH RAILROAD EMBANKMENT
