REPORT DOCUMENTATION PAGE		READ INSTRUCTIONS BEFORE COMPLETING FORM
1. REPORT NUMBER NJ00473	2. GOVT ACCESSION NO.	3. RECIPIENT'S CATALOG NUMBER
4. Title I Inspection Report National Dam Safety Program Lake Wildwood Dam Sussex County, N.J.		5. TYPE OF REPORT & PERIOD COVERED 9 FINAL rept.

LAKE WILDWOOD DAM (NJ00473)

PHASE I REPORT
NATIONAL DAM INSPECTION PROGRAM

Name of Dam Lake Wildwood Dam Fed ID# NJ 00473

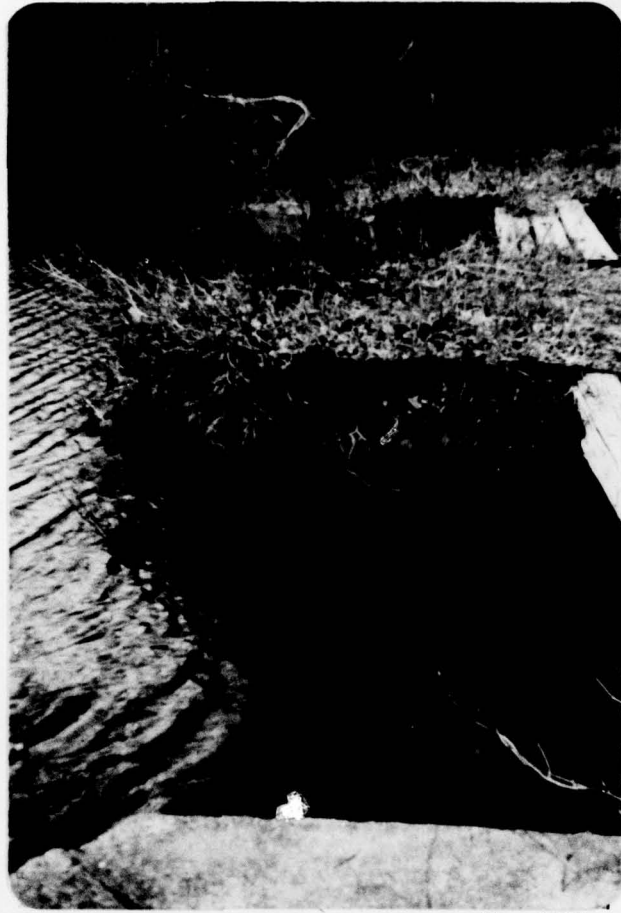
The 20" thick concrete wingwalls at both spillways are spalled, cracked, and in an advanced state of deterioration. The walls are partially overgrown with vegetation as is the center pier which separates the spillways. The area behind the right wingwall is eroded and the wall has a vertical structural crack about one foot from its junction with the sidewall of the spillway. The left wingwall is also cracked and is tilted out toward the lake. The concrete center pier is in better condition although some light spalling and surface cracking exists. The approach apron to both spillways is buried by silt and could not be examined. The sloping portion of the outfall apron below the step at the right spillway is cracked, spalled and covered with stone and gravel deposits. The left spillway outfall is in better condition and a more uniform flow was passing over this weir although both crests are at basically the same elevation. The right spillway has steel stoplog racks bolted to the sidewalls about 3 feet back from the approach sill. These 12 inch high steel angles are rusty but appear capable of supporting stoplogs (which are presently missing). Both spillways drop straight into the bedrock channel. Timber railroad ties have been laid across both spillways to form a pedestrian bridge.

VISUAL EXAMINATION OF	OBSERVATIONS	REMARKS OR RECOMMENDATIONS
CONCRETE WEIR	Concrete is spalled, cracked and generally deteriorated. Apron is about 10' long with a 5' straight drop to the streambed.	Weir is 20" below crest height of retaining walls.
APPROACH CHANNEL	Spalled where visible. Mostly covered with silt between wingwalls. Left wingwall tilting out and broken away from retaining side wall.	
DISCHARGE CHANNEL	Weir drops straight to old natural channel. Strewn with boulders and overgrown with large trees.	
BRIDGE AND PIERS	Center pier appears in somewhat better shape although most of concrete is buried of overgrown. Foot bridge over spillways consist of several railroad ties laid together.

View of Spillway May, 1979

On the basis of present conditions, no remedial improvements are envisioned insofar as the spillway capacity is concerned. The owners should undertake the general rehabilitation and repair of the concrete walls in order to halt further deterioration.
