# COOL SPRINGS RESERVOIR DAM DE 00014

## PHASE 1 INSPECTION REPORT NATIONAL DAM SAFETY PROGRAM

Cool Springs Reservoir Dam (DE-00014),  
Delaware River Basin, Brandywine Creek,  
New Castle County, Delaware. Phase 1  
Inspection Report.

O'BRIEN & GERE ENGINEERS, INC.  
JUSTIN & COURTNEY DIVISION

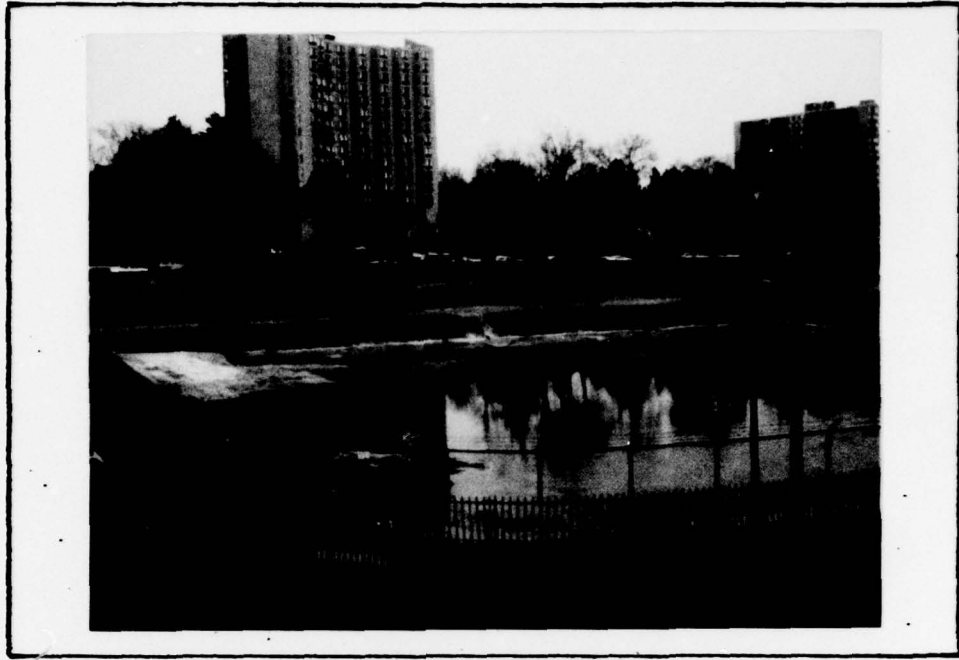
*OVERVIEW OF COMPLETED REPAIRS  
ON COOL SPRING RESERVOIR APRIL 1978*

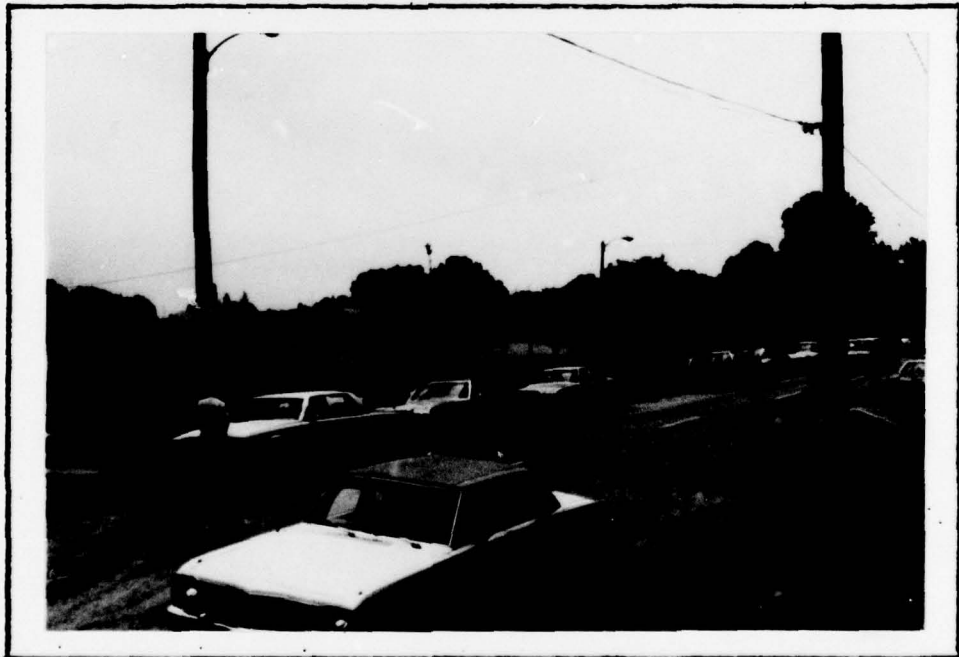
*OVERVIEW OF COOL SPRING RESERVOIR  
MAY 1979*

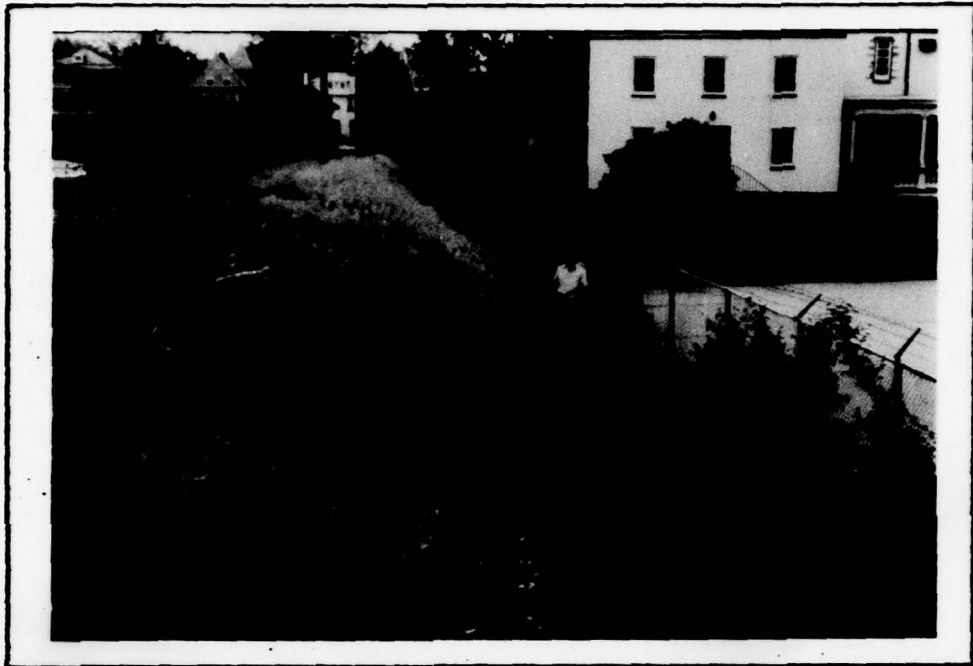
*NORTH SIDE OF THE RESERVOIR SHOWING  
EXCELLENT VEGETATIVE COVER 5/24/79*

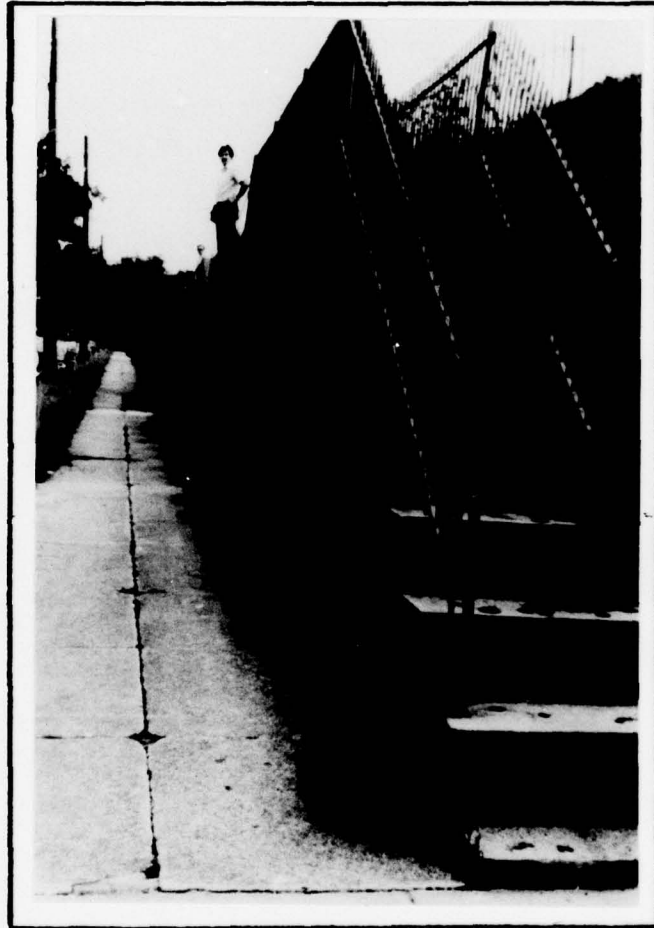
The continued loss of stone blocks and mortar from the 10th Street slope retaining wall could eventually cause its failure and that of the embankment. However, it was evident during the visual inspection that some repointing of the wall has been performed since its original construction.

TENTH STREET (SOUTH) SIDE 5/24/79  
OF THE RESERVOIR SHOWING  
THE STONE MASONRY RETAINING WALL

(3) The stone masonry retaining wall supporting the 10th street slope should be repointed and the missing stone blocks replaced to maintain the wall's structural integrity. According to the Owner's representative, this work is presently under way.
