PASSAIC RIVER BASIN
PEQUANNOCK RIVER TRIBUTARY,
MORRIS COUNTY
NEW JERSEY

TERRACE LAKE DAM

NJ 00542

PHASE 1 INSPECTION REPORT
NATIONAL DAM SAFETY PROGRAM.

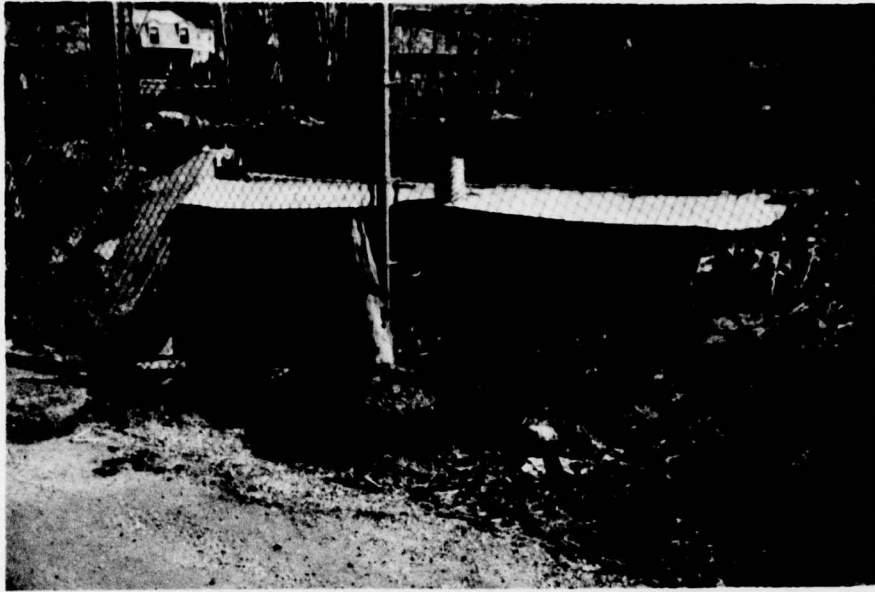
PHOTO 1
SPILLWAY CREST

The spillway was observed to be in satisfactory condition. Overflow from the spillway flows onto an apron and then into a box culvert under Terrace Road. Entrance to the culvert was partly blocked by stones and debris. Near the mid-section of the road the culvert transitions to a 48-inch corrugated metal pipe. The 48-inch pipe discharges into a small pond before flowing into the downstream channel.

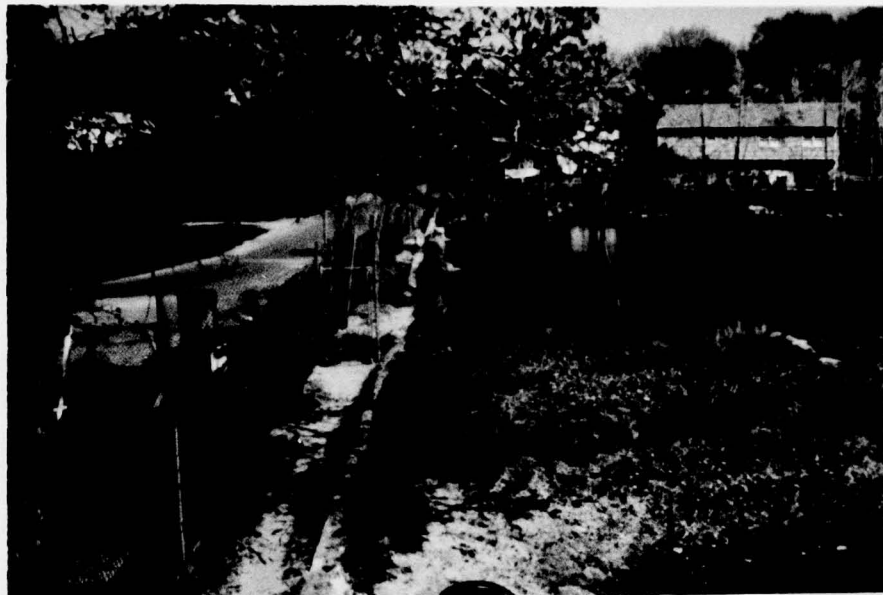
PHOTO 3

The east-west embankment at the main lake area was generally grass covered with some bare areas. The corewall is exposed for most of its length and appears to be structurally intact. The north-south embankment along the east side of lake is significantly deteriorated and eroded. The dam at the swim area consists of a concrete core wall, part of which is modified to form a sliding platform.

CREST OF DAM - NORTH EDGE OF LAKE

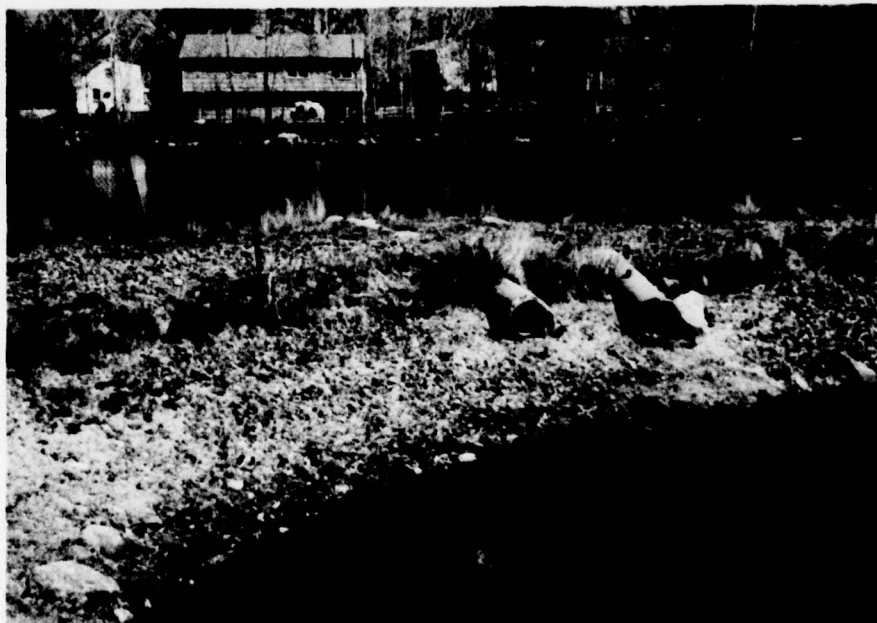
PHOTO 8

The reservoir is divided into a swim area and a main lake area used for boating. The swim area is about one-fourth the size of the entire lake. It is separated from the main area by a gravel dike which appeared to be in satisfactory condition. Two recreational slides are located at the northern edge of the lake.

LEVELING PIPES IN DIKE BETWEEN
SWIMMING AREA AND MAIN LAKE

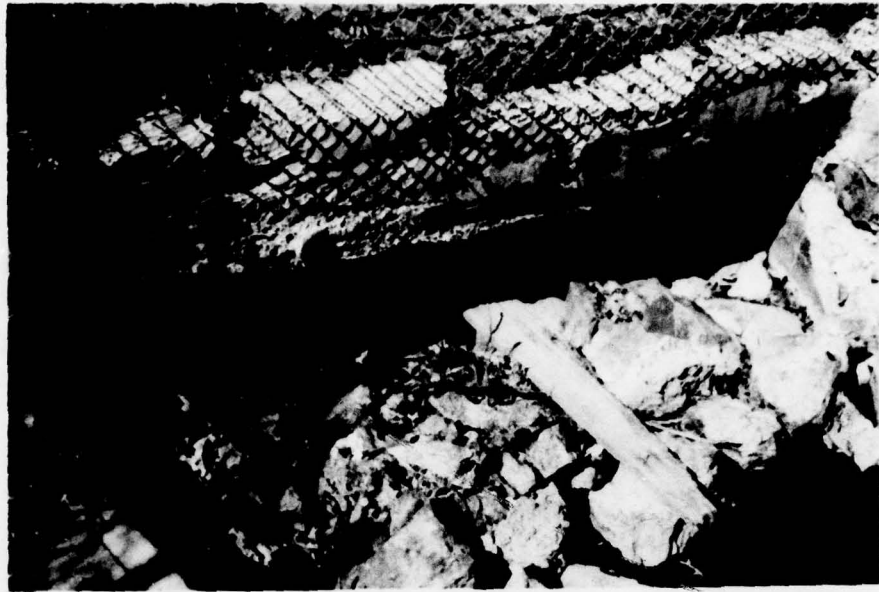
PHOTO 9

Reportedly, the box culvert under Terrace Road is undersized and often backs up causing flooding conditions in the vicinity of the road. Reportedly, the dam is occasionally overtopped due to heavy rain and on one occasion the house immediately downstream from the spillway was inundated to approximately one foot above ground level. The inundation apparently was primarily due to the inadequate capacity of the culvert.

VISUAL EXAMINATION OF	OBSERVATIONS	REMARKS OR RECOMMENDATIONS
<p>CONDITION (OBSTRUCTIONS, DEBRIS, ETC.)</p>	<p>Rocks and debris at entrance to box culvert result in a significant obstruction to flow.</p>	<p>Discharge from spillway discharge cha enters box culvert under minor road directly downstream from dam.</p>
<p>SLOPES</p>	<p>From the box culvert, discharge is piped across a lawn to a small pond. The pond outlets into a small stream bed located between backyards of homes.</p>	
<p>STRUCTURES ALONG BANKS</p>	<p>3 homes are located adjacent to the small pond approx. 100' downstream from the dam.</p>

CULVERT UNDER ROAD DOWNSTREAM FROM SPILLWAY

- (1) Renovate the concrete core wall in the north-south section of the dam (eastern edge of the lake).
- (2) Remove debris in the stilling basin and box culvert.
- (3) Remove trees and brush from the embankment.

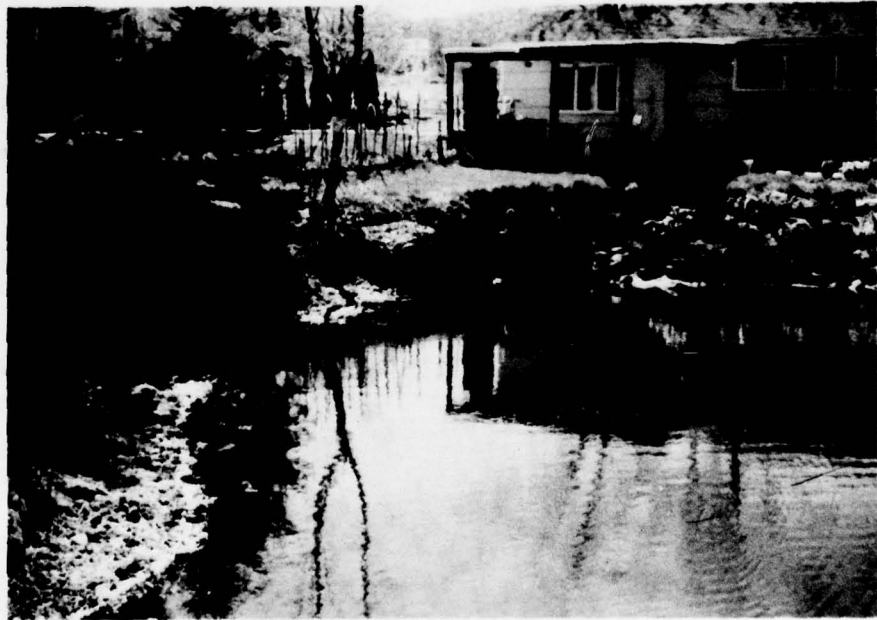
PHOTO 10

OUTLET OF CULVERT DOWNSTREAM FROM SPILLWAY
