DELAWARE RIVER BASIN
NORTH BRANCH TIMBER CREEK,
CAMDEN COUNTY
NEW JERSEY

NEW CAMP SITE DAM NJ 00412

PHASE 1 INSPECTION REPORT NATIONAL DAM SAFETY PROGRAM

Name of Dam New Camp Site Dam Fed ID# NJ 00412
NJ ID# 31-41

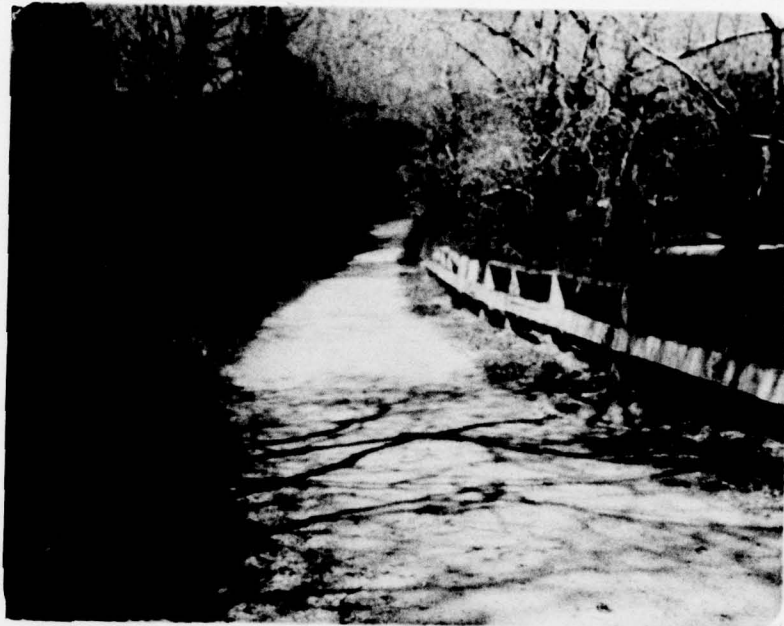
View of Crest
