DELAWARE RIVER BASIN
MUSCONETCONG RIVER,
MORRIS & SUSSEX COUNTIES
NEW JERSEY

LAKE WATERLOO DAM NJ 00276

6 PHASE 1 INSPECTION REPORT NATIONAL DAM SAFETY PROGRAM.

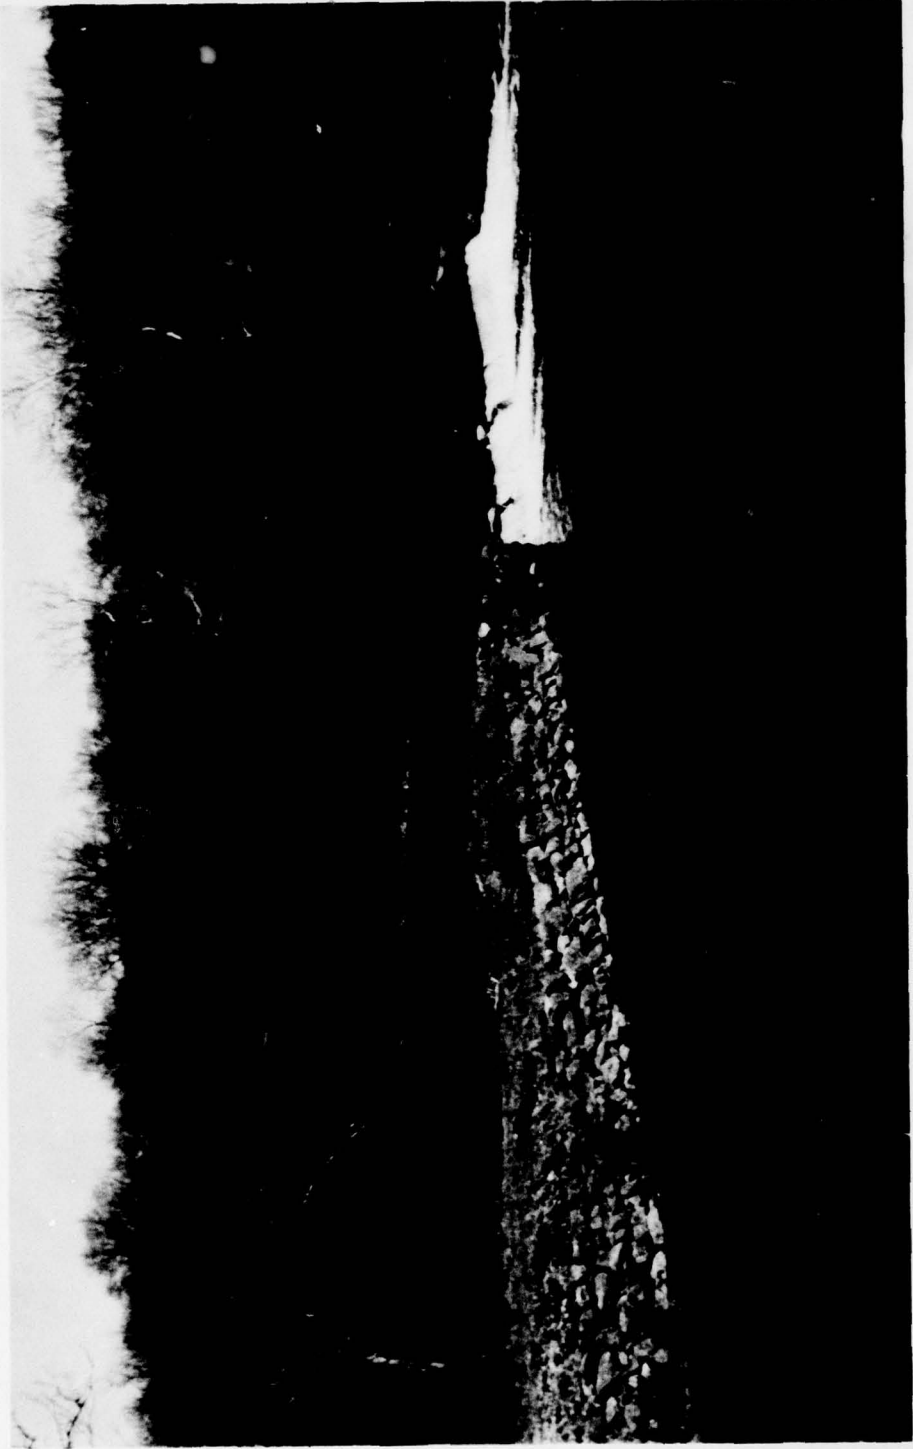
OVERVIEW - LAKE WATERLOO DAM

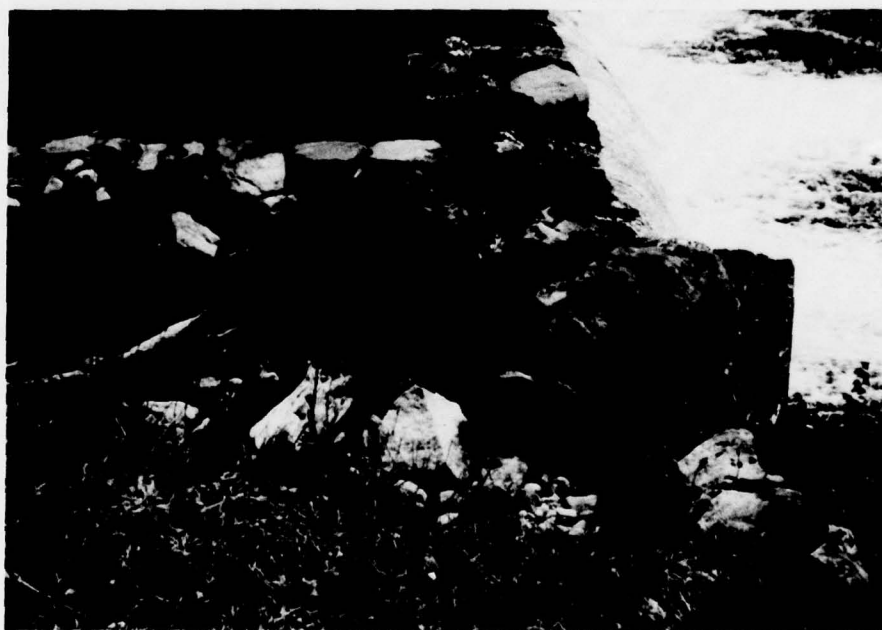
rocks and soil. A section of the dam adjacent to the north end of the spillway on the downstream side of embankment, was in a partially washed out condition at the time of inspection.

The most recent maintenance was the filling of the breach section of the embankment adjacent to the north end of the spillway about two years ago. Subsequent to that repair, the section has again partially washed out. Other maintenance was performed about four years ago when a breach section in the south section of the embankment was filled with rocks and earth.

PHOTO 2
WASHOUT ADJACENT TO NORTH END OF SPILLWAY

In addition, it is recommended that a professional engineer experienced in the design and construction of dams be engaged in the near future to investigate the repairs made at the breach locations and to determine their adequacy and prepare a detailed design for embankment improvements, including any necessary filling, regrading and riprap, and the embankment should be renovated accordingly. This remedial work should include a complete inspection and renovation of the spillway.

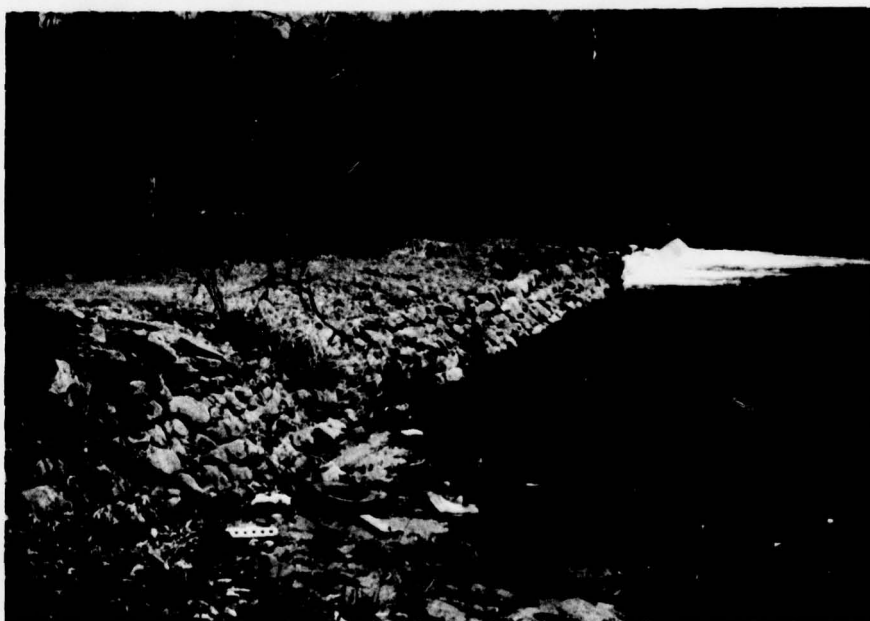
PHOTO 4

DOWNSTREAM FACE OF DAM

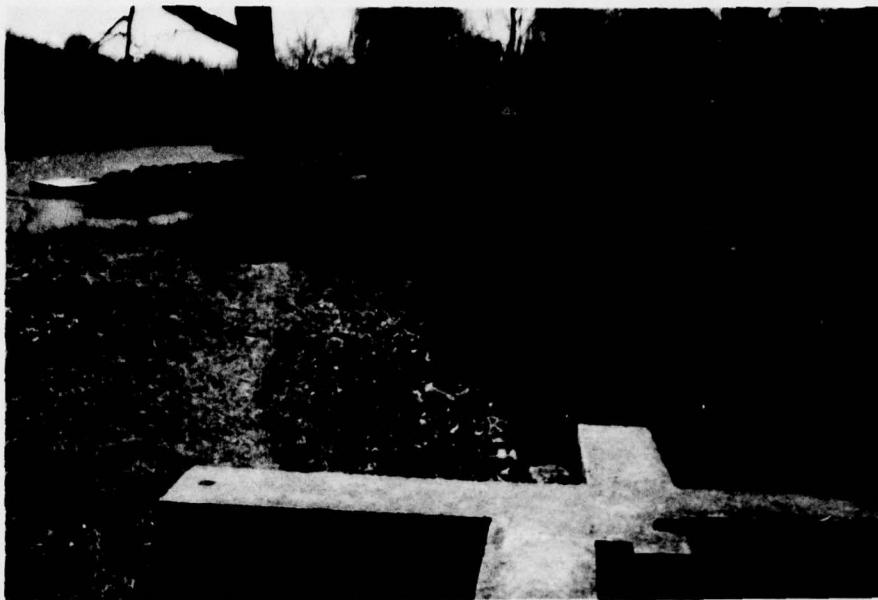
PHOTO 9

OUTLET WORKS DISCHARGE CHANNEL
