OLD MORRIS CANAL DAM NJ 00173

PHASE 1 INSPECTION REPORT NATIONAL DAM SAFETY PROGRAM.

Old Morris Canal Dam (NJ-00173).
Passaic River Basin. Rockaway River,
Morris County, New Jersey.

11 Jul 1979

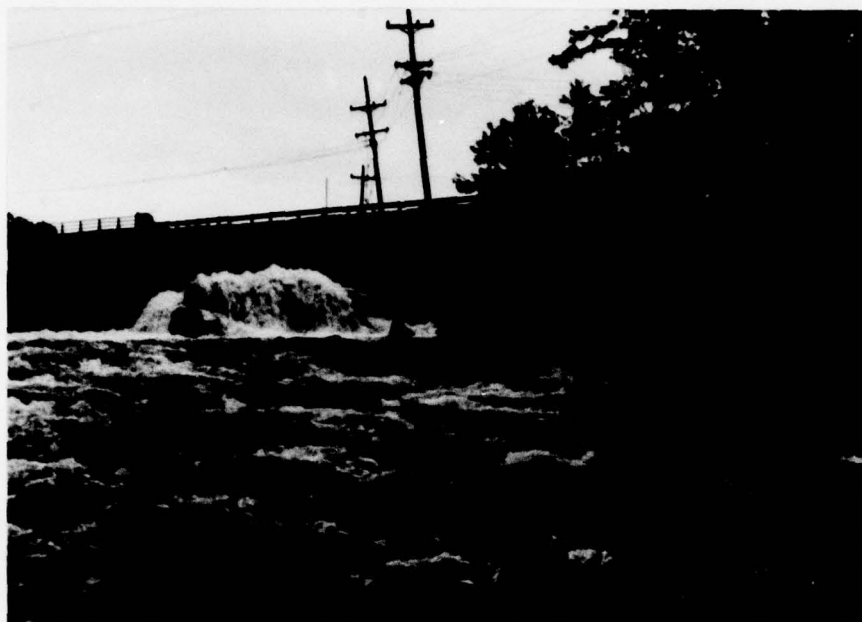
VIEW OF NORTHEAST SIDE OF SPILLWAY FROM DOWNSTREAM

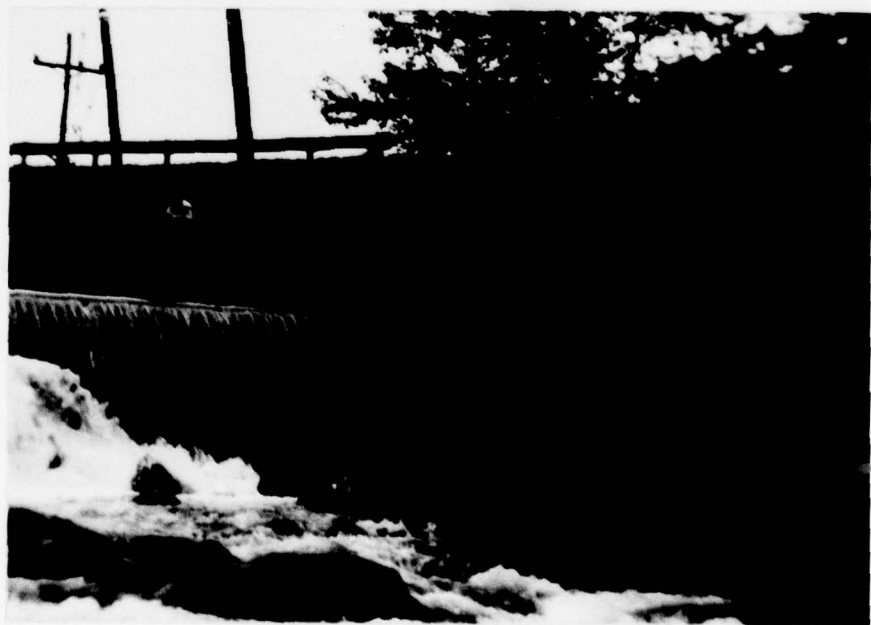
VISUAL EXAMINATION OF	OBSERVATIONS	REMARKS OR RECOMMENDATIONS
SURFACE CRACKS CONCRETE SURFACES	<p><u>Left Abutment:</u> Wall surface badly eroded and spalled wall undermined @ water surface. <u>Right Abutment:</u> Same as left. Stone masonry training wall - 40' D/S is raveling.</p>	<p>Concrete undermining should be repaired. Wall should be repaired.</p>
STRUCTURAL CRACKING	<p>Some hairline cracking.</p>	
VERTICAL AND HORIZONTAL ALIGNMENT	<p>No indication of movement. No indication of distress.</p>	
MONOLITH JOINTS	<p>None visible.</p>	
CONSTRUCTION JOINTS	<p>None visible.</p>

DOWNSTREAM SIDE OF NORTHEAST ABUTMENT

a. Within 30 days from the date of approval of this report, engineering studies and analyses should be initiated to design and supervise repairs to the undermining and serious erosion at and below the northeast abutment.

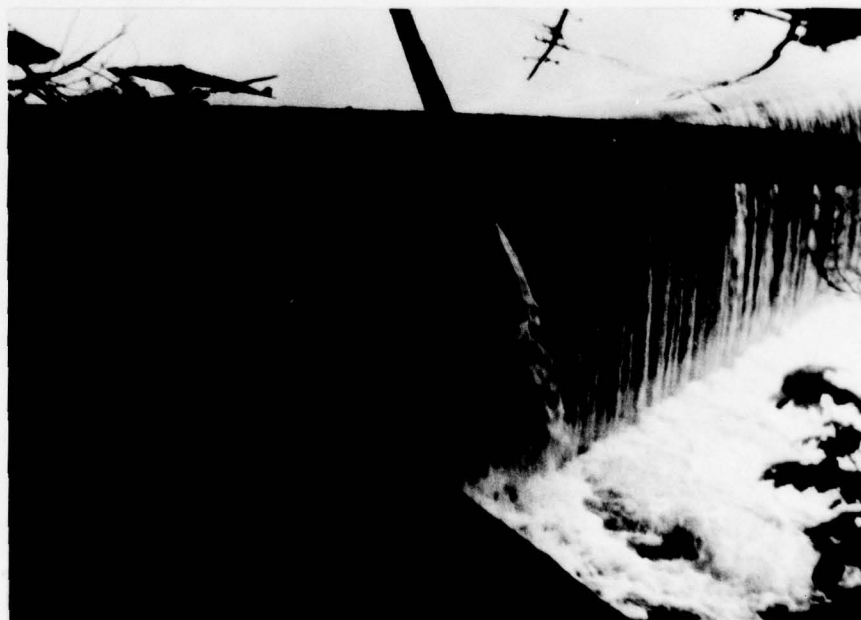
b. Dam. Water was discharging over the overflow section of the dam at the time of the inspection, and it was consequently not possible to determine visually the character and condition of that section. Based on what could be seen beneath the overflowing water close to the abutments, it appears that the overflow section is a stone masonry dam with a concrete cap and upstream facing. The concrete cap near the abutments appears to be in fair condition. It shows evidence of limited erosion and some coarse aggregate is visible. The crest of the overflow section is very straight along each of the two sections of the dogleg alignment. There is a bedrock knob exposed on the downstream face at the break in alignment of the crest and bedrock is also exposed on both sides of the channel downstream of the dam. It appears, therefore, that the overflow section is founded on bedrock. There is a concrete training wall at each end of the overflow section. The surface of both training walls is badly spalled and eroded, particularly at the water surface. Between the northeast end of the dam and the northeast abutment (which is a highway fill) there is a fill which extends upstream and downstream with an essentially horizontal surface. This fill is used as parkland. A large timber, a large log and several other pieces of debris are lodged on the crest of dam near the southwest concrete training wall.

DEBRIS ON TOP OF SOUTHWEST ABUTMENT

b. Within 30 days from the date of approval of this report, the debris lodged on the southwest end of the spillway crest should be removed.
