POWERVILLE DAM

NJ 00174

6 PHASE 1 INSPECTION REPORT  
NATIONAL DAM SAFETY PROGRAM.

11 June, 1979

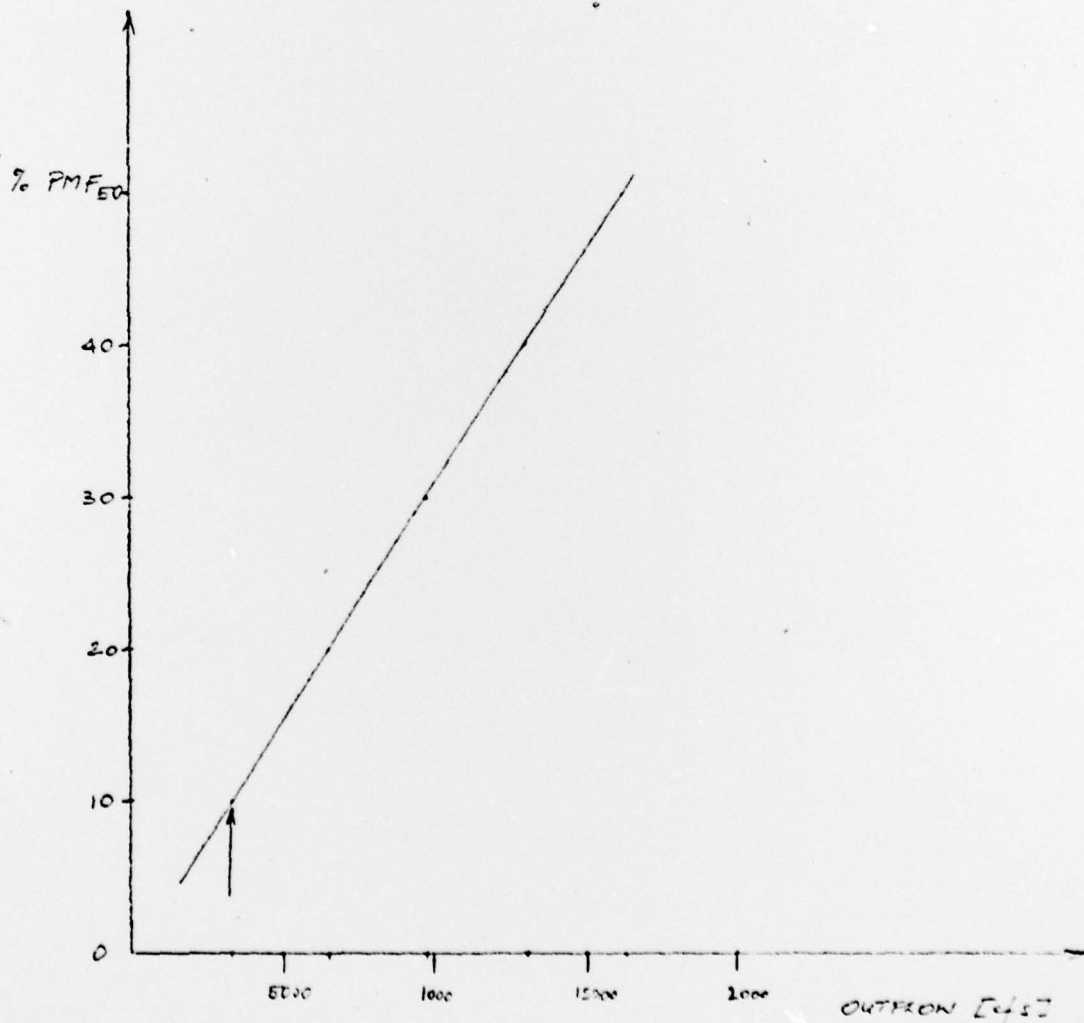
OVERTOPPING POTENTIAL

DAM OVERTOPS AT APPROX EL. 495.2 WITH  $Q = 3246 \text{ cfs}$   
 $\therefore$  DAM CAN PASS 10% OF PMF
