LAKE CUSHETUNK DAM NJ 00347

PHASE 1 INSPECTION REPORT NATIONAL DAM SAFETY PROGRAM

August, 1979

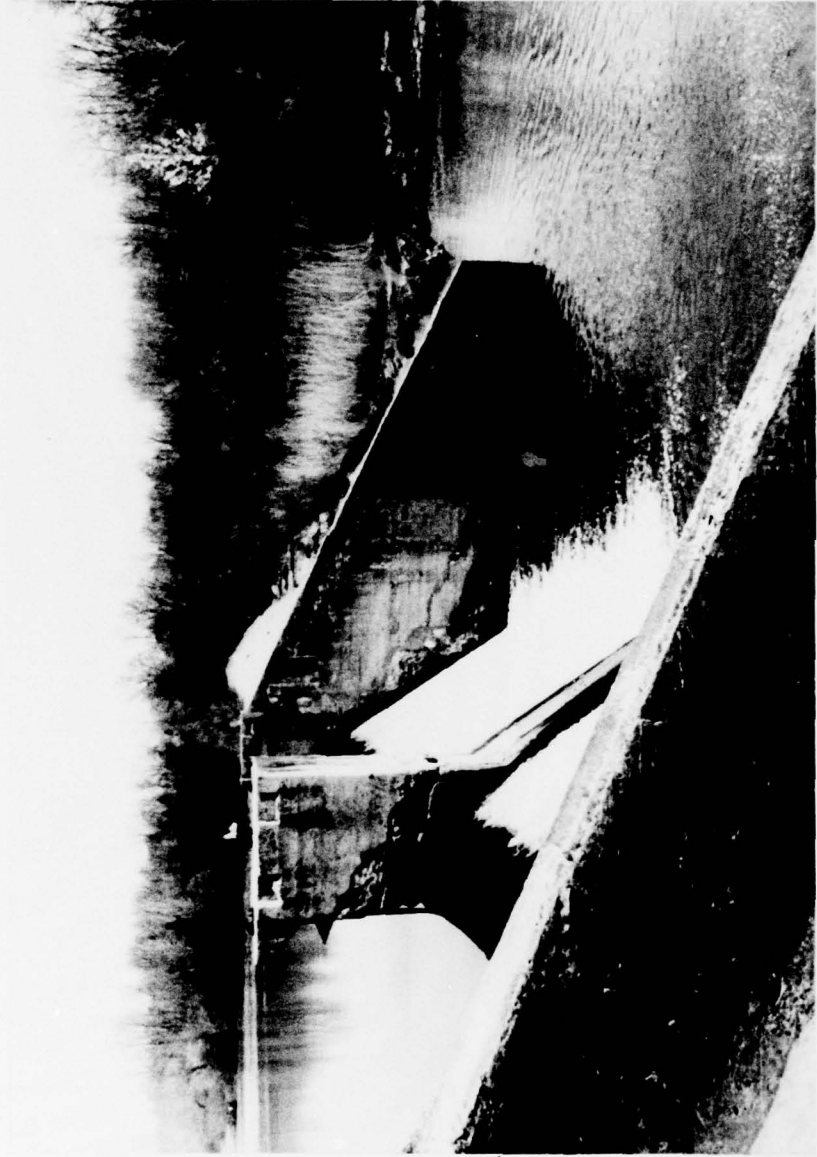
Lake Cushtunk Dam
Overall view of dam from the right.

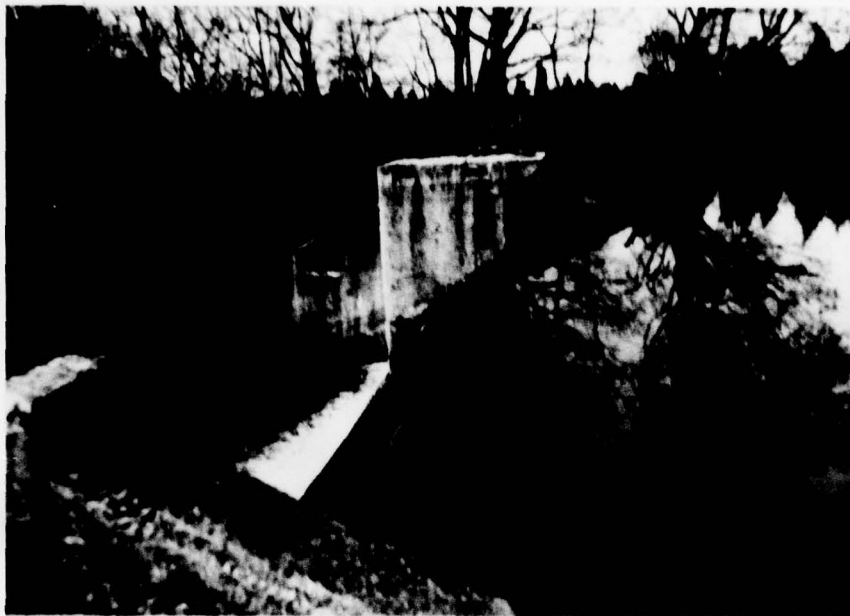
The original footbridge giving access across the spillway and to the low-level outlet valve shaft has been removed. The footings are cracked, and the central pier is in danger of collapse due to the severe cracking at the waterline.

Photo No. 1 - Overall view of spillway from left side. The foot-bridge has been removed. Note the key shaft for the low level outlet valve in the central buttress, and the advanced deterioration of the concrete at the water line.

2. A safe means of lowering the lake should be provided. This would involve restoring the existing outlets to operable condition and reinstating the footbridge across the spillway. This work should commence within six months.

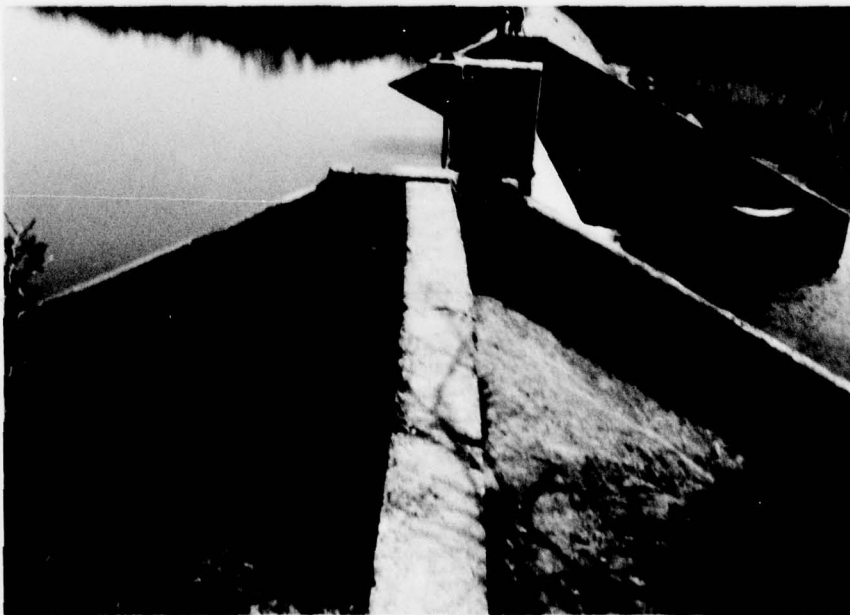
Photo No. 2 - View of spillway from the right embankment showing the exposed core-wall and the left embankment with its concrete cover. Note also the crack in the upstream wingwall and the general deterioration of concrete.

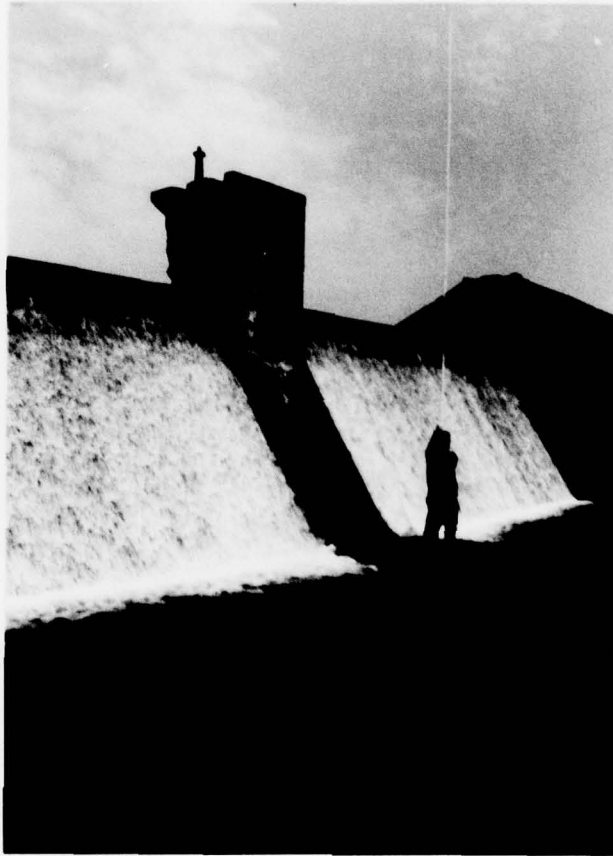
Photo No. 3 - View of spillway from downstream, showing low-level outlet.

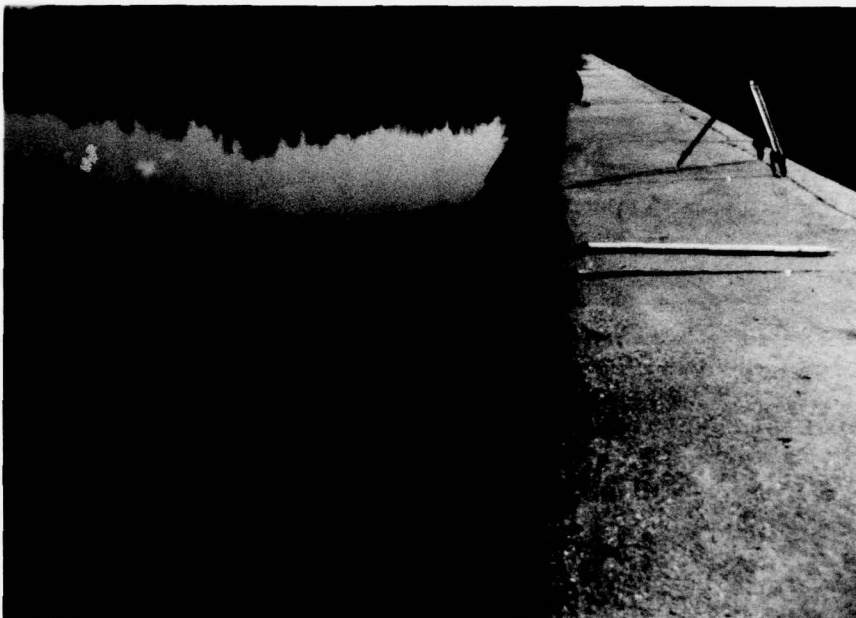
The left embankment, modified for 260' of its length to serve as an auxiliary spillway, is also in a deteriorated condition. The modified section, covered on top and both faces by a concrete slab, shows signs of settlement and erosion of fill. Extensive surface cracking parallel and normal to the axis has taken place on the concrete covering of the embankment. The most serious cracking is on the upstream side of the crest, where the covering is sheared by up to 6". All cracks appear to have penetrated the full thickness of the concrete. In several places, vegetation and small bushes are growing in the cracks, aggravating the cracking process. At the toe, there is minor superficial cracking, and the weephole drains in this zone are blocked. The upstream concrete slab has been undermined by wave action and pronounced misalignment has occurred. The unmodified section of the left embankment is covered with a very heavy growth of trees and brush.

Photo No. 4 - View of left embankment, covered by concrete to form an emergency spillway. Extensive cracking has occurred and vegetation is growing in the cracks.

3. Repair all cracked and spalled concrete with epoxy cement within six months.
4. Provide rip-rap protection along entire upstream face within 12 months.

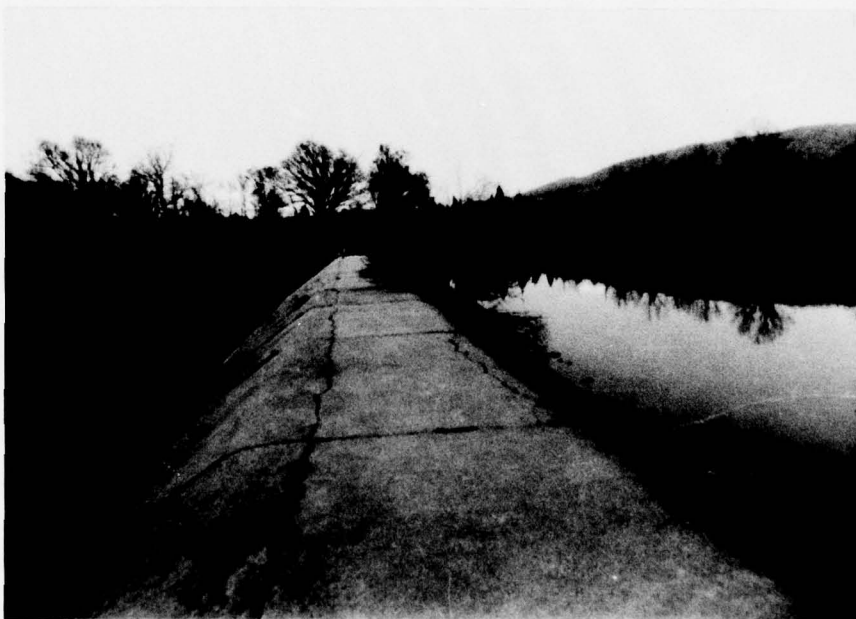
Photo No. 5 - View of left embankment looking towards the spillway. Note that toe protection has been provided along the length of the embankment.

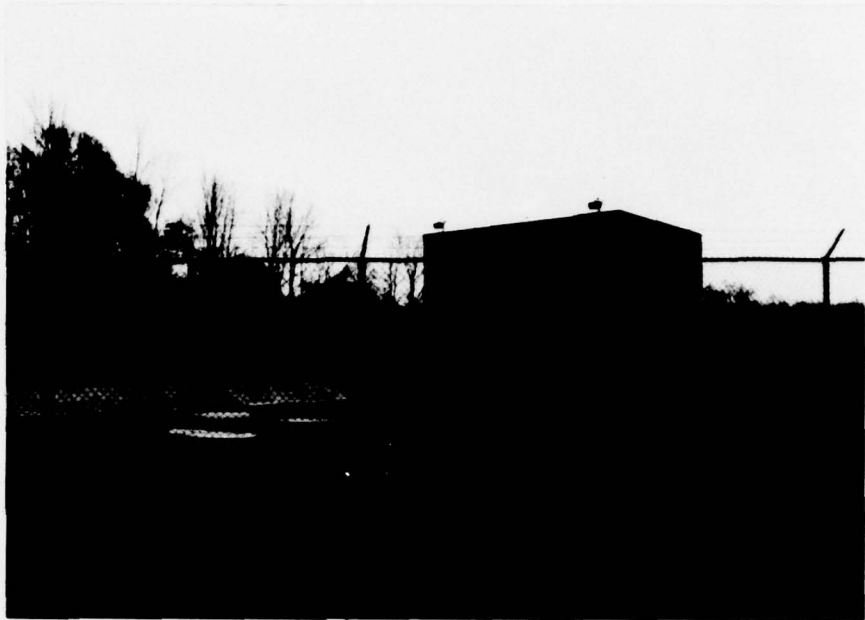
Photo No. 8 - View of valve house 1,000 feet downstream of the dam. The valve house controls an outlet from the Round Valley Reservoir.
