HUDSON RIVER BASIN
PAPAKATING CREEK TRIBUTARY
SUSSEX COUNTY
NEW JERSEY

LAKE NEEPAULIN DAM NJ 00282

PHASE 1 INSPECTION REPORT NATIONAL DAM SAFETY PROGRAM

August, 1979

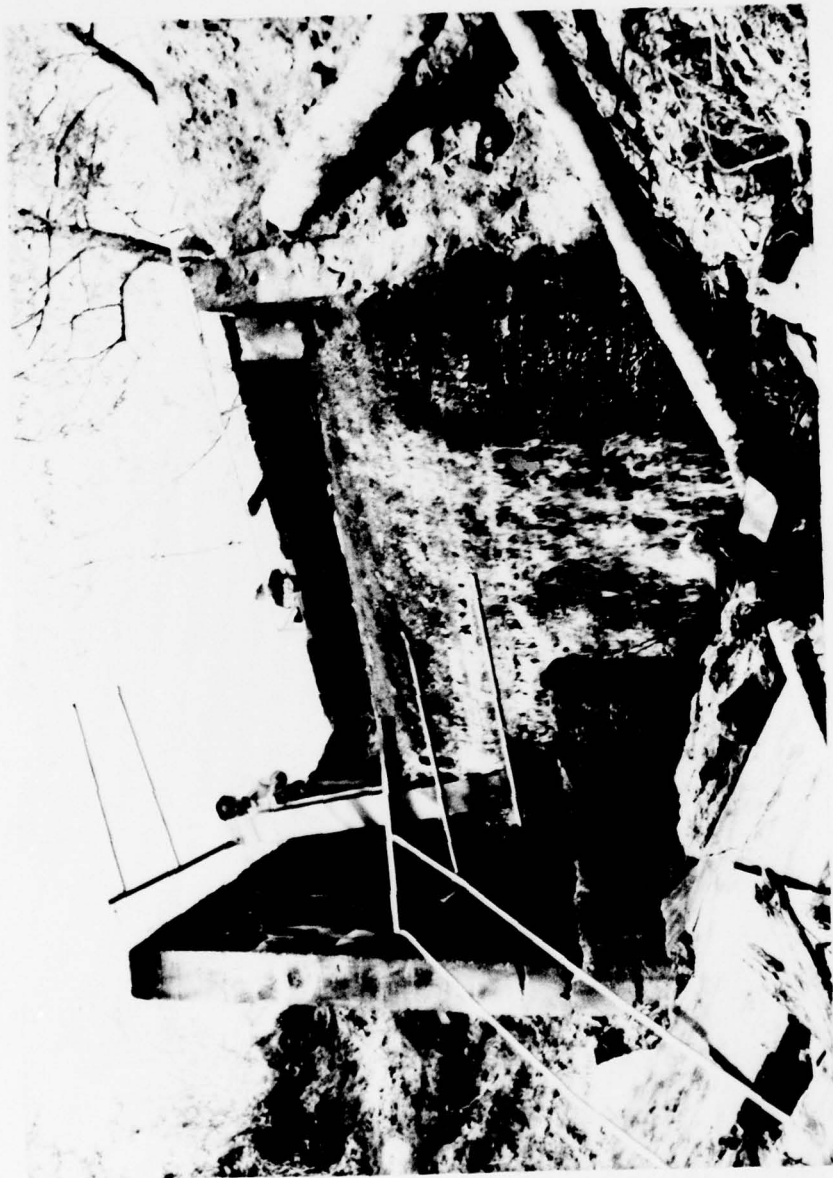
Lake Neepaulin Dam
View of spillway, downstream face.

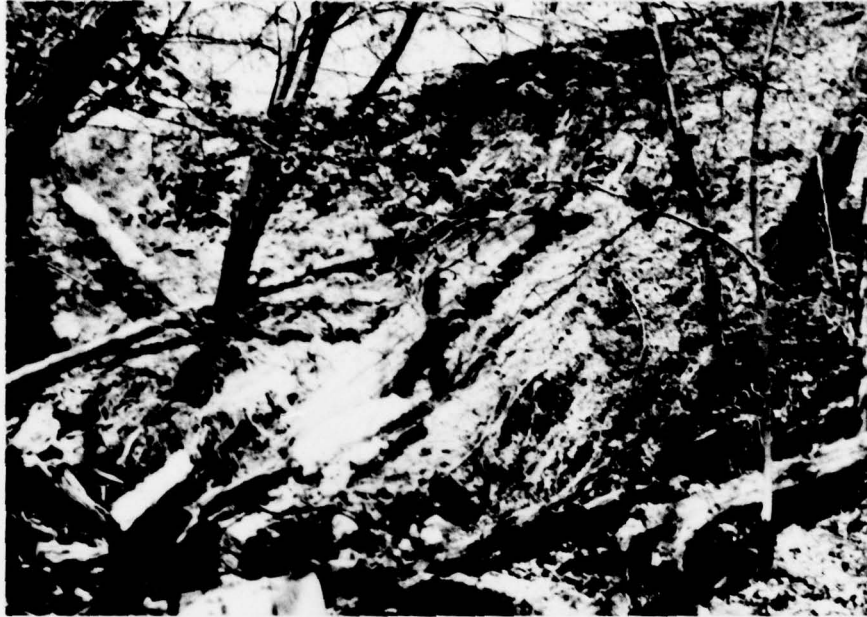
The dam embankment does not appear to be stable. The downstream face has a 1H:1V slope. The left embankment is severely eroded at the downstream face next to the spillway, to a nearly vertical slope along the top 11 feet for 25 feet of length. Similarly, the face of the upstream embankment, above the lake surface is on a 1H:1V slope and no rip-rap protection was placed on this face. However, no cracking is visible anywhere on the embankment, and no misalignment has been noted. On top of the upstream face, trees are growing uncontrolled to 8-inch diameters. Brush and trees, to 9-inch diameters are also growing uncontrolled on left and right downstream embankment faces.

Photo No. 3 - View of left downstream face near spillway showing severely eroded embankment slope and fallen trees. Note also the retaining wall at toe.

1. The embankment material that has been eroded from the downstream face, particularly adjacent to the left wingwall of the spillway, should be replaced with quarry-process stone or gravel. Slopes should be reconstructed with keying and compaction of material to improve stability and to support the abutments and wingwalls. Slopes should be as determined by the stability analysis, and should be protected with rip-rap near the spillway. This work should be undertaken within six months.

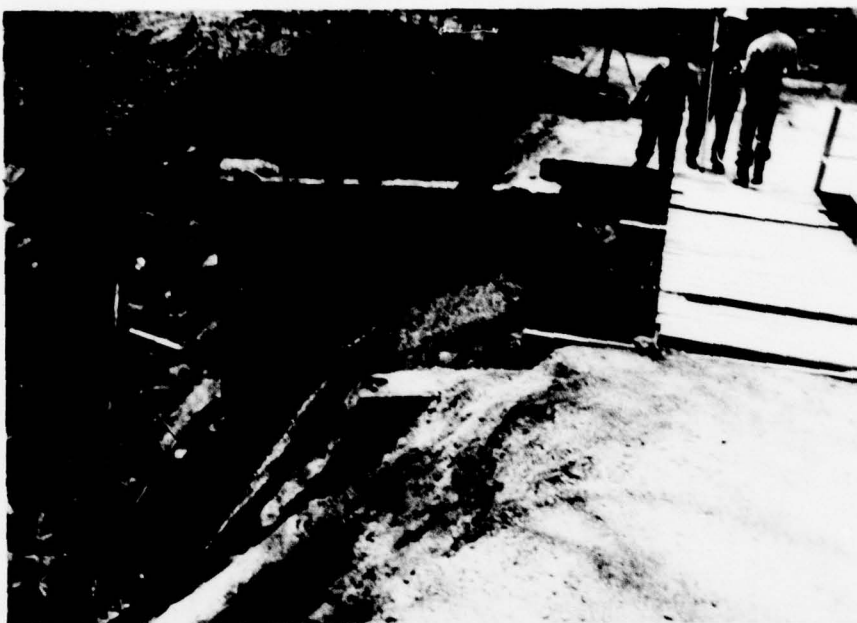
The downstream steel stringer of the footbridge has been dislodged by ice, and is resting on the spillway. Timber planking of the remaining bridge is deteriorated and the small bridge piers are cracked.

Photo No. 5 - View of top of dam showing footbridge, spillway structure, and right embankment. Note fallen stringer and hand-railing. Outlet pipe discharge is partially visible beyond right wingwall.

(5) Rehabilitate the footbridge across the spillway.

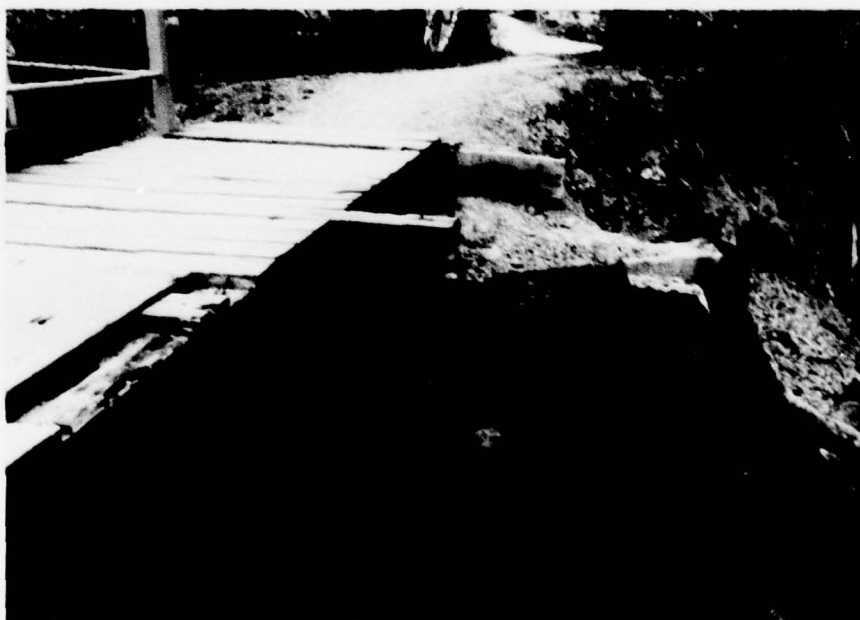
The concrete ogee spillway shows signs of surface weathering, with erosion along the construction joints. The left wingwall is broken off where it intersects the spillway surface. Erosion is visible around the concrete structure.

Photo No. 6 - View of top of dam showing spillway and left embankment. Note eroded downstream slope, spillway, the broken left wingwall and footing of fallen stringer.

3. Repair all cracked and spalled concrete with epoxy cement within six months. Rebuild the left wingwall and resurface the ogee spillway to a smooth finish.

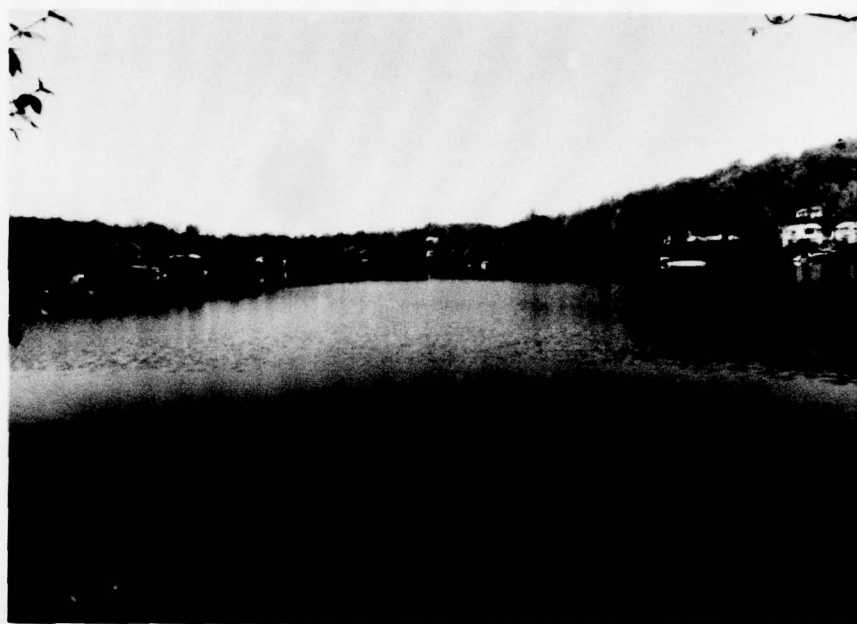
Photo No. 7 - View upstream from top of dam, showing lake and lakefront properties. Note moderate, wooded slopes.

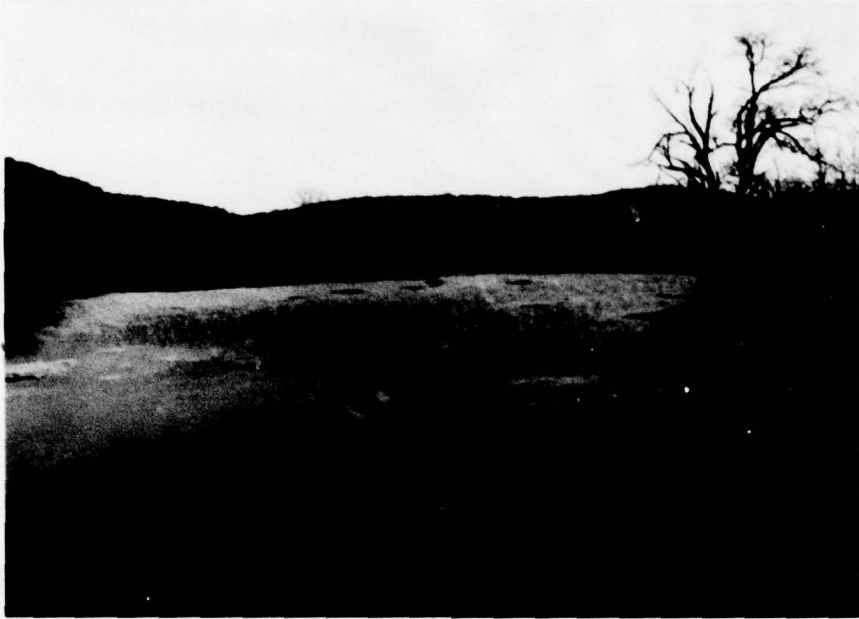
Photo No. 9 - Small pond located about 1/2 mile downstream from Lake Neepaulin Dam, where downstream channel widens out into a broad floodplain. The view is upstream.

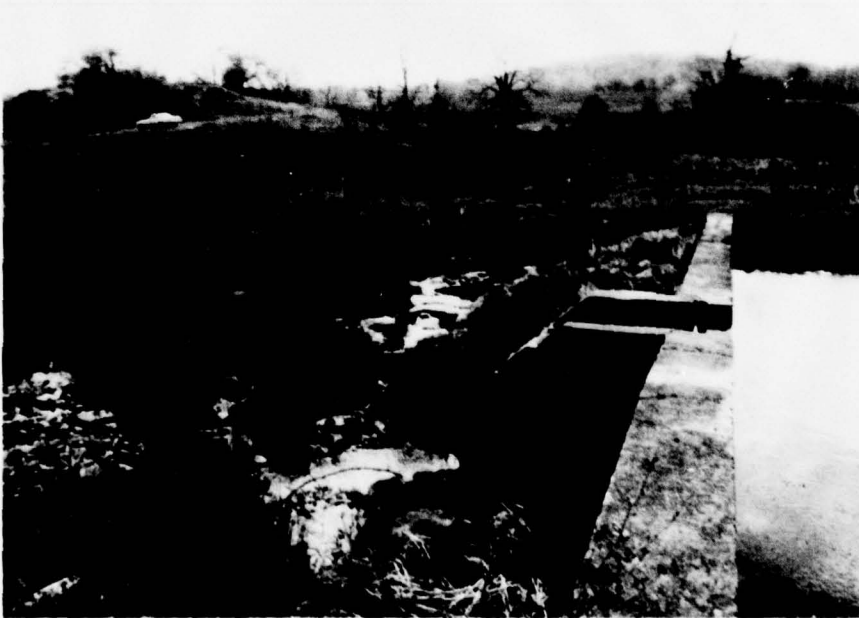
Photo No. 10 - Retaining structure of downstream pond.
