NEW JERSEY DEPT OF ENVIRONMENTAL PROTECTION TRENTON  
NATIONAL DAM SAFETY PROGRAM. GREENWOOD LAKE DAM (NJ-00187), HUD--ETC(U)  
AUG 79 A G POSCH

DACW61-79-C-0011

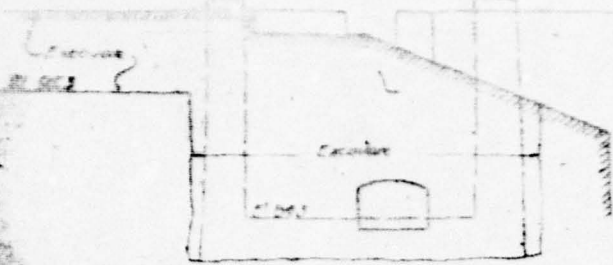
SECT. TU OF FOREBAY 10 FT. NW FROM  
AND PARALLEL WITH NEW GATE HO.  
NEW WORK SHOWN IN BROKEN LINES  
SCALE 1 IN. = 8 FT.

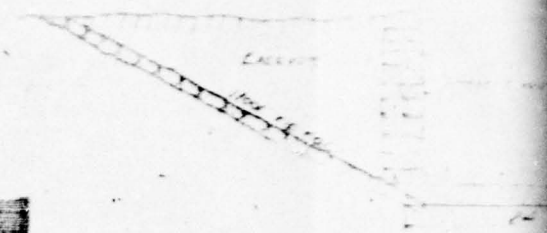
SECT. XY OF FOREBAY 16  
PARALLEL WITH REAR  
UPPER DAM MAY BE AT THIS SECTION  
LAKE TO BE DRAWN OFF TO ELEV. 92  
SCALE 1 IN. = 8 FT.

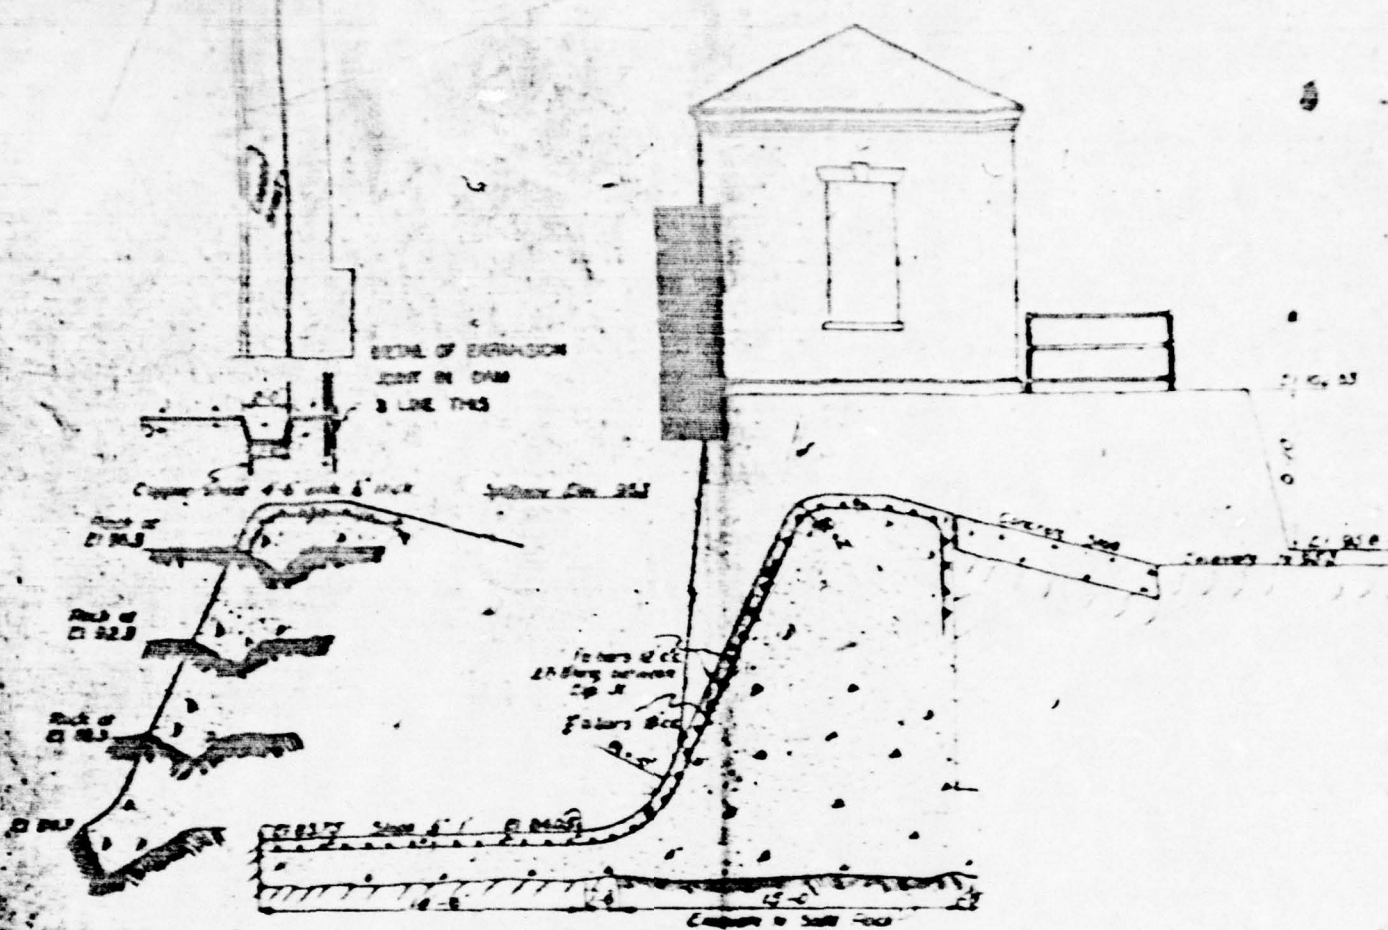
BROKEN SECTION CD THROUGH FOREBAY LOOKING TOWARD GATE HOUSE

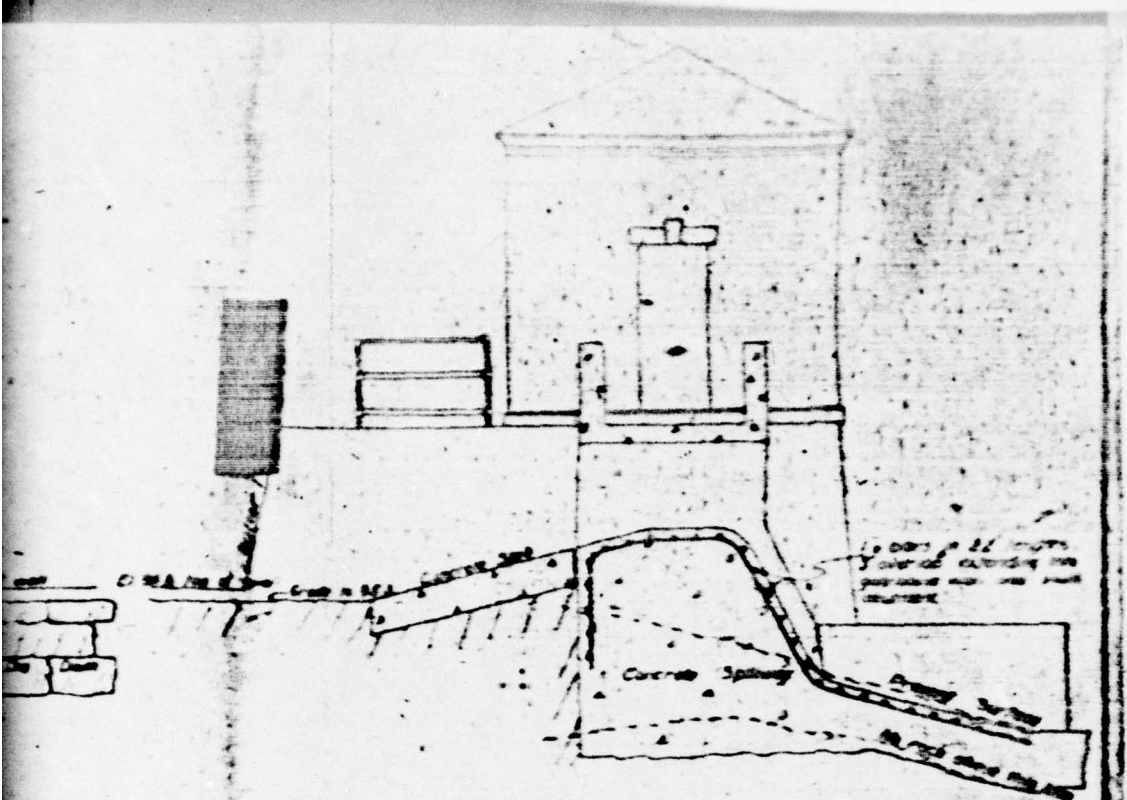
WEST ELEV. OF GATEHOUSE AND SECTION THROUGH  
 SPILLWAY AND BRIDGE 10 FEET WEST OF GATEHOUSE

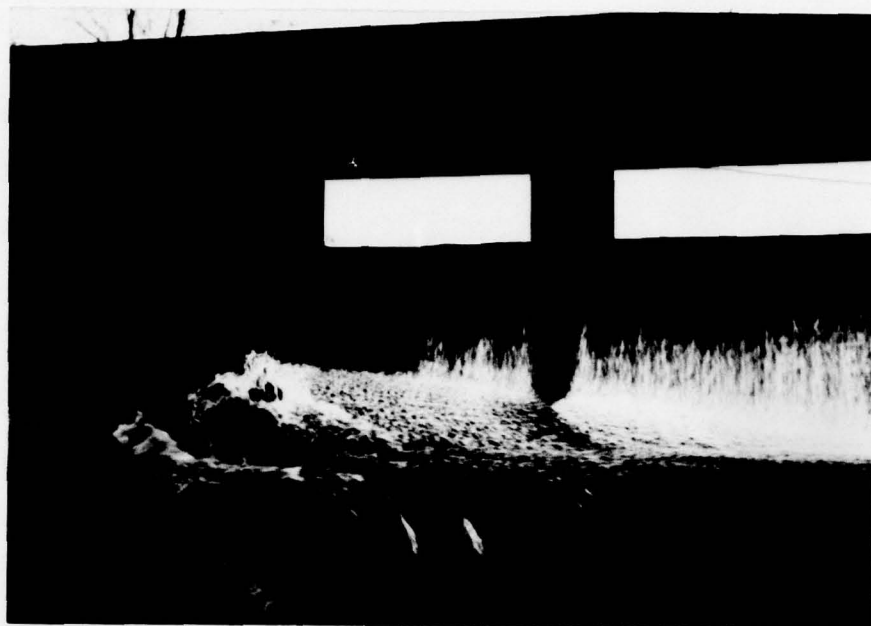
Photo No. 3 - Detail of right spillway. Note the deteriorated concrete at the foot of the bridge pier, the smooth overall flow, the good condition of the bridge and the minor debris on the apron.

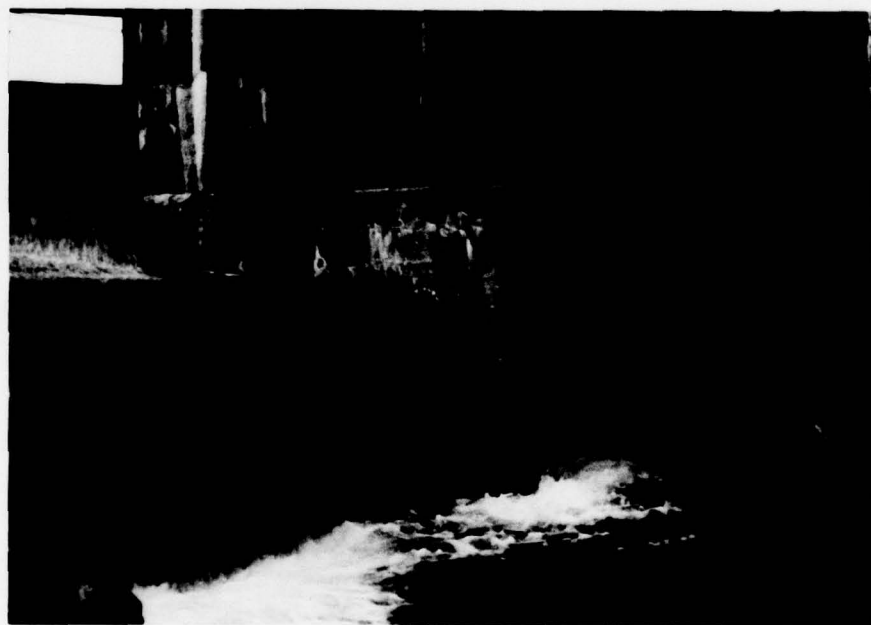
Photo No. 4 - Detail of gatehouse foundation, showing the spalled concrete at the water line, and the leak in the central sluice.

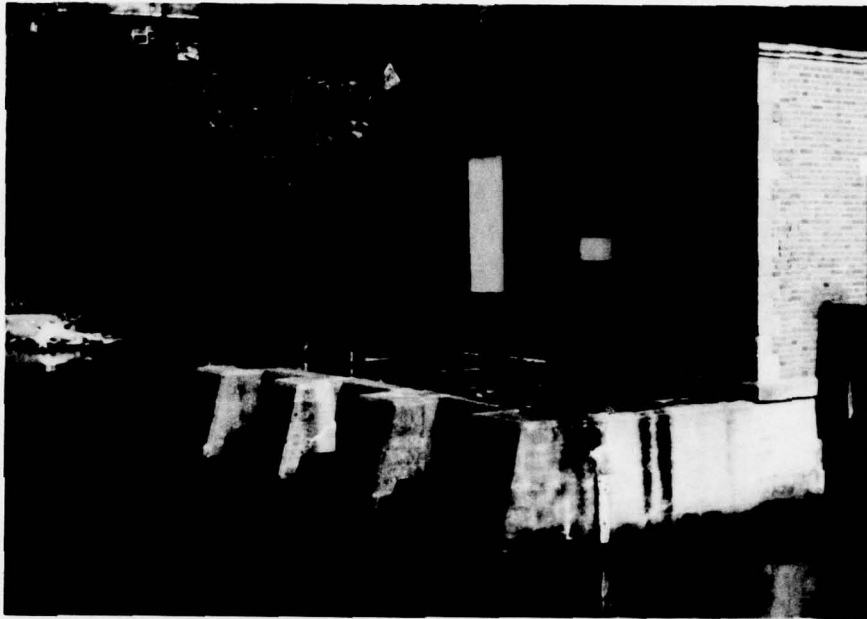
Photo No. 5 - Detail showing the upstream side of the gatehouse. Note the headwater gage, the lifting gantry for the trash screens, and the good exterior condition of the house.

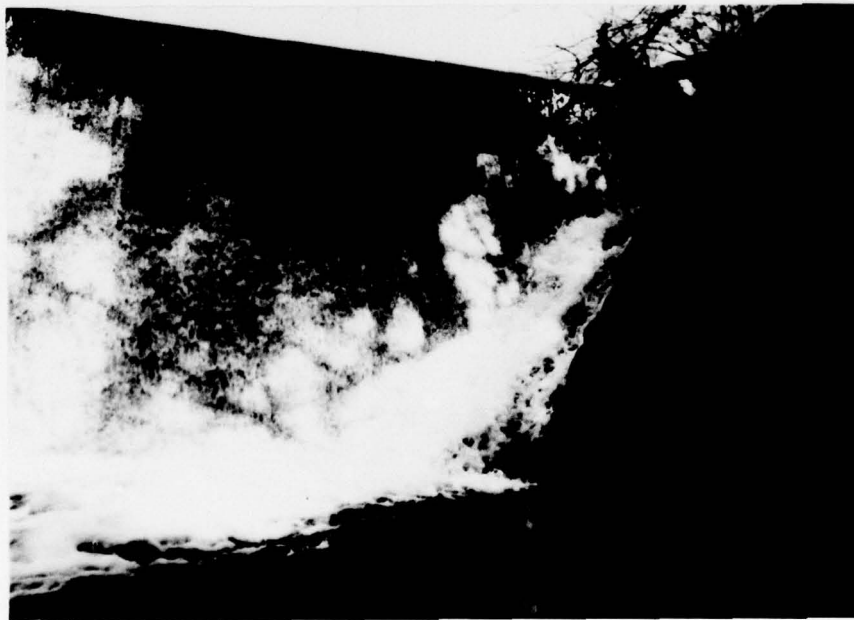
Photo No. 6 - Detail of the left rock abutment, showing the tree lodged at the spillway crest, and the smooth flow on the spillway.

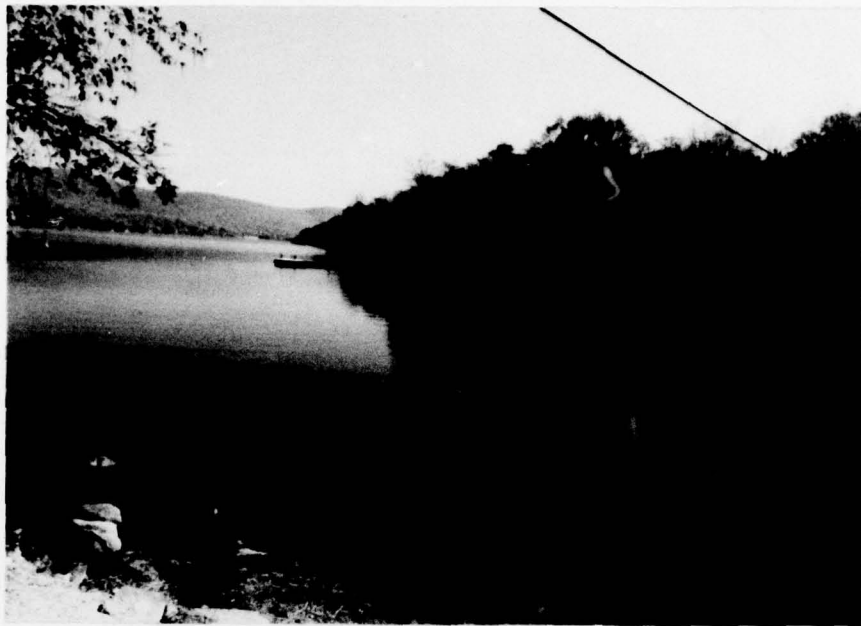
Photo No. 9 - Overall view of Greenwood Lake looking upstream. Note the shoreline buildings and boat stages.

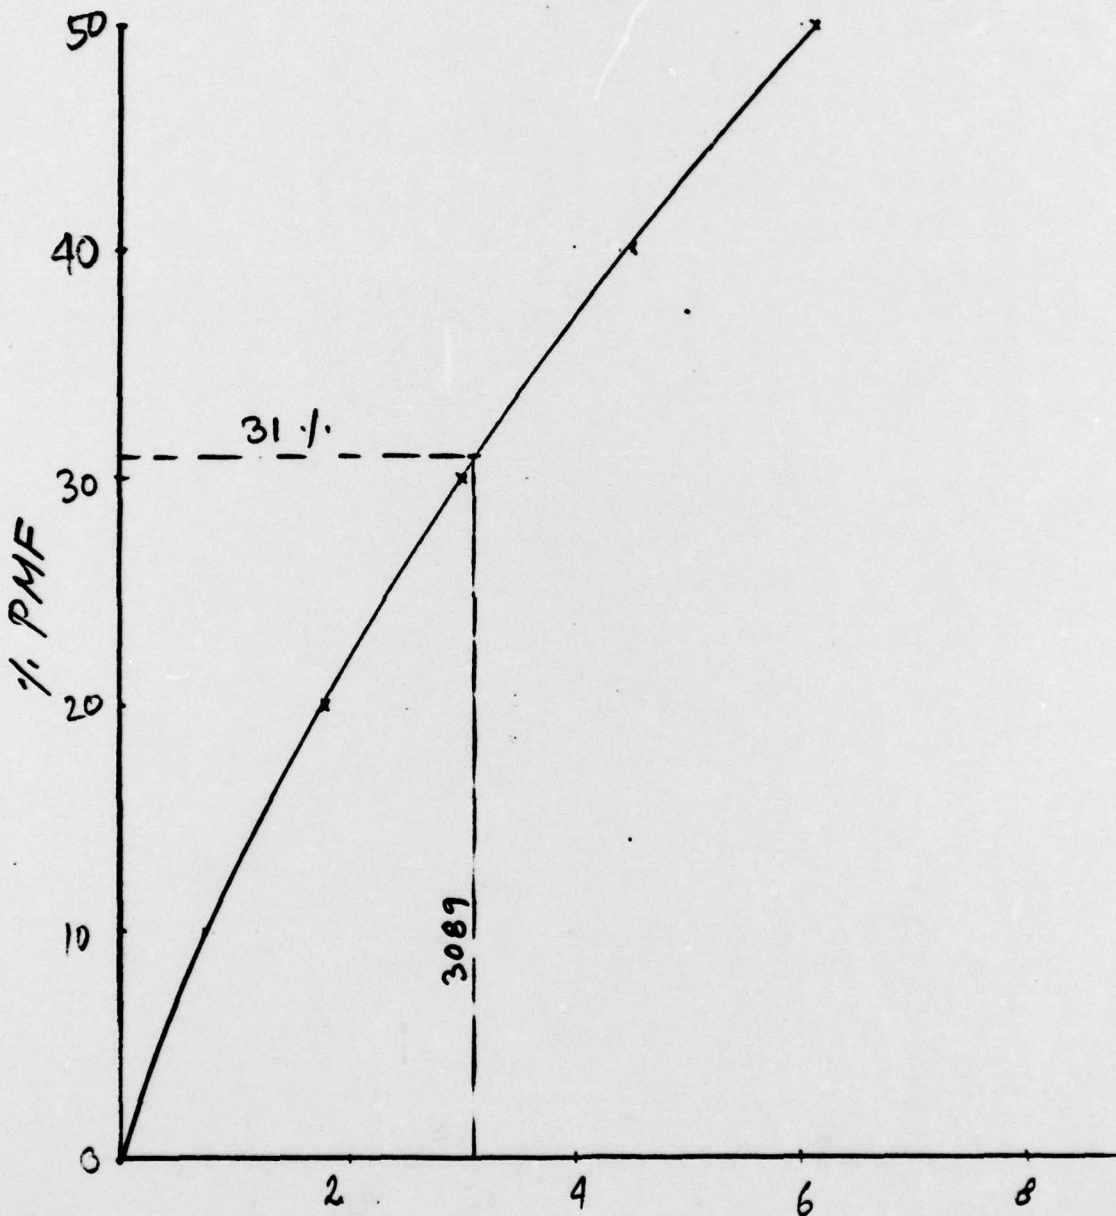
Outflow in  $10^3$  cfs.  
Overtopping of the Dam occurs at El 639.10  
 $Q = 3089$  cfs (31% of PMF)
