DELAWARE RIVER BASIN
NISHISAKWICK CREEK
HUNTERDON COUNTY
NEW JERSEY

NISHISAKWICK CREEK DAM NJ 00129

PHASE 1 INSPECTION REPORT NATIONAL DAM SAFETY PROGRAM

79 10 02 042
August, 1979

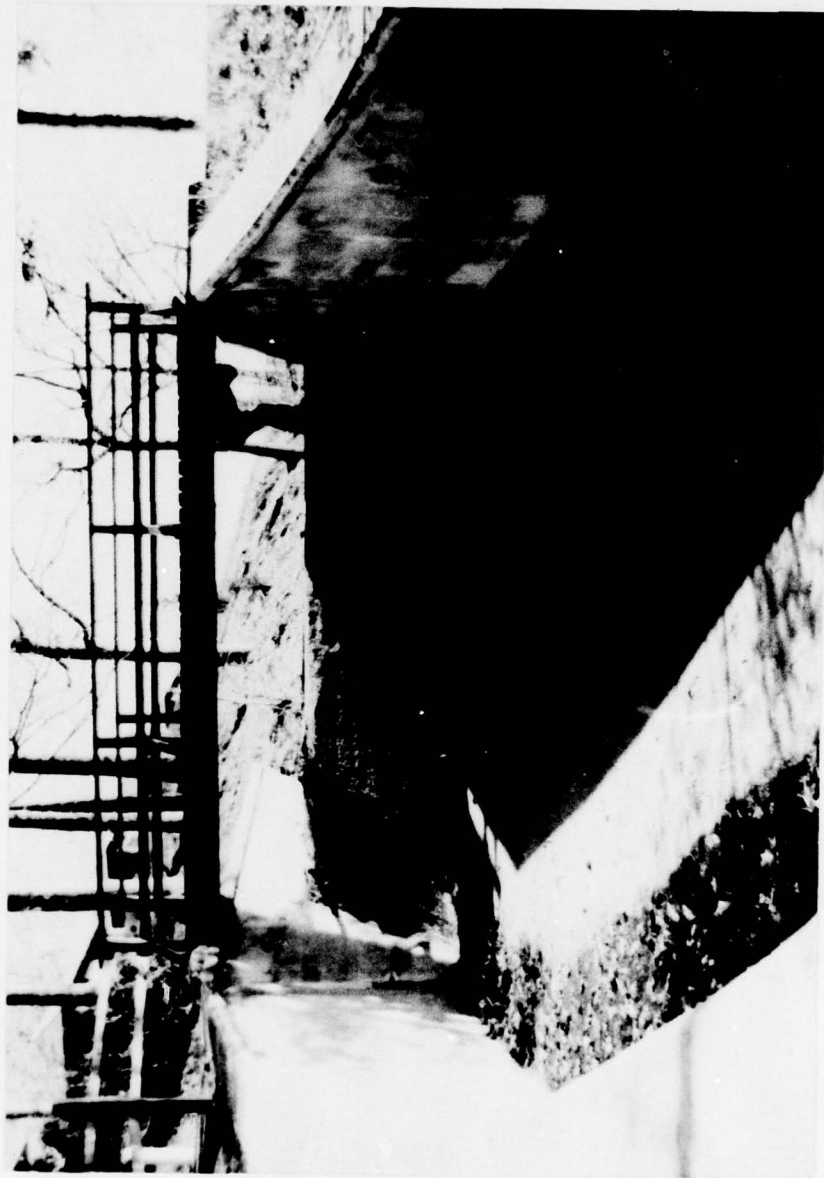
Nishisakwick Creek Dam
Overall view of spillway structure from downstream.

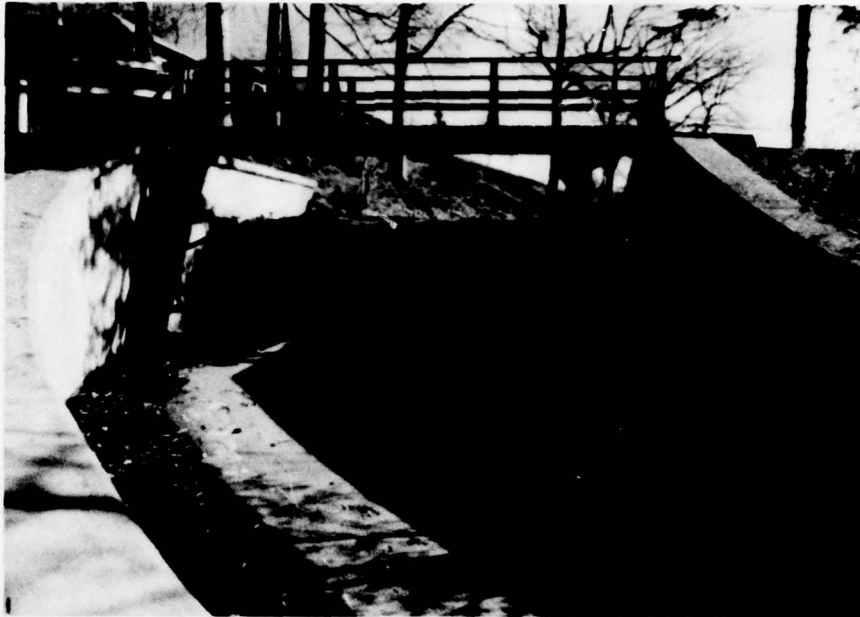
The lake level at the time of inspection was below the spillway crest. The concrete ogee and discharge channel were found to be in satisfactory condition. Minor cracks in the channel wall and across the ogee were noted, from which water was seeping at a rate not exceeding 1/2 gpm. The secondary outlet gate on the left side appeared to be susceptible to blockage with debris.

Photo No. 1 - Overall view of spillway and bridge structure from downstream. Note crack at joint of vertical and sloped right wing-wall, also seepage at the base of the spillway.

(3) Replacement of small quantities of eroded fill and riprap, and repair of minor cracks should be undertaken during routine maintenance.

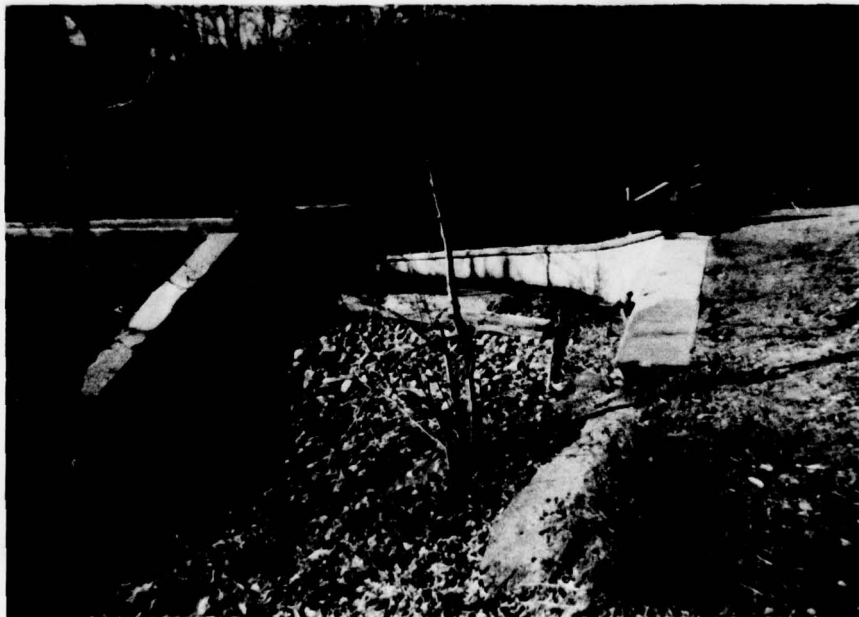
Photo No. 2 - Overall view of upstream face of spillway. Note build-up of stones and silt at the spillway inlet.

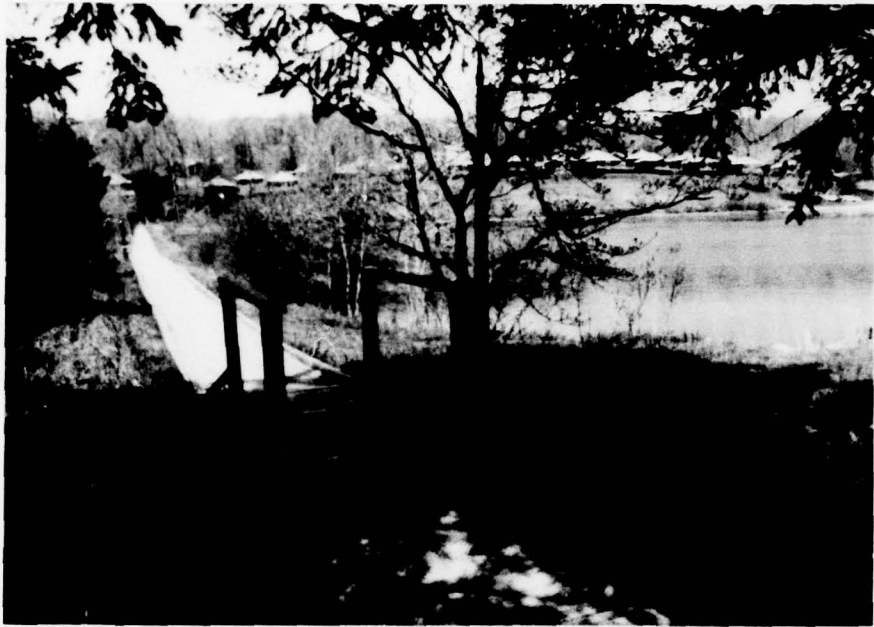
Photo No. 3 - View of concrete walkway along the crest and the emergency spillway. Note outlet pipe from the lake.

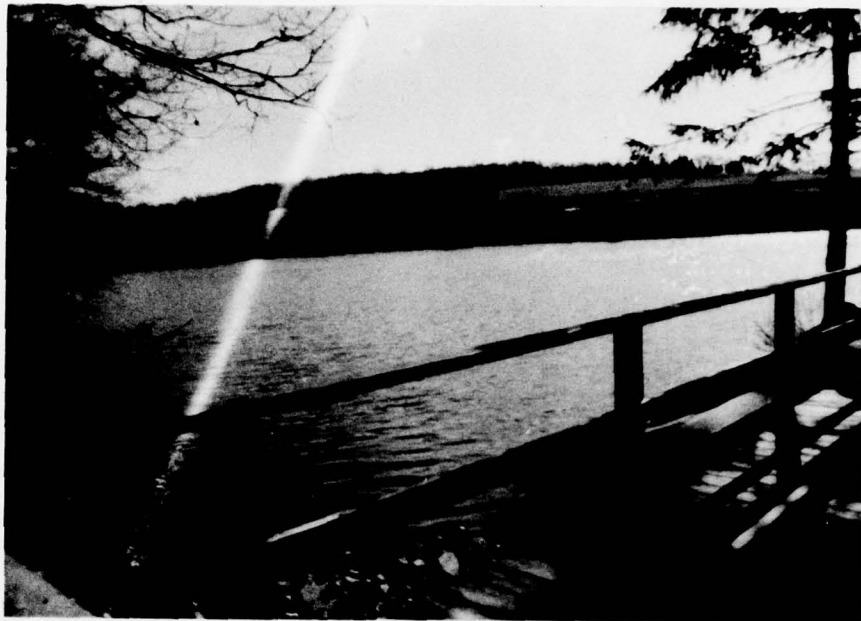
Photo No. 7 - Overall view of reservoir from spillway bridge, looking upstream.

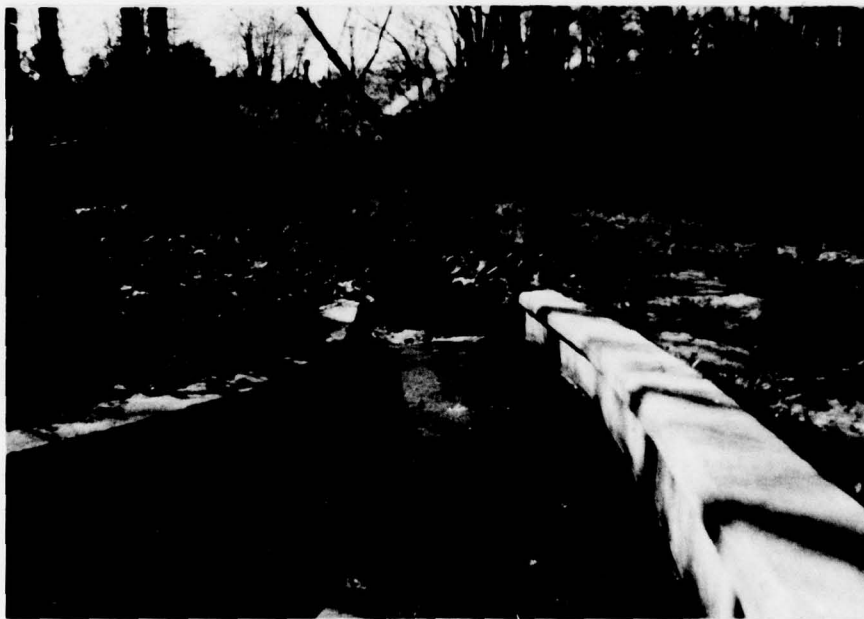
Below the concrete channel, the natural channel is obstructed by numerous cobbles and boulders. The side slopes are moderately flat and support trees and brush. Minor erosion and undercutting of the banks was observed. The low-level discharge runs into the downstream channel approximately 150 feet downstream of the dam. A footbridge near this point has collapsed into the stream. Adjacent to the low-level discharge channel there is a two-story house which is reported to be used as a camp recreation building.

Photo No. 8 - View of downstream channel - Nishisakwick Creek. Note slight cracks and spalling of the left wingwall on the spillway outlet.
