HUDSON RIVER BASIN
BLACK CREEK TRIBUTARY, SUSSEX COUNTY
NEW JERSEY

NJ NO NAME DAM

NO 20

PHASE 1 INSPECTION REPORT
NATIONAL DAM SAFETY PROGRAM

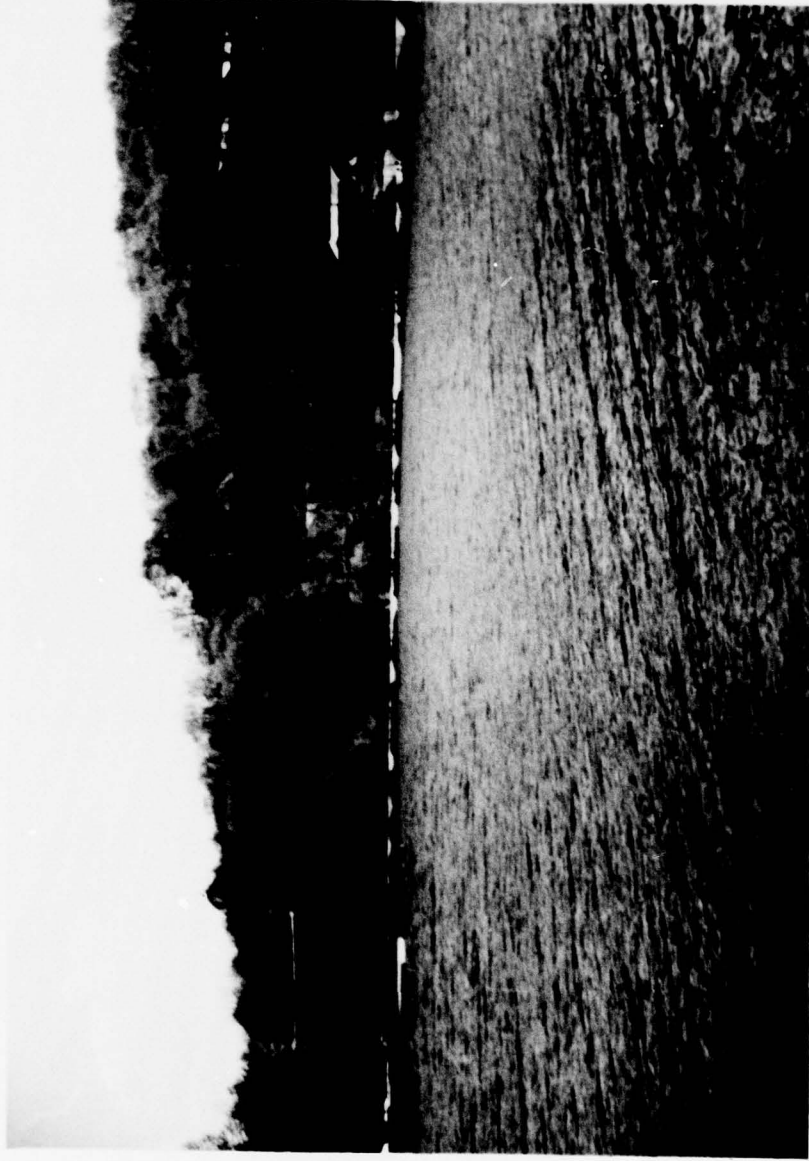
New Jersey No Name 20 Dam
Overall view of dam from upstream.

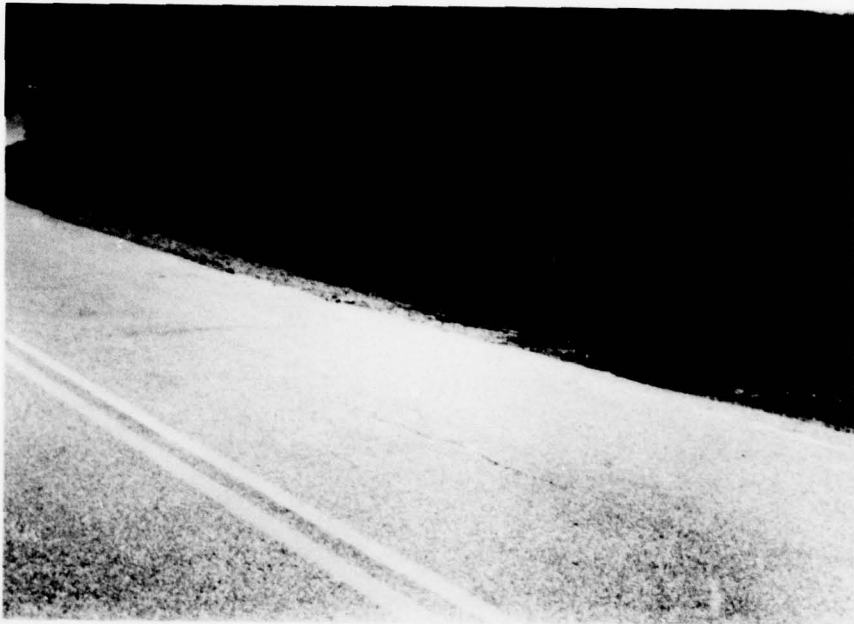
Photo No. 3 - View of Pleasant Valley Road looking to the right. Note the crack in the pavement and the trees on the upstream slope of the embankment.

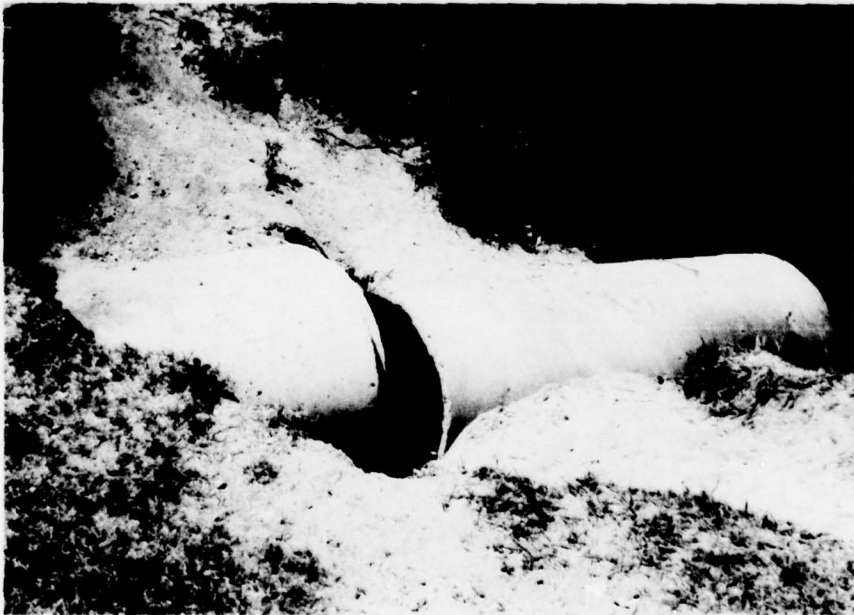
Photo No. 6 - Detail of the 27" diameter outlet discharging into the pond. Note the deteriorated condition. No flow was occurring at the inspection.

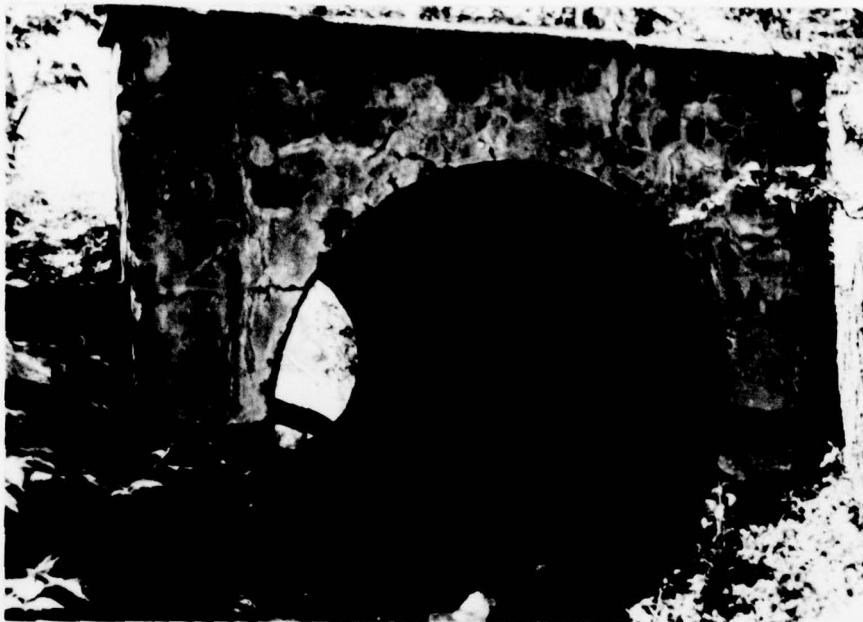
Photo No. 7 - View of 5 foot diameter Armco discharge culvert from the pond. Note deteriorated and cracked headwall. Headwall at other end has partly collapsed. The culvert drains directly onto the embankment face.

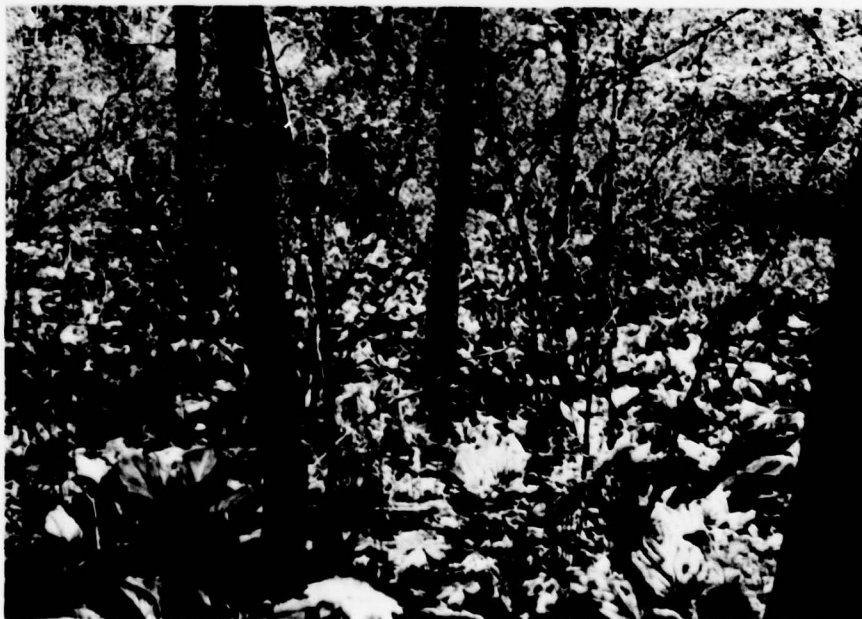
Photo No. 12 - View of ill-defined downstream channel. Note heavy tree and brush growth.
