WHITE MEADOW LAKE DAM

NJ 00340

**PHASE 1 INSPECTION REPORT
NATIONAL DAM SAFETY PROGRAM**

August, 1979

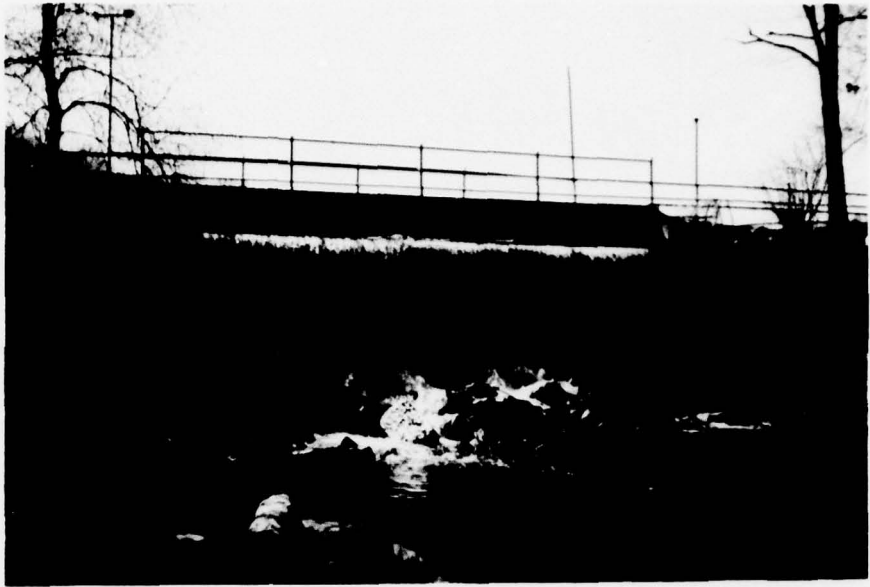
PHOTO 1
SPILLWAY

The spillway crest appears to be in fair condition. Some debris has accumulated on the weir crest and the concrete surface appeared to be eroded with aggregate exposed. A crack 1/8 inch wide and running in a diagonal direction was observed at the south spillway training wall. A group of large rocks at the downstream side of the spillway serve as an energy dissipator.

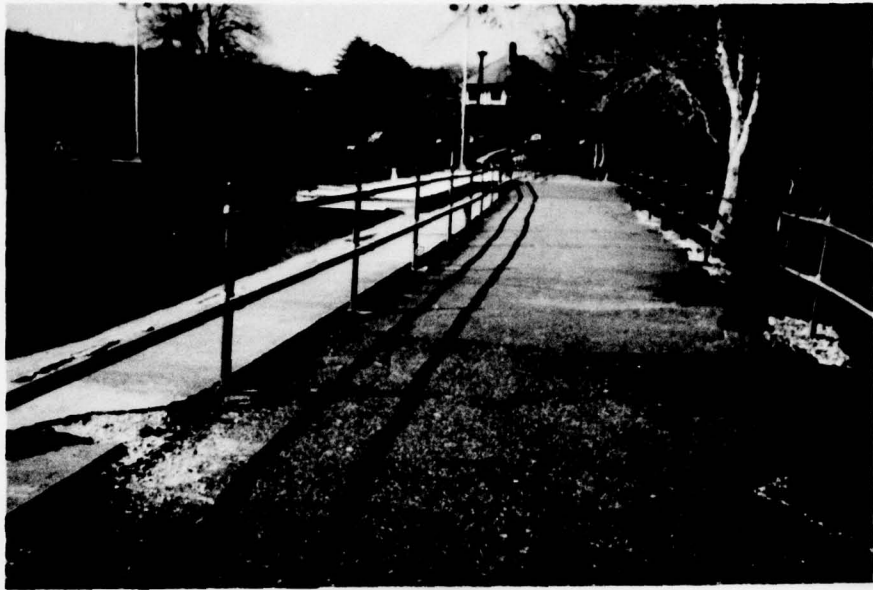
PHOTO 3
CREST OF DAM

The entire length of the dam crest is paved for pedestrian use. The upstream portion of the pavement is concrete while the remaining portion is bituminous. The concrete pavement generally is in adequate condition with some settlement noted. Also, some bituminous patches were observed on the concrete pavement. The bituminous pavement generally is in adequate condition with several longitudinal cracks approximately 2 feet from the downstream edge and one small area of failure in the north section resembling a "pothole."

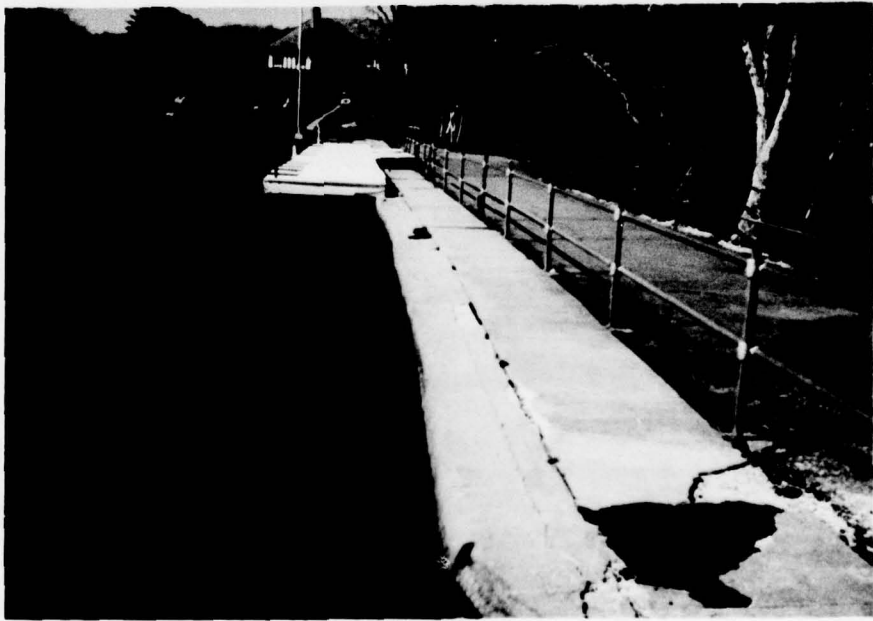
PHOTO 4
UPSTREAM FACE OF DAM

The concrete wall comprising the upstream face of embankment is in generally adequate condition. The south section of wall appears to have a "shotcrete" surface. The construction joint between the wall and the concrete pavement is in generally satisfactory condition with some separation noted along the south section.

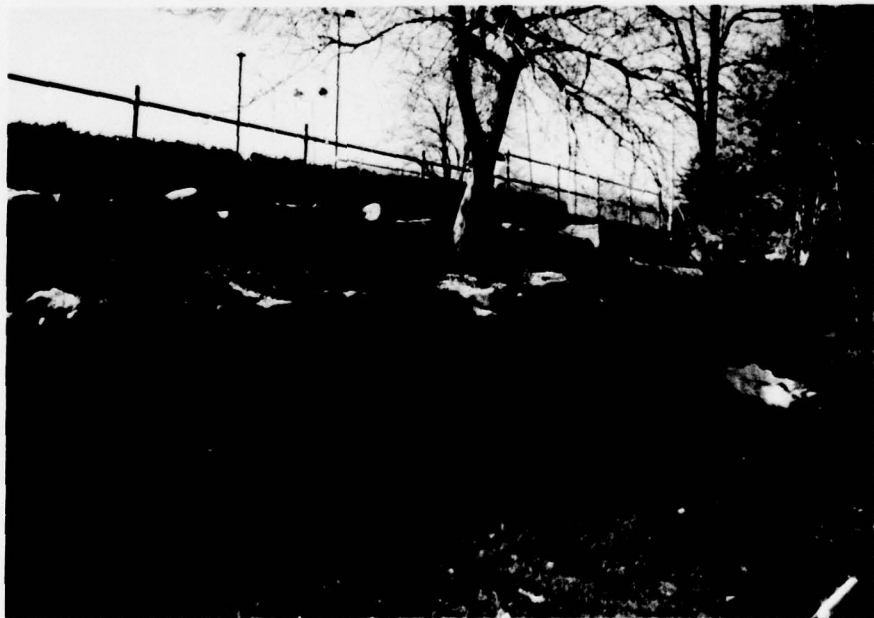
PHOTO 6

The stone wall along the north section of the downstream face of embankment is in generally satisfactory condition. The south half of this wall is stone masonry while the north half consists of ungrouted stone. The stone masonry wall along the south section is constructed in two tiers. A portion of the lower tier is tilted in the downstream direction.

DOWNSTREAM FACE OF SOUTH SECTION OF DAM
