CLOVE RIVER DAM

NJ 00035

6 PHASE 1 INSPECTION REPORT  
NATIONAL DAM SAFETY PROGRAM

Clove River Dam (NJ-00035). Hudson River  
Basin, Clove Brook, Sussex County,  
New Jersey. Phase 1 Inspection report.

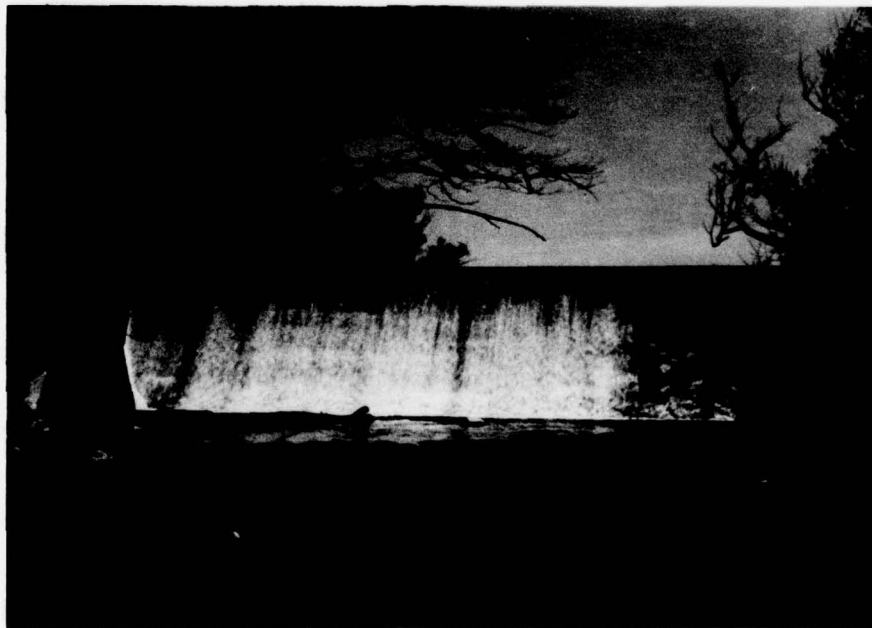
Photo No. 2 - View of spillway from downstream.

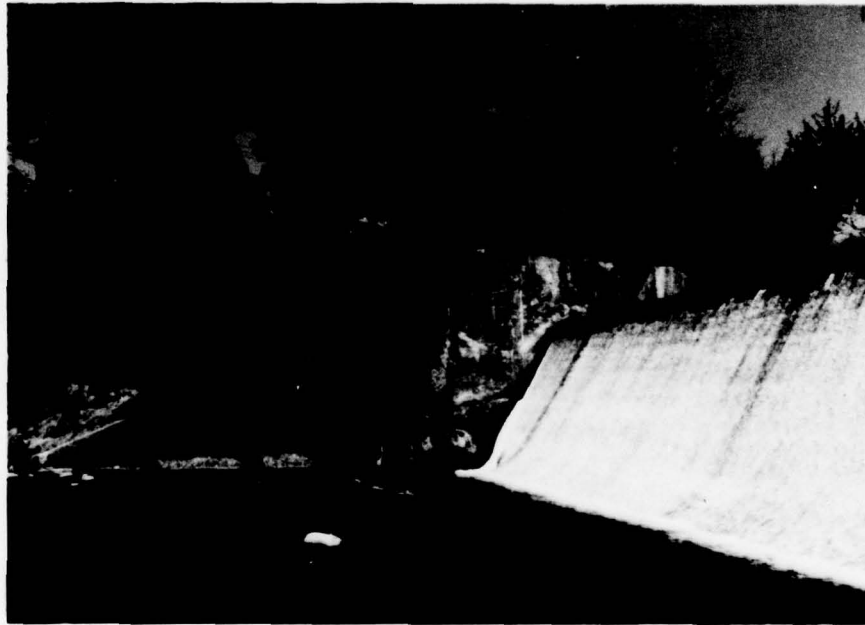
Photo No. 4 - View of right wingwall. Note the seepage from the drains and the minor erosion of concrete at the water-line.
