Lake Therese Dam (NJ-00349). Raritan River  
Basin, McVickers Brook, Morris County,  
New Jersey. Phase 1 Inspection Report.

| REPORT DOCUMENTATION PAGE | | READ INSTRUCTIONS<br>BEFORE COMPLETING FORM |
|---|---|---|
| 4. TITLE (and Subtitle)<br>Phase I Inspection Report<br>National Dam Safety Program<br>Lake Therese Dam<br>Morris County, N.J. | | 5. TYPE OF REPORT & PERIOD COVERED<br><br>FINAL |

LAKE THERESE (NJ00349)

OVERVIEW - LAKE THERESE DAM

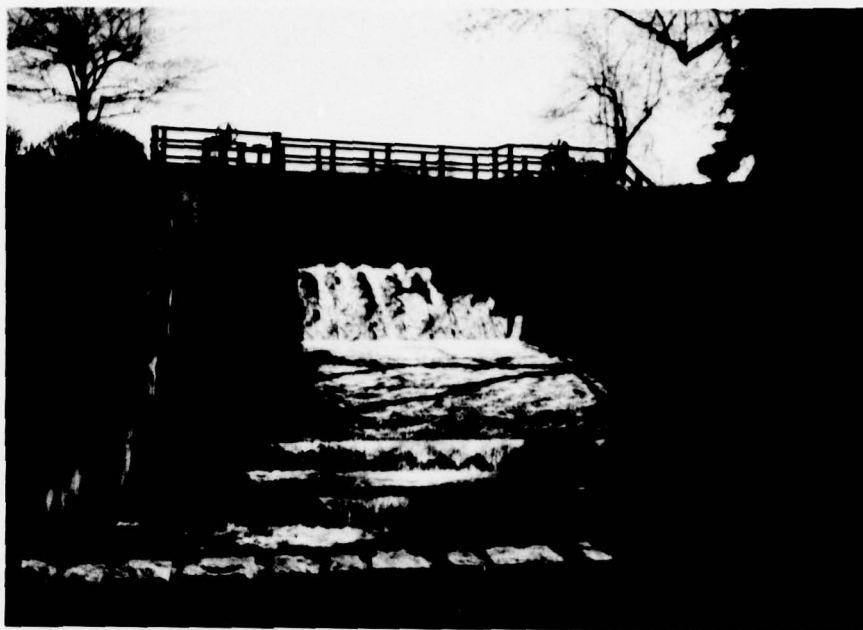
The training walls of the spillway continue as retaining walls for the discharge channel. The concrete apron and retaining walls are in good condition. The ogee portion of the spillway and the flashboards and gates appeared to be in generally good condition. Some leakage was observed at the side of the south radial gate. The leakage appeared to be caused by localized spalling of the concrete surface adjacent to the gate and deterioration of the rubber seal along the edge of the gate.

PHOTO 1  
SPILLWAY

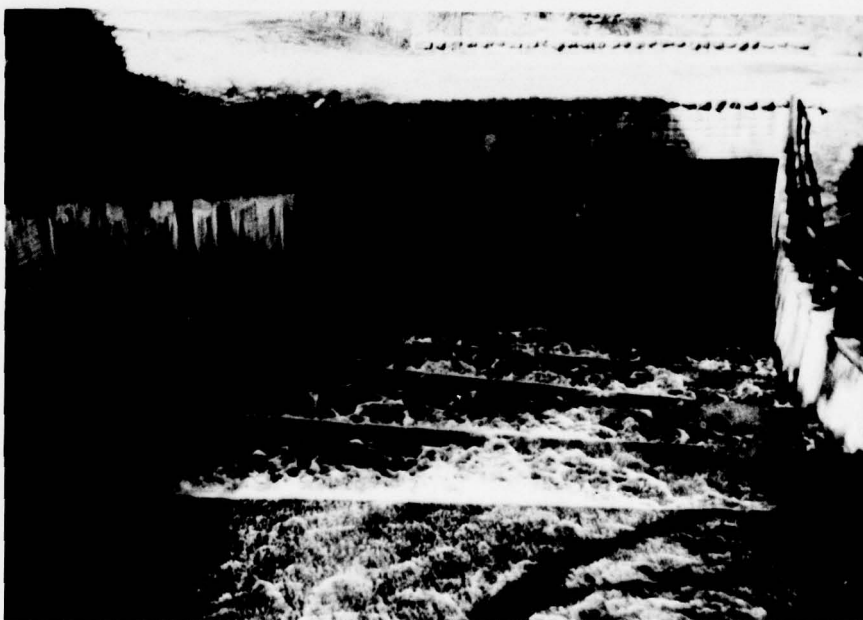
| VISUAL EXAMINATION OF | OBSERVATIONS | REMARKS OR RECOMMENDATIONS |
|---|---|---|
| DISCHARGE CHANNEL | Condition of training walls is generally satisfactory with some patching noted. Condition of bottom slabs is generally satisfactory with some erosion and spalling noted. Some exposed aggregate was observed. | Discharge channel consists of wide channel with rectangular section and concrete bottom constructed in steps. Sides consist of concrete training walls. |

PHOTO 2  
SPILLWAY DISCHARGE CHANNEL
