PASSAIC RIVER BASIN  
MILL BROOK, MORRIS COUNTY  
NEW JERSEY

**DALRYMPLE POND DAM**  
**NJ 00350**

**PHASE 1 INSPECTION REPORT**  
**NATIONAL DAM SAFETY PROGRAM.**

30 APRIL 1979

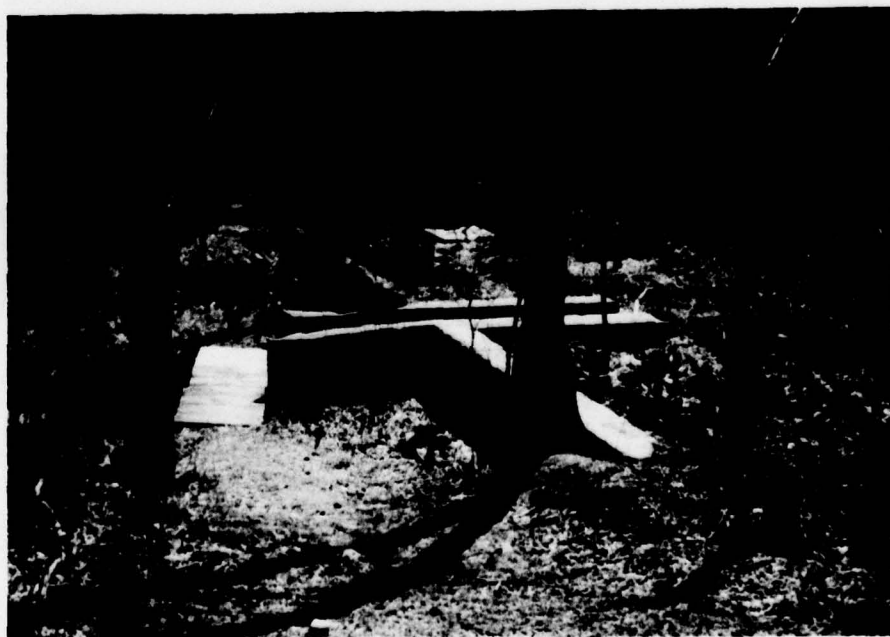
PHOTO 10  
UPSTREAM DIVERSION GATE

Upstream of Dalrymple Pond, a diversion ditch is observed where a gate can be installed to divert flow from the pond.
