Nanticoke Creek Watershed Project Site Number 8  
(Inventory Number NY-573). Susquehanna  
River Basin. Broome County, New York.  
Phase I Inspection Report.

SUSQUEHANNA RIVER BASIN  
 NANTICOKE CREEK WATERSHED PROTECTION  
 PROJECT SITE No. 8  
 I.D. No. NY-573 (# 85D-3645)  
 PHASE 1 INSPECTION REPORT

Date of Inspection: November 8, 1978

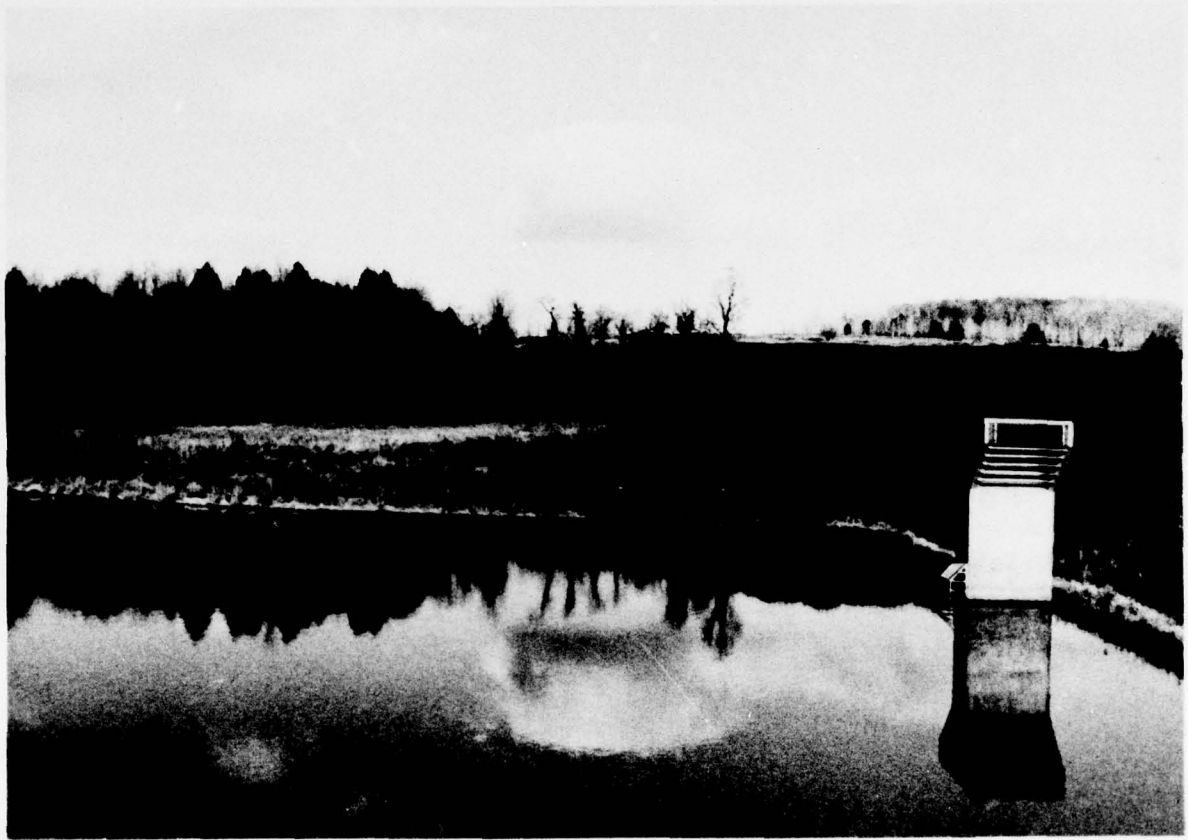
NANTICOKE CREEK SITE No. 8 OVERVIEW  
NORTHERN END OF UPSTREAM FACE AND EMERGENCY SPILLWAY

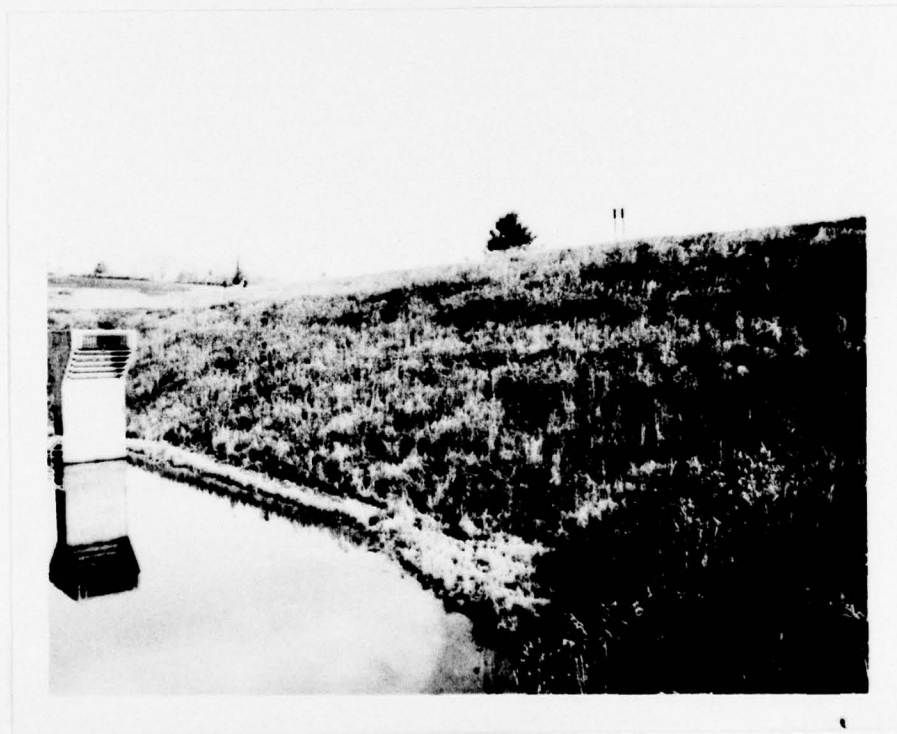
OVERVIEW  
SOUTHERN END OF UPSTREAM FACE

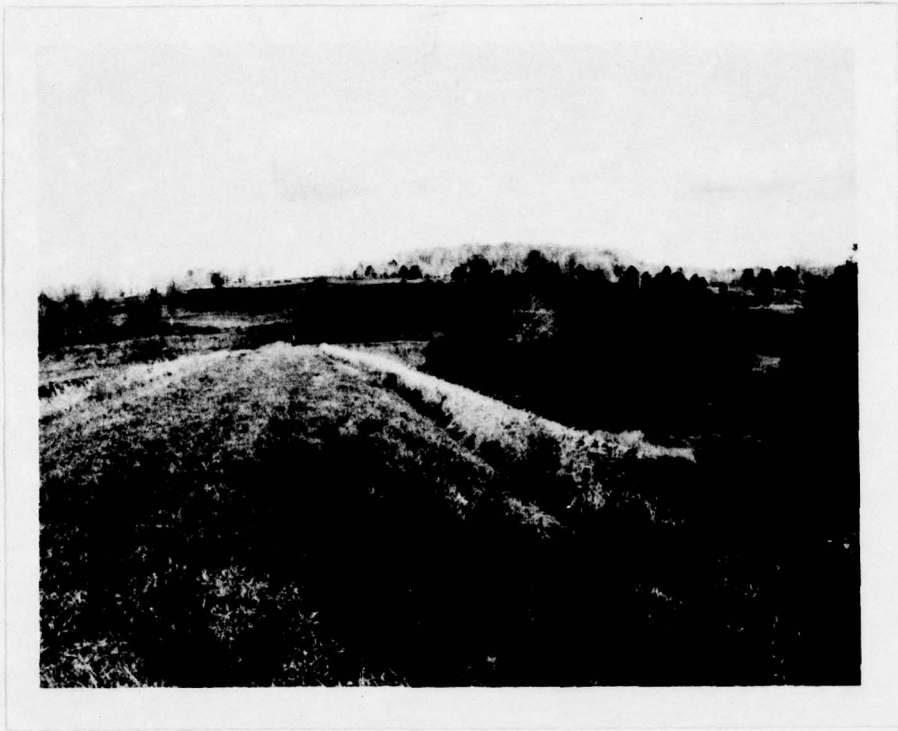
The earth embankment showed no signs of distress. The vertical and horizontal alignment of the crest appears to be as it was constructed, with no visible surface cracks appearing on the crest or embankment slopes. There were no areas of serious sloughing or subsidence noted. Some minor sloughing was observed on the upstream slope in the range of fluctuation of the water surface level.

VIEW LOOKING EAST ALONG DAM CREST

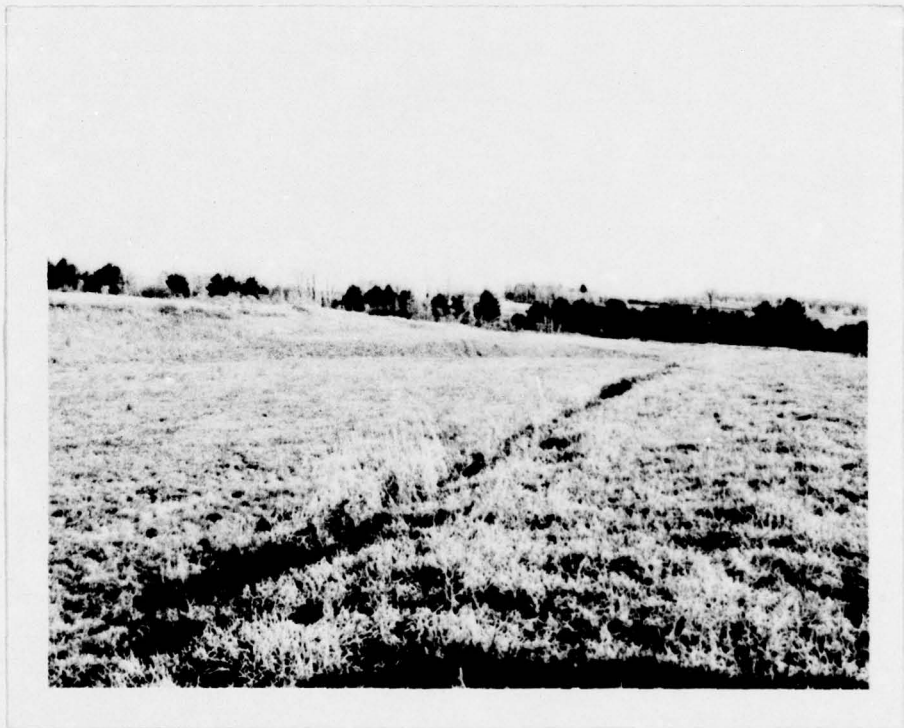
A grass lined emergency spillway in an earth cut section is located beyond the northern end of the embankment. The spillway had been mowed and appeared to be in satisfactory condition.

EMERGENCY SPILLWAY LOOKING DOWNSTREAM

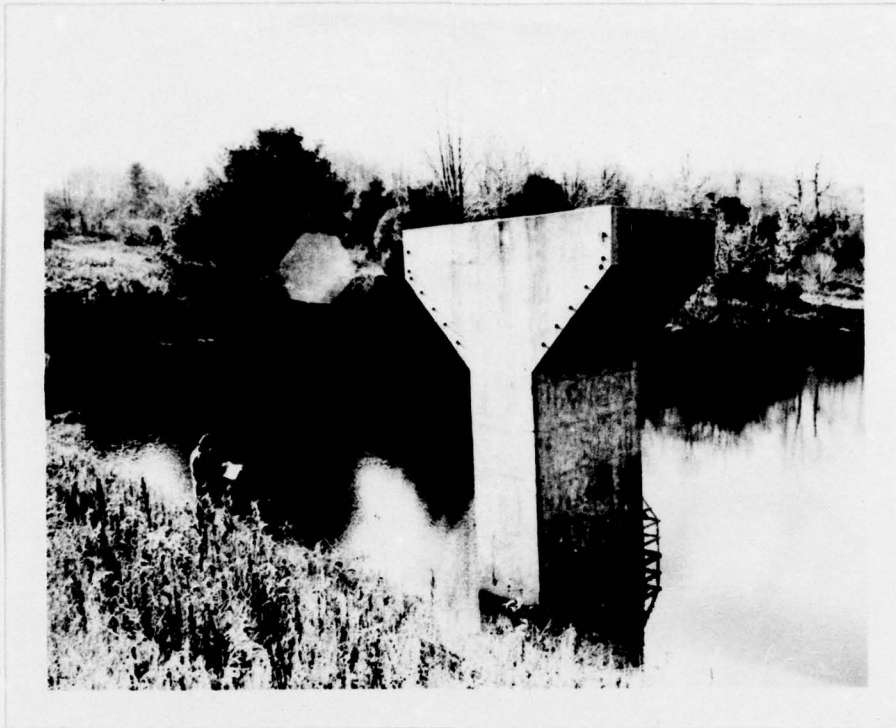
The principle spillway consists of the vertical drop inlet structure, a reinforced concrete pressure pipe through the embankment, a plunge pool and an outlet channel. All of these components were in satisfactory condition. The only minor deficiency noted concerned the plunge pool. The downstream toe of the dam, the bottom of the stream channel and the stream banks were lined with riprap, but there was no riprap in the center of the stream to check the velocity of water coming through the spillway pipe.

RISER - PRINCIPAL SPILLWAY INLET

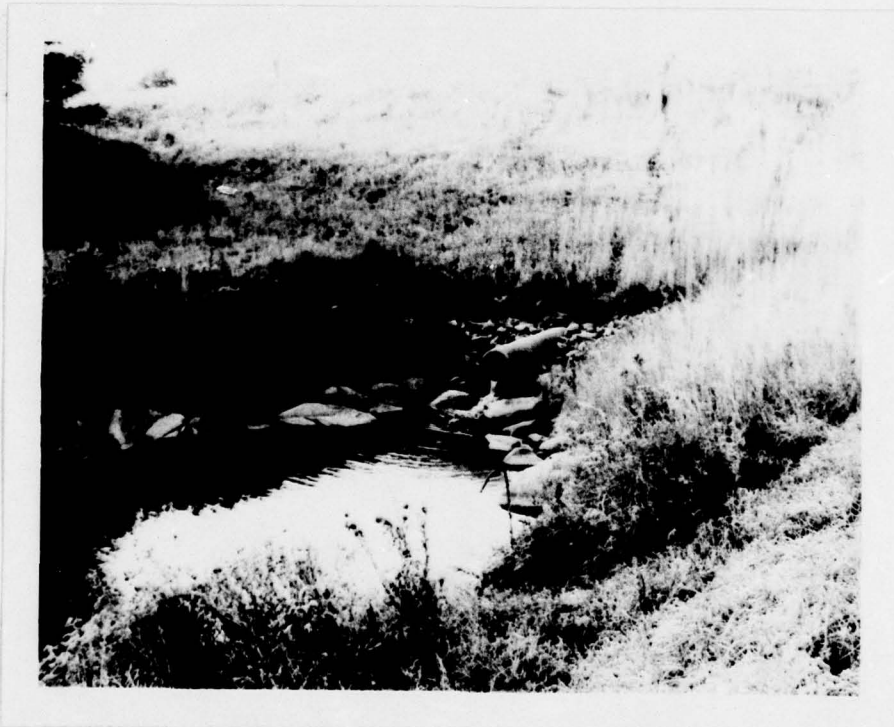
PRINCIPAL SPILLWAY OUTLET PIPE  
AND PLUNGE POOL (LOOKING UPSTREAM)

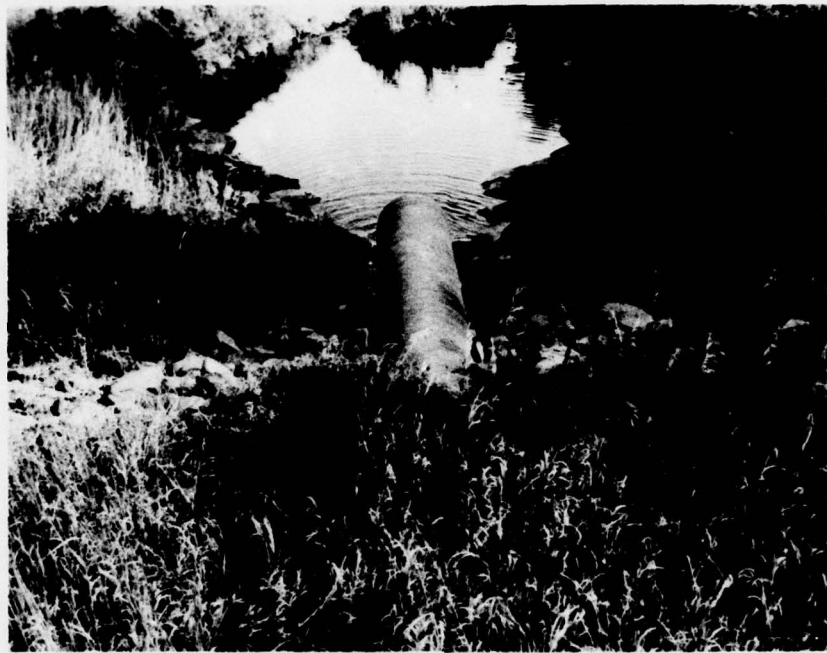
PRINCIPAL SPILLWAY OUTLET PIPE  
AND PLUNGE POOL (LOOKING DOWNSTREAM)

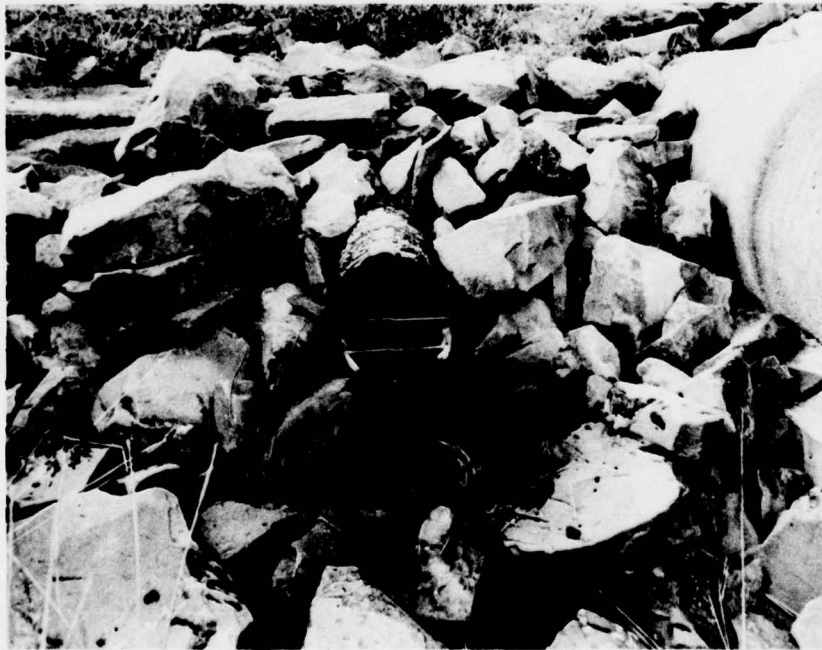
OUTLET OF INTERNAL DRAINAGE  
SYSTEM COLLECTION PIPE
