NEW YORK STATE DEPT OF ENVIRONMENTAL CONSERVATION ALBANY F/G 13/2  
NATIONAL DAM SAFETY PROGRAM. LOCK 3 DAM AT MECHANICVILLE (INVEN--ETC(U)  
JUN 79 G KOCH DACW51-79-C-0001

REPORT DOCUMENTATION PAGE		READ INSTRUCTIONS BEFORE COMPLETING FORM
1. REPORT NUMBER	2. GOVT ACCESSION NO.	3. RECIPIENT'S CATALOG NUMBER
4. TITLE (and Subtitle) Phase I Inspection Report Lock 3 Dam at Mechanicville Upper Hudson River Basin Rensselaer-Saratoga Co. Inventory No. NY 215		5. TYPE OF REPORT & PERIOD COVERED Phase I Inspection Report National Dam Safety Program

PHASE 1 INSPECTION REPORT  
NATIONAL DAM SAFETY PROGRAM  
LOCK 3 DAM @ MECHANICVILLE  
I.D. No. NY - 215  
(#119 - UH)  
UPPER HUDSON RIVER BASIN  
RENSSELAER - SARATOGA COUNTY, NEW YORK

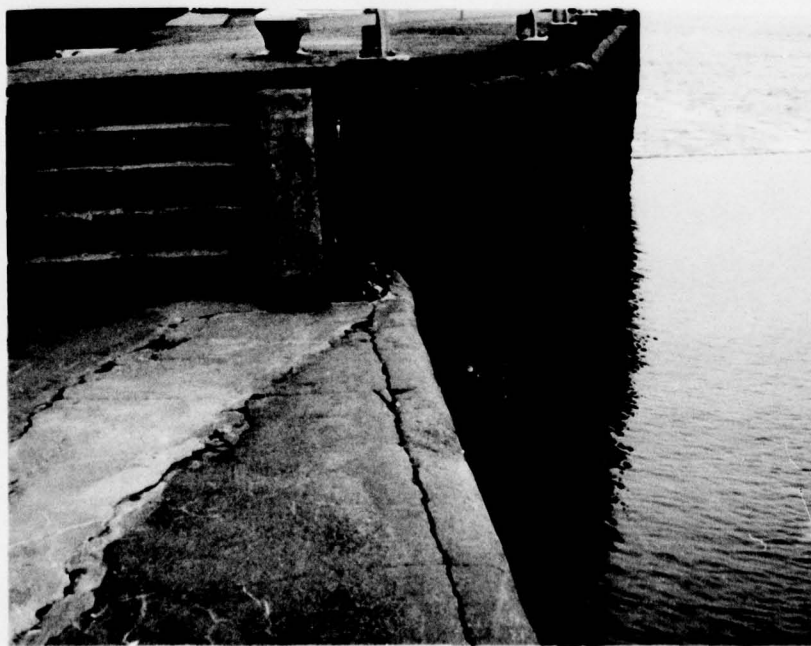
1. Concrete spalling on the river-side face of the lock upstream protection pier.
2. Smaller areas of spalled concrete on the outer lock walls both upstream and downstream of the crest, in the zone of flow aeration.
3. At the spillway-gatehouse contact, seepage through one masonry block horizontal joint immediately adjacent to the crest was observed.

CONCRETE SURFACE DETERIORATION @  
LOCK - SPILLWAY CONTACT

Those deficiencies within the zone of water level fluctuations (below elevation 77.0 - BCD) should be corrected prior to the next period of anticipated high flows (Spring 1980). All other deficiencies observed during the visual inspection can be corrected during normal maintenance operations.

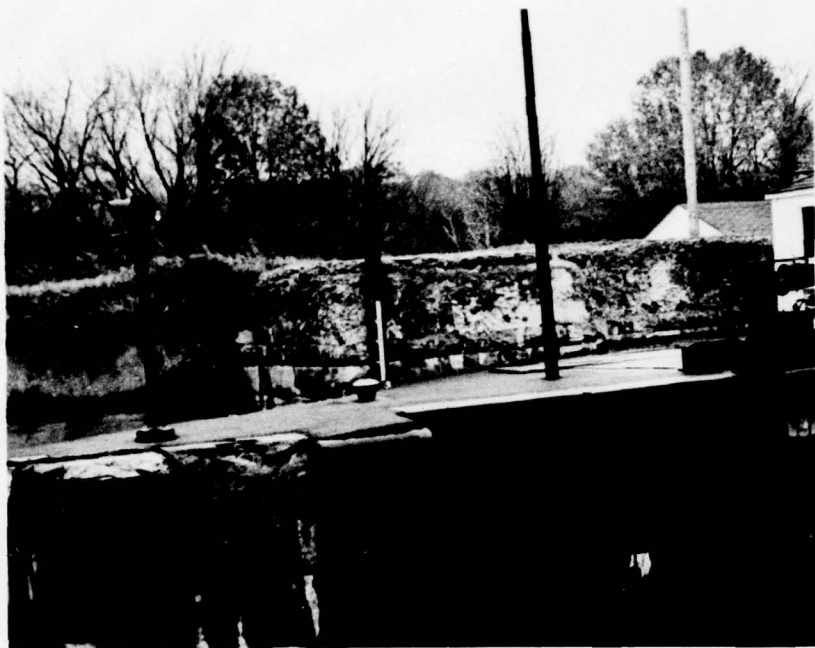
1. The concrete surfacing on the Lock-earth dike masonry abutment was deteriorated considerably; having aggregate exposed and surface corners well-rounded from weathering.

CONCRETE DETERIORATION @ ABUTMENT  
OF EARTH DIKE - LOCK 3

Operation and maintenance of the Lock is satisfactory. Additional maintenance is needed to remedy the earth dike deficiencies stated above. In addition, all masonry and concrete structures including the gatehouse-forebay should be repaired as necessary.

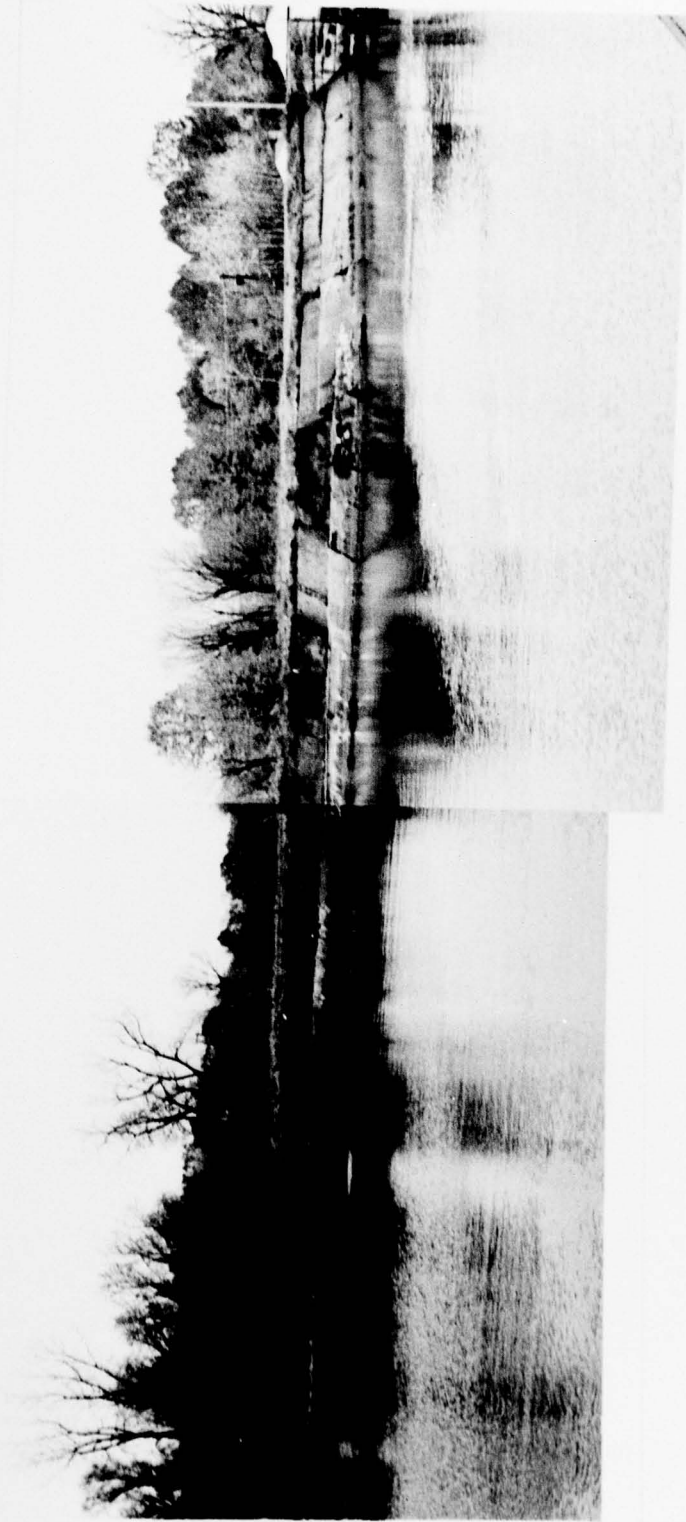
2. The concrete facing on the dike embankment's upstream slope protection was cracked.
3. The vertical alignment of the crest was somewhat irregular sloping downward in the upstream direction; a vehicle path existed on the top of the dike.
4. Several large trees existed on the top of the embankment.
5. Small trees and brush existed on the downstream slope of the embankment.

UPSTREAM SLOPE PROTECTION ON EARTH DIKE

Maintenance of Lock 3 is satisfactory. However, the earth dike has not been maintained as evidenced by trees and brush growing on the downstream slope. The concrete slope protection facing also requires some remedial work to prevent further deterioration.

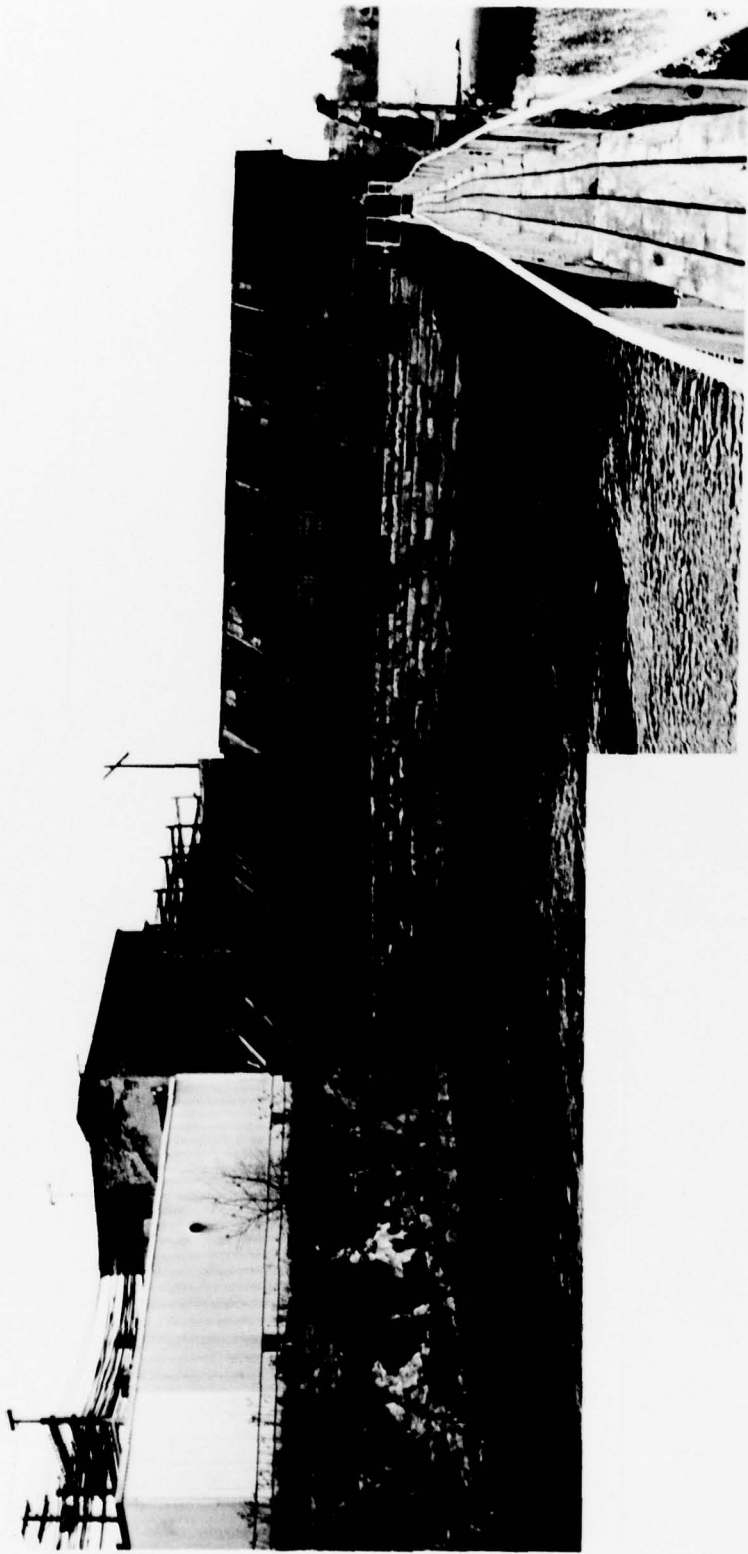
GATEHOUSE - FOREBAY  
(LOOKING UPSTREAM)

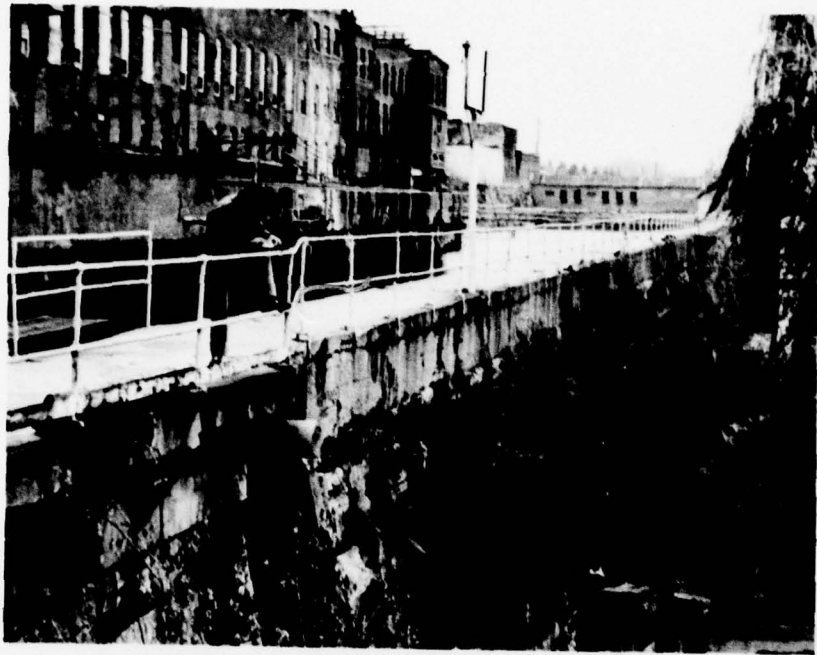
6. Seepage through the east wall was occurring in three areas which were all in excess of 200 feet downstream of the axis of the dam.
7. Cracked concrete and joint separation in the masonry was evident along much of the east wall.

OUTER FOREBAY WALL  
(GATEHOUSE - BACKGROUND CENTER)

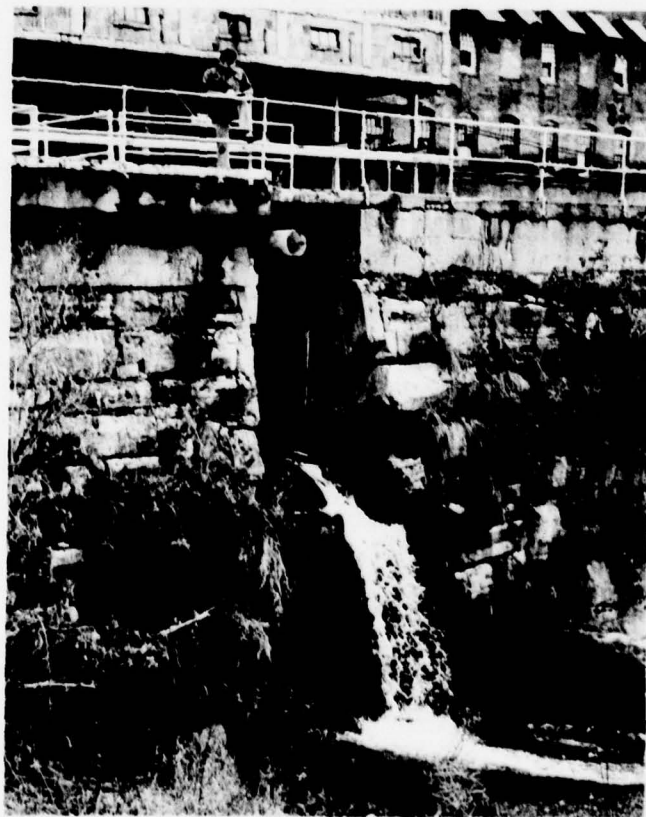
The navigation Lock 3 was in satisfactory condition. The functioning of the 12 forebay gates could not be ascertained although some flow was occurring downstream of the gatehouse.

SLUICE GATE - FOREBAY WALL

- 1) The physical condition of the wrought-iron framework supporting the apron slabs and the concrete surfaces of both the crest and apron.
- 2) The actual method of anchorage between the wrought-iron framework and the underlying foundation.
- 3) The physical condition and operational status of the forebay gates.
