Special Report 79-27

EXTENDING THE USEFUL LIFE OF DYE-2 TO 1986

PART I: PRELIMINARY FINDINGS AND RECOMMENDATIONS

Wayne Tobiasson, Charles Korhonen and Robert Redfield

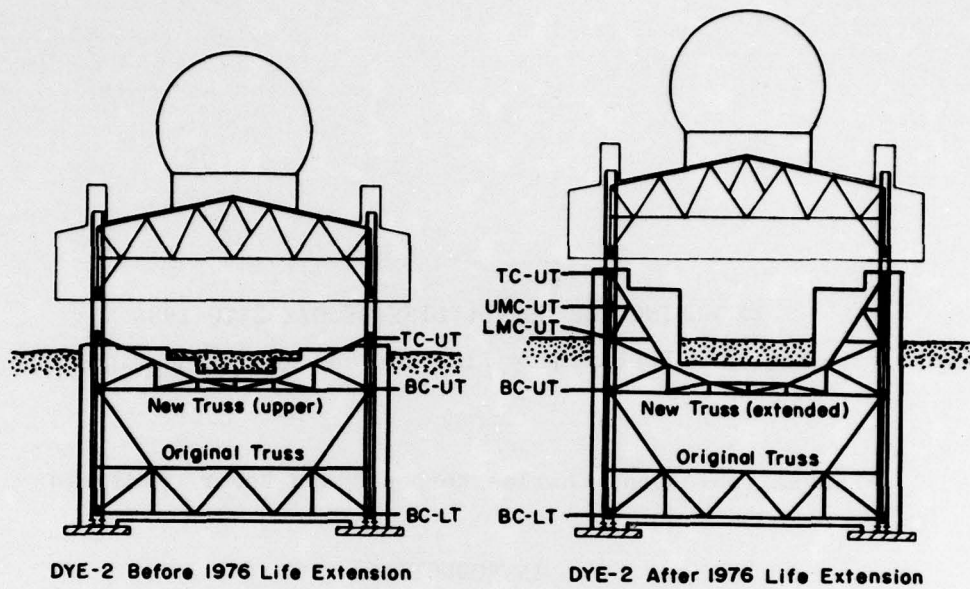
Elevation views of the DYE-2 structural system before and after the 1976 life extension operation are presented in Figure 1. In 1972, 1975 and 1977 we measured forces within the DYE-2 structural frame at essentially all sway bolt interaction points. The technique used is described in CRREL Special Report 205 (Tobiasson, 1974). In addition, we made similar measurements at three "check" locations in 1973, 1974, 1976 and 1978. The 1976 measurements were made just after the life extension operation that year.

Figure 1. Elevation views of DYE-2 before and after the 1976 life extension.

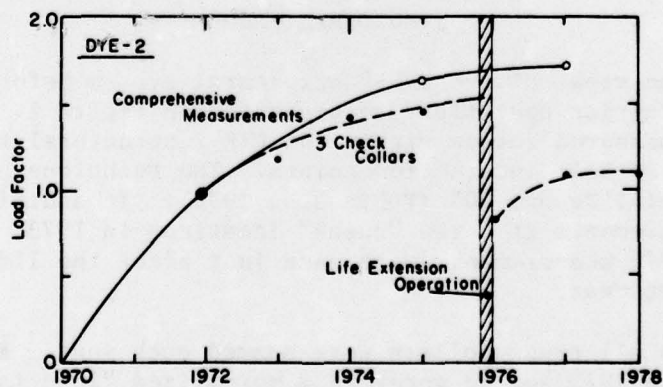
Figure 2. Load factor vs time for both comprehensive sway bolt measurements and measurements at three check collars. The check collars are defined in Table I.

The significant drop in the load factor shown in Figure 2 for the three check collars after the 1976 life extension operation is of interest. All readings taken of those collars are summarized in Table I. That information indicates that loads in those three collars were altered significantly by the life extension operation.

Since the comprehensive measurements in 1977 (Fig. 2) did not show a post-life-extension decrease, it is evident that the loads lost by the three check collars during the life extension operation were gained by other collars.

We recommend a comprehensive sway bolt measurement program at DYE-2 for the summer of 1979. Results from that program should allow us to better estimate the current rate of secondary stress accumulation in the structural frame. If those measurements indicate that the rate of stress increase is slight, it may be possible to continue with the existing structural system to 1986.
