ROYAL AIRCRAFT ESTABLISHMENT FARNBOROUGH (ENGLAND)
HOLOGRAPHIC INTERFEROMETRY OF CFRP WING TIPS. (U)
AUG 78 M MARCHANT
RAE-TR-78105

Technical Report 78105

**HOLOGRAPHIC INTERFEROMETRY
OF CFRP WING TIPS**

M. Marchant

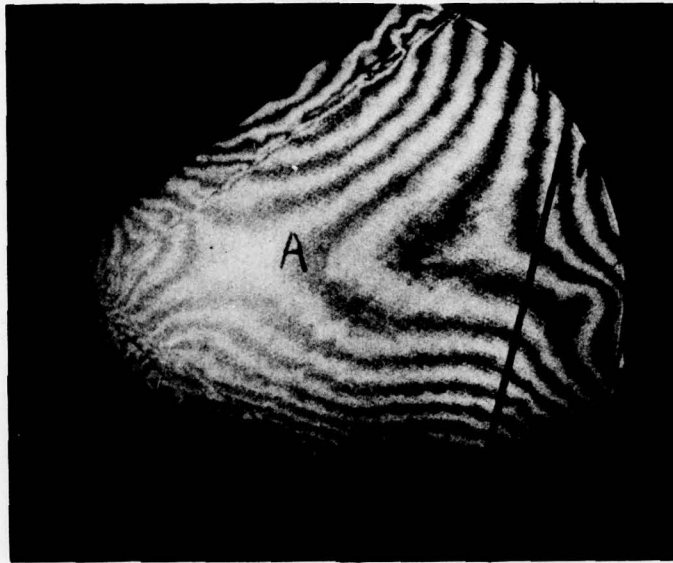
introduce misleading fringe patterns; the large distortion in the fringes on the right in Fig 3 corresponded to the position of such a point, and disappeared completely when the cords were readjusted. With a structure such as the wingtip, the patterns formed are naturally complicated, particularly around joints in the framework, which itself produces discontinuities. However, major faults should be distinguishable, since very similar basic patterns are recorded for each tip.

Fig 3 Distortion caused by strain in mounting

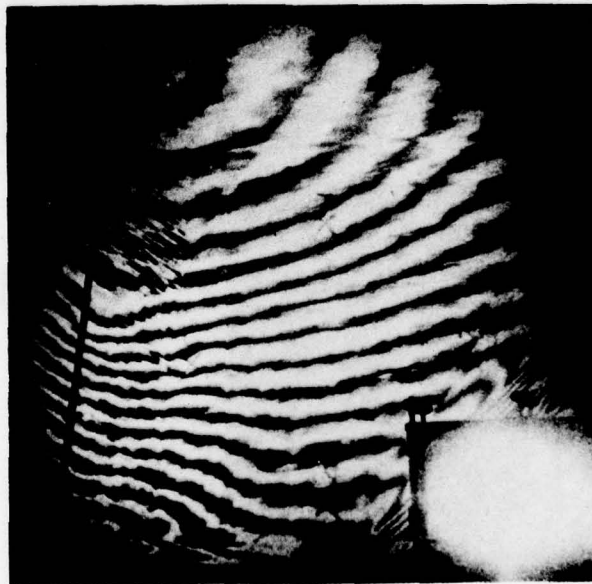
Fig 4 shows two prominent anomalies detected on the bottom surface of tip 6. These are, firstly, a part of the straight line seen on all but the first tip examined, and running horizontally in the photograph, and secondly an area of rather jagged fringes on the left, quite unlike any other area seen. It has been suggested that the latter might be caused by poor skin quality and the former by an overlap in the film adhesive. It was visible on both top and bottom surfaces in the same position on the wingtip, and was not revealed by radiography nor ultrasonic scan. A very minor discontinuity for which no explanation is available appears at 60° to the main line; the large pattern at bottom right behind the reference mirror corresponds to the internal framing.

Fig 4 Anomalies in wing tip 6

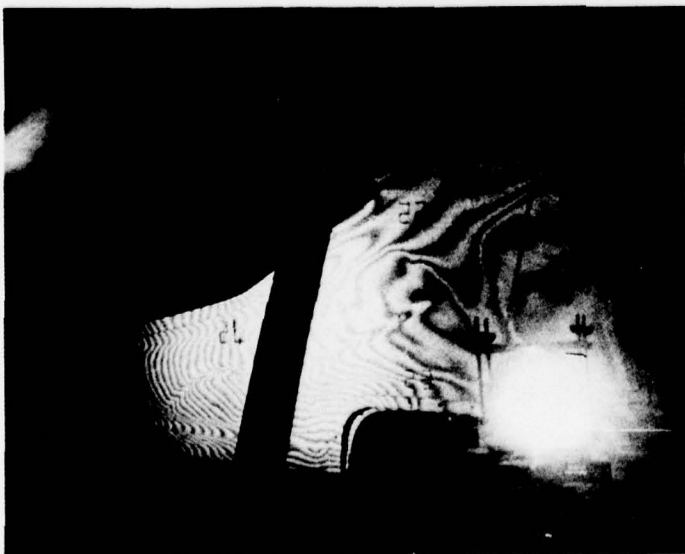
Figs 5a-c show the results obtained on the top surface of tip 8. This tip was received direct from the manufacturers and had had no previous tests applied to it. Some very prominent anomalies were found in all areas as well as traces of a straight line (above '10' and '15') similar to that on tip 6. It seemed just possible that this line might be due to some strain in the mounting, although the earlier tests had involved relocation, so a series of photographs was taken with the support rollers lower relative to the 3-point mount and then with the tip tilted through approximately 12° in each direction.

c Area 3 - various anomalies

Fig 5a-c Wing tip 8 - top

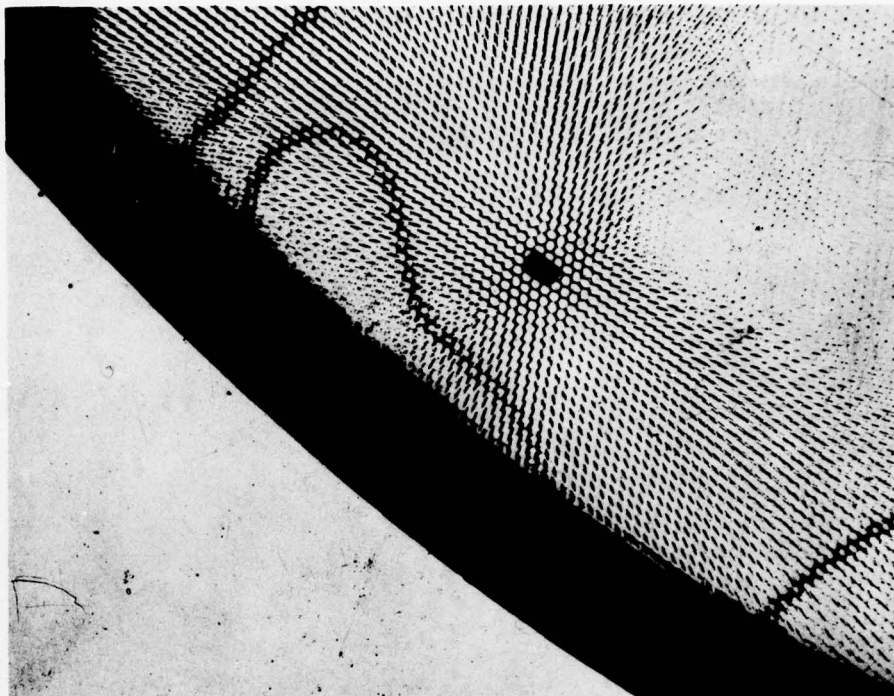
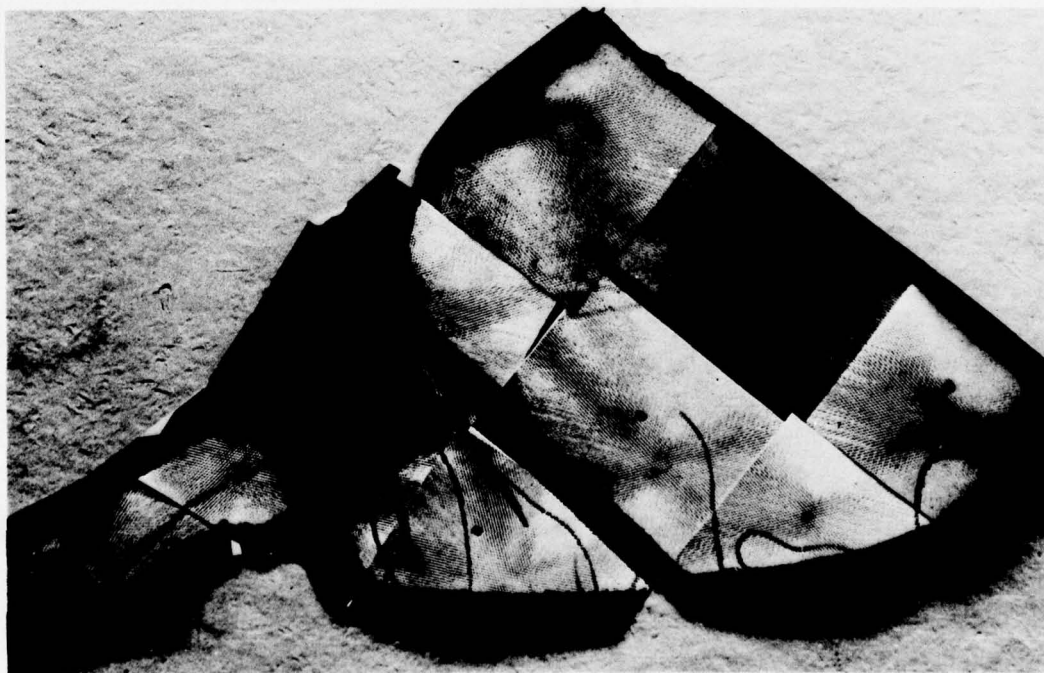
The wingtip was radiographed in an attempt to find the cause of these anomalies. A typical result is given in Fig 7a and a rough mosaic of the whole

tip in Fig 7b. Agreement with the holographic results is remarkably good. All the 'faults' shown in Fig 5 (and two others, thought to be nearer the bottom skin) can be seen with the exception of the straight line. These two 'faults' were detected holographically later (see Appendix).

a Radiograph of area near '12'

b Mosaic of radiographs of whole wing tip

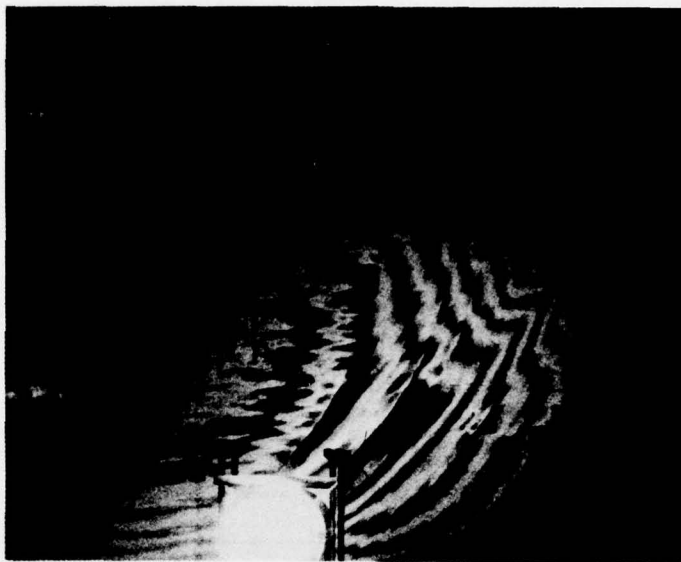
The set-up for examining the bottom surface was extremely stable and it was noticed that after some hours more skin laminae could be seen (Fig 8a is an example) and that later still the fringes developed a very irregular appearance (eg Fig 8b).

a Area 5 – laminae prominent after 4 hours

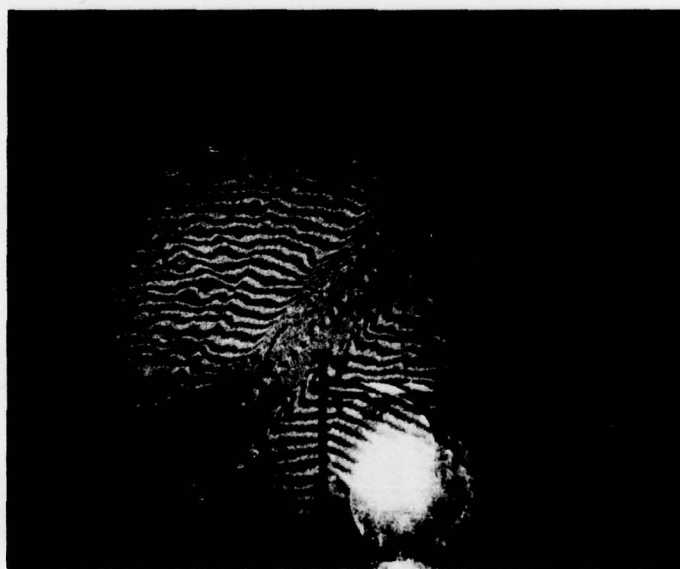
b Area 6 – irregular fringes after 8 hours

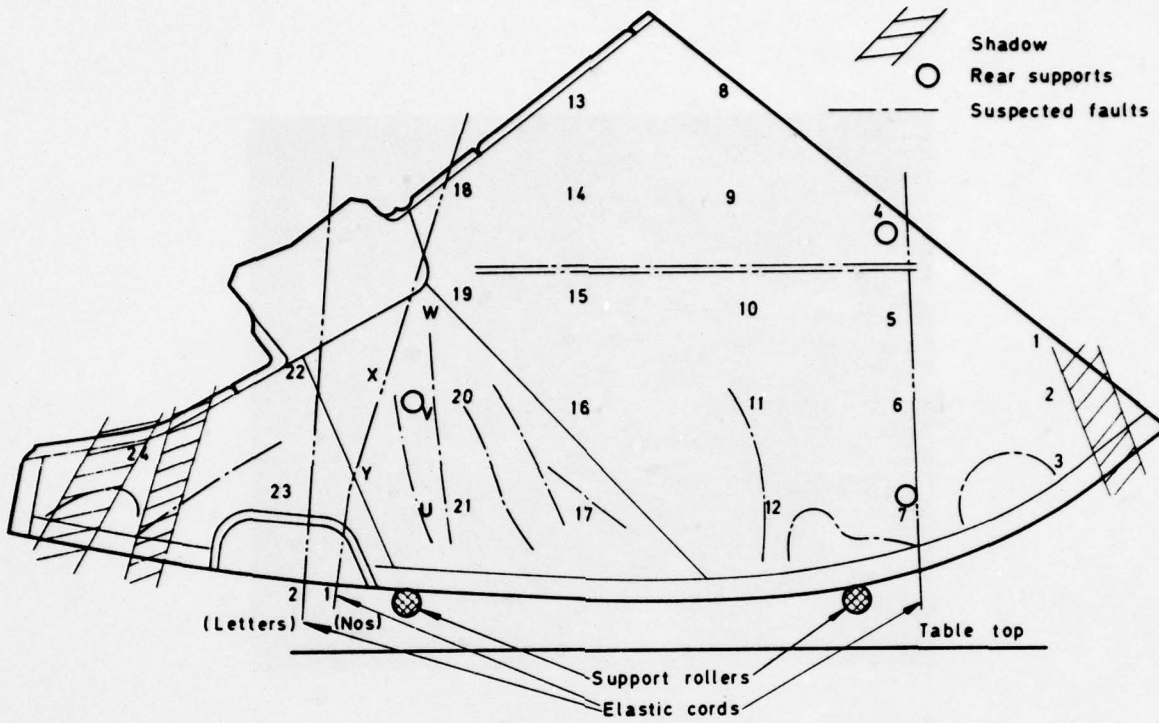
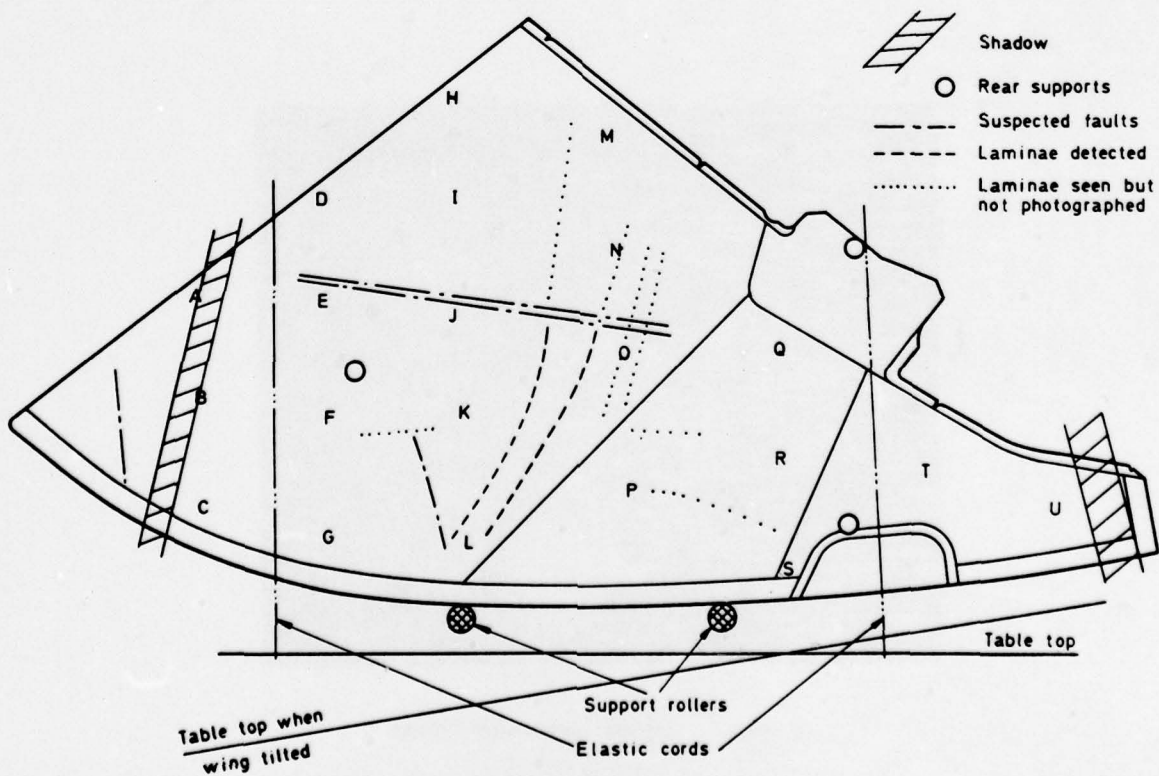
Fig 9a&b are sketches to show mountings, reference marks, and all anomalies seen. These include (9b) an indication of a number of laminae which were detected visually after prolonged heating of the front surface but were not photographed because of focus changes.

Fig 9a Wing tip 8 - top surface

Fig 9b Wing tip 8 - bottom surface

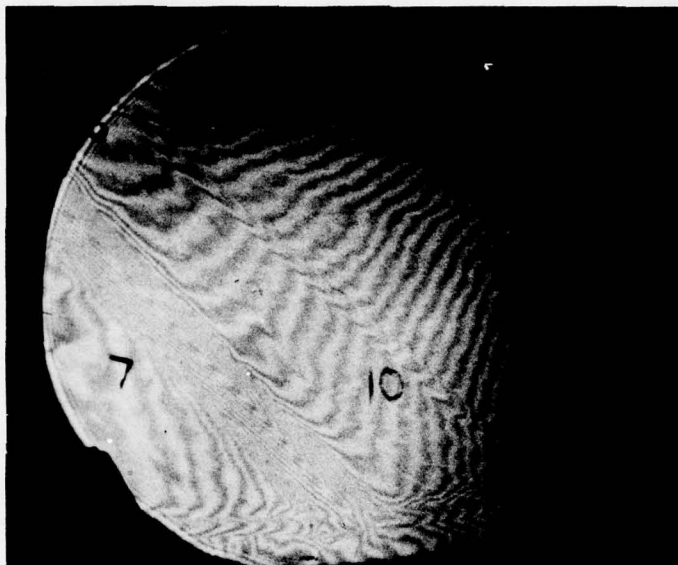
Tip 10 had undergone other tests before reaching us and cement patches remained on the bottom surface. The positions of three circular anomalies detected on the top surface (between '9' and '11' in Fig 10, for example) correspond to such cement patches underneath. There was no sign of a straight line in the position of those on tips 6 and 8, but a very similar effect can be seen running diagonally and roughly parallel to the internal rib. A similar line was seen on the bottom surface in approximately the same position on the wingtip; and also on both sides of tips 12, 13 and 14.

Fig 10 Anomaly corresponding to cement on rear surface

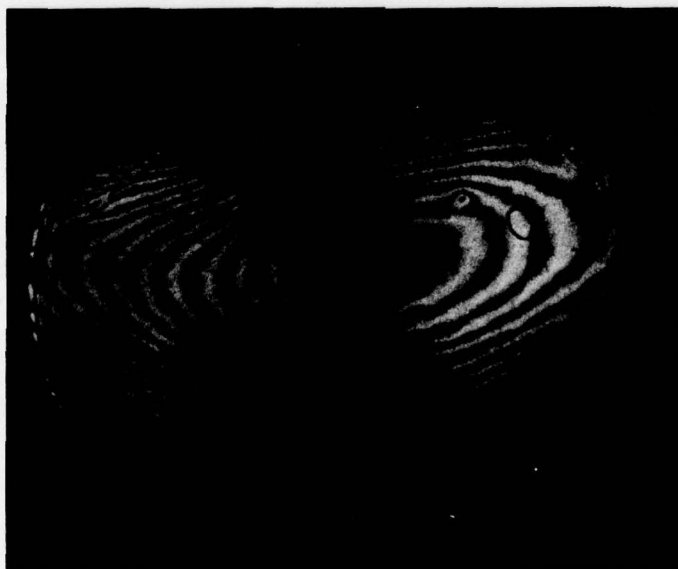
Patterns which may indicate debonding between skin and core were seen in a number of the photographs of various tips, and Fig 11 shows a typical one on the bottom surface of No 12.

Fig 11 Suspected debond

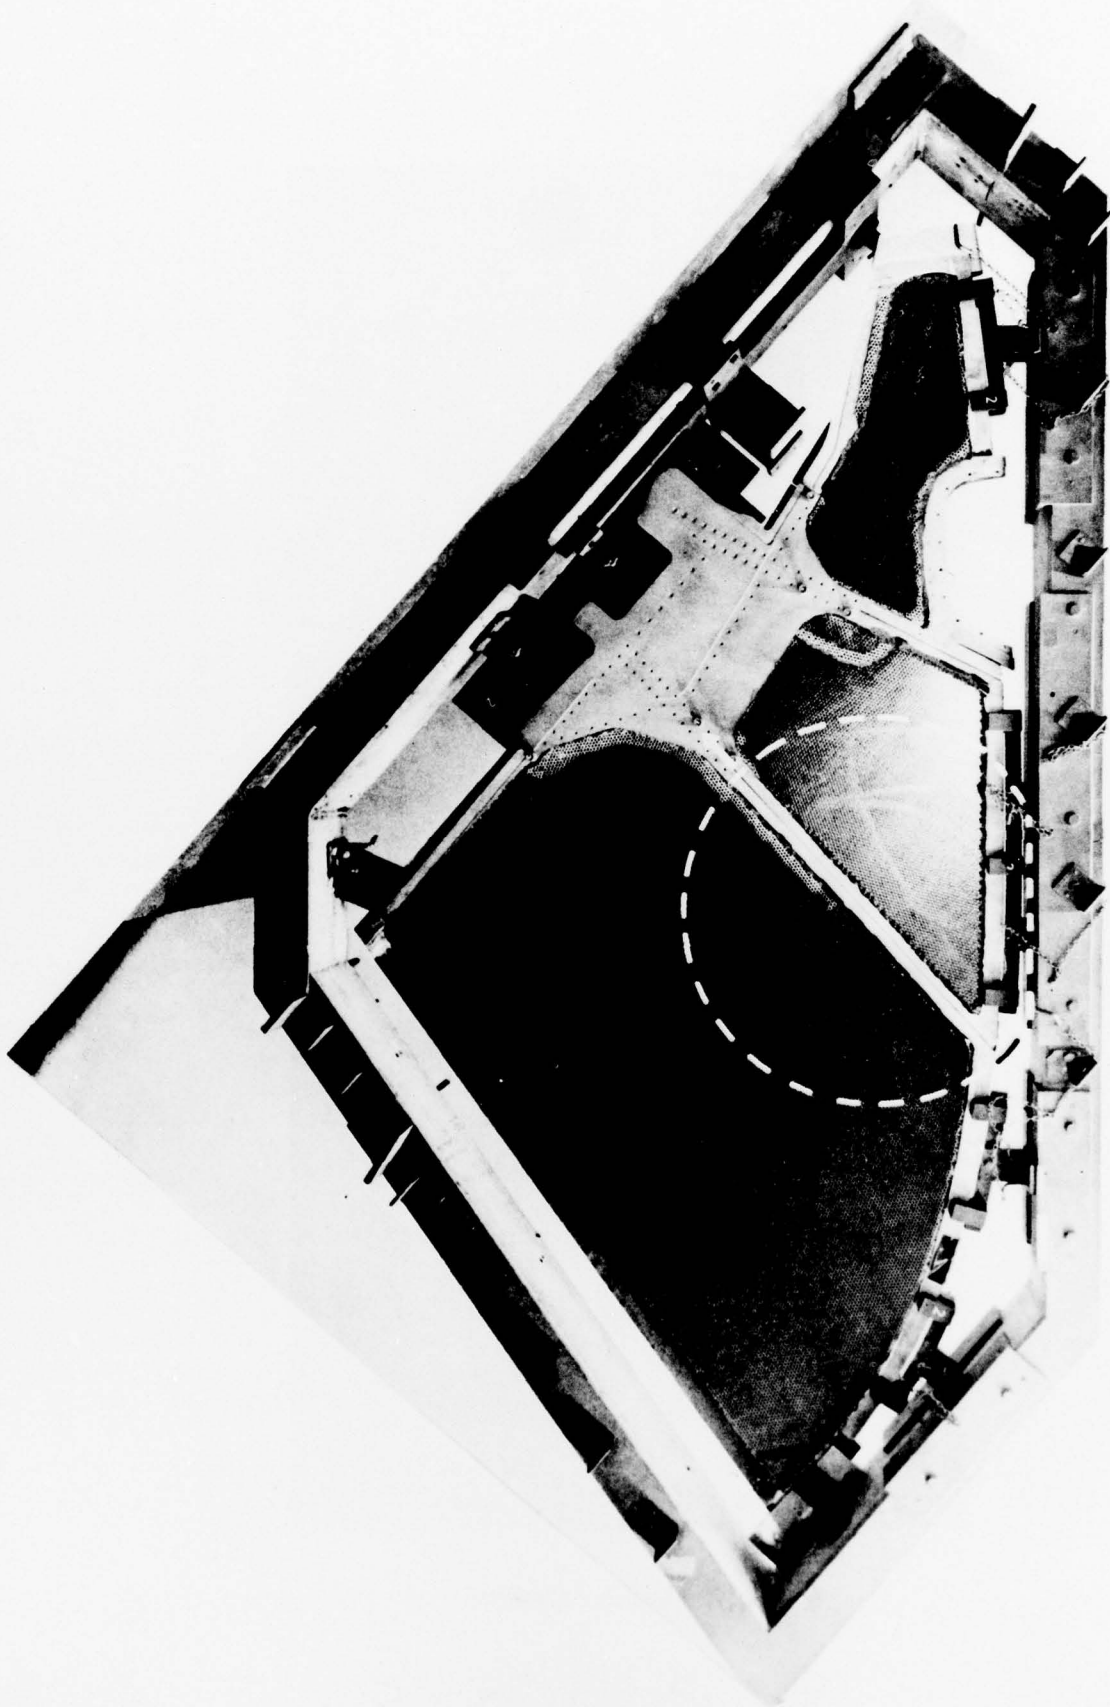
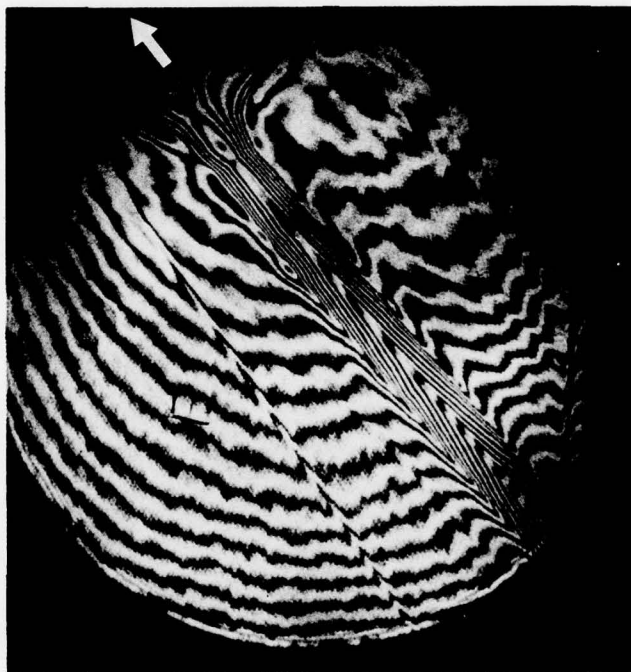
A photograph (Fig 12) supplied by HSA shows this tip before the skin was attached; a number of curved lines are clearly visible in the section between the ribs, but nothing was seen of these in the holographic examination (eg Fig 12). Radiographs showed no defects of any kind.

Fig 12a Wing tip 12 before skin attached

Fig 12b Patterns in area indicated by dashed circle

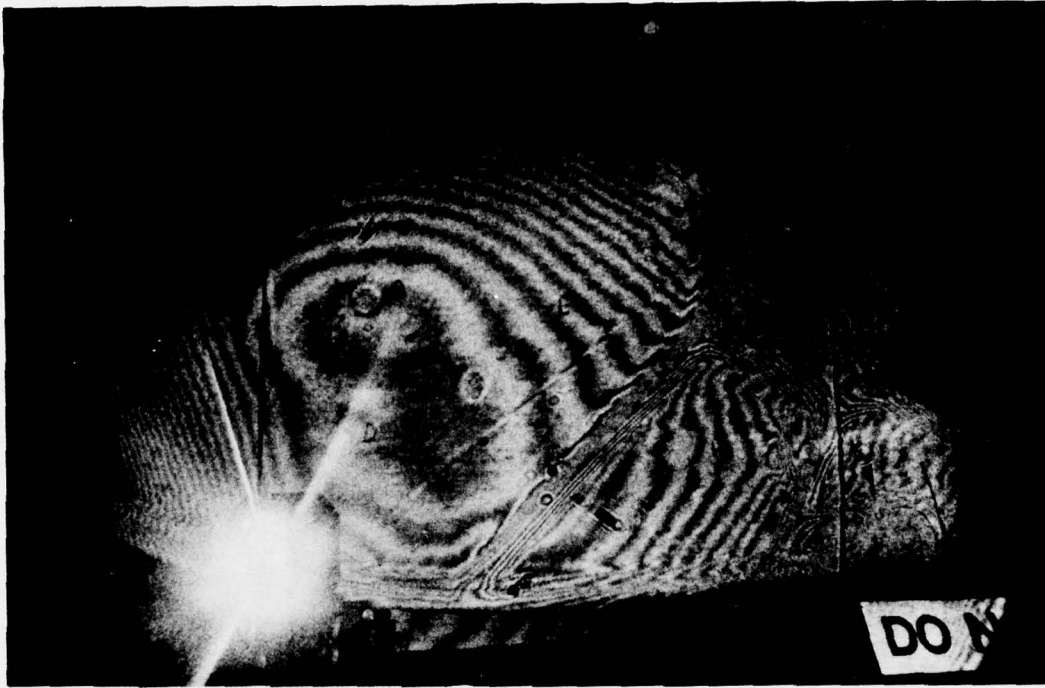
One surface of tip 10 was also examined using a much more divergent beam so that the whole area was illuminated at once. The result is shown in Fig 13; although the major anomalies can be seen, the quality is not good enough in this particular set-up to detect fine detail. In order to obtain sufficient divergence of the illumination, a negative lens had to be added and so the beam could not be spatially filtered; there are therefore spurious patterns caused by dust etc in the optical train as well as flare from the reference mirror which could not be placed outside the picture. These were, however, purely experimental problems and could be overcome with suitable equipment. It was also difficult to avoid

Fig 13 Whole surface illuminated

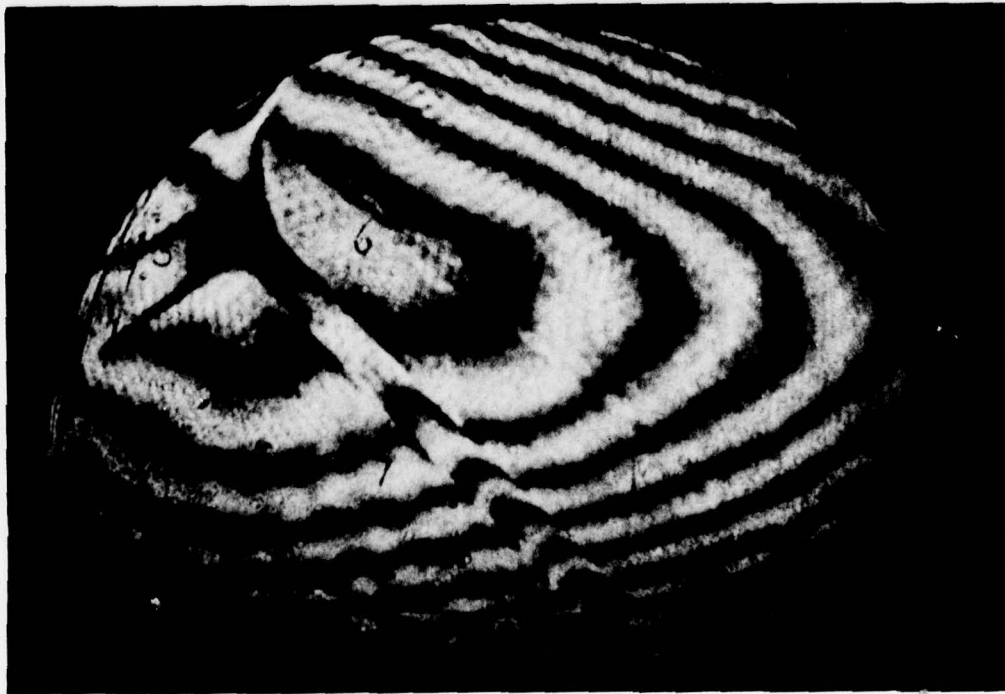
Double-exposure holograms were made of tips 8 and 10 using a pulsed ruby laser giving an exposure time of 30 ns with the tips simply set up on a wooden bench with a box as support. After recording the first hologram, heat was applied for a minute or so and the surface then allowed to cool a little before making the second exposure, the total time between exposures being approximately three minutes. A typical result is shown in Fig 14, which may be compared with Fig A11c.

Fig 14 Double pulse photograph

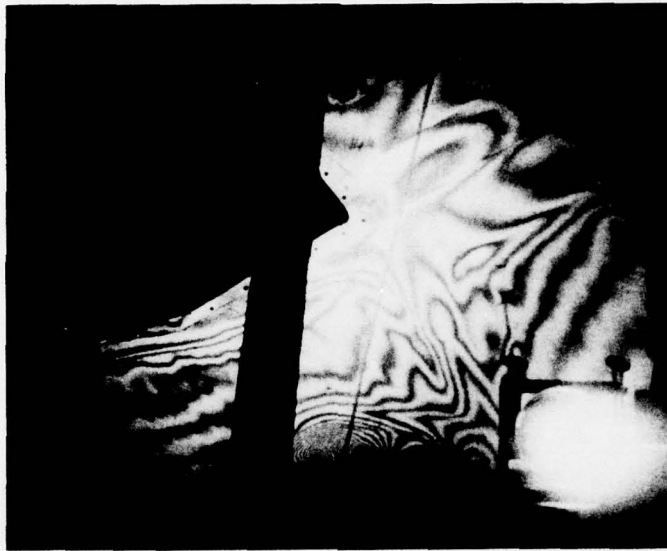
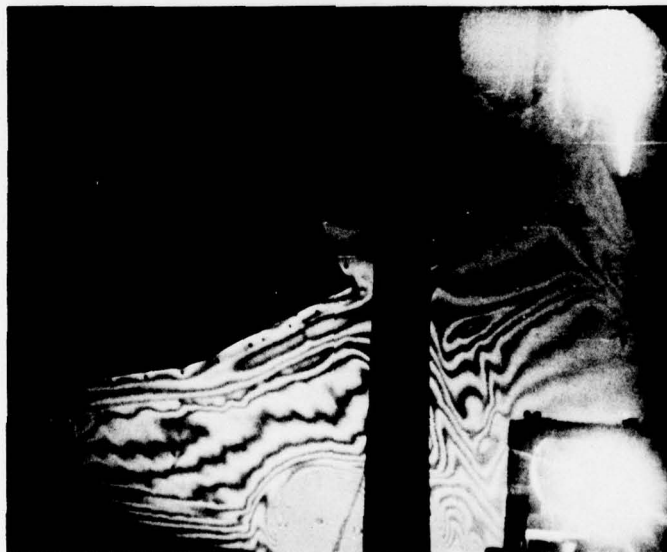
- Fig A3 Diagonal line left of '1'
Lines at centre left and top right of shadow.
Possible debond between '8' and cement patch.
- Fig A5 Long horizontal line between '8' and '7' (second run).
Possible debond below '9' (first run).
Note: (d) and (e) are from different mounting positions and the shadow obscures different areas.

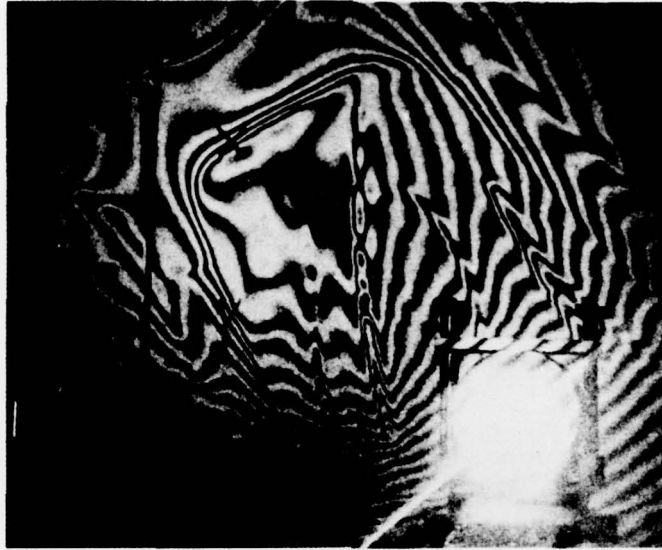
f Detection of remaining fault (see main report)

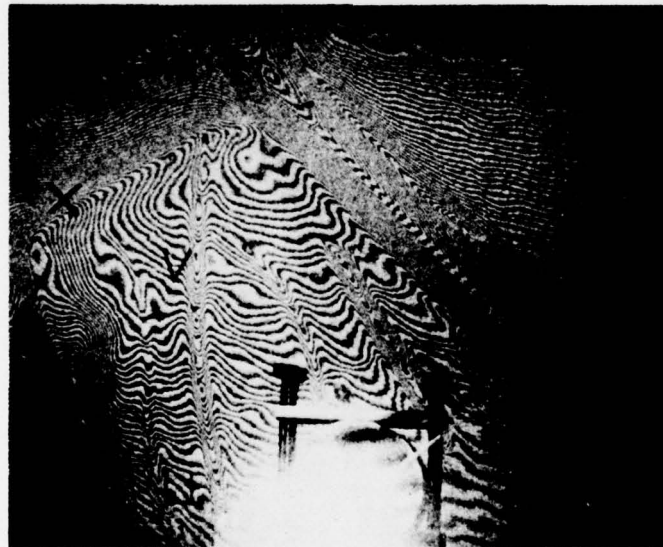
g After 4 hours — compare Fig 8b

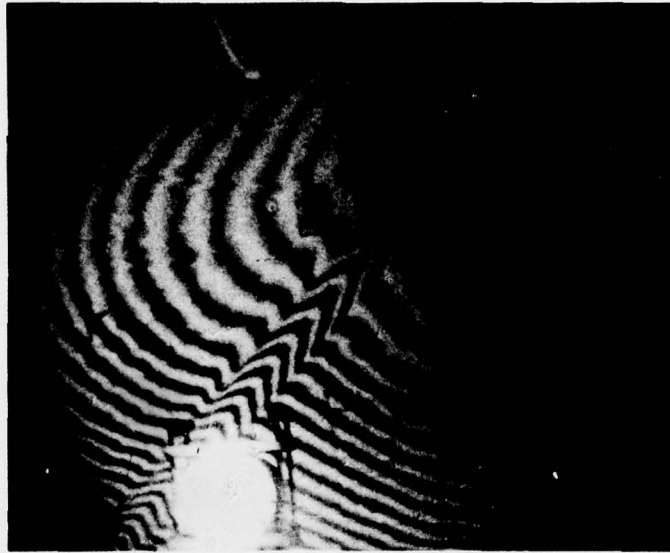
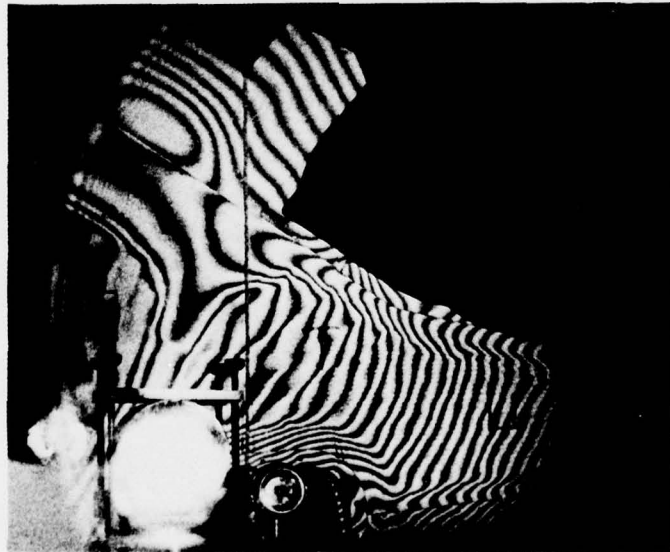
- Fig A8 See main report.
Note: shadow covers different areas in (d) and (e).
- Fig A9 Horizontal line through 'E', 'J' and 'O'.
Diagonal line left of shadow in Fig A9a.

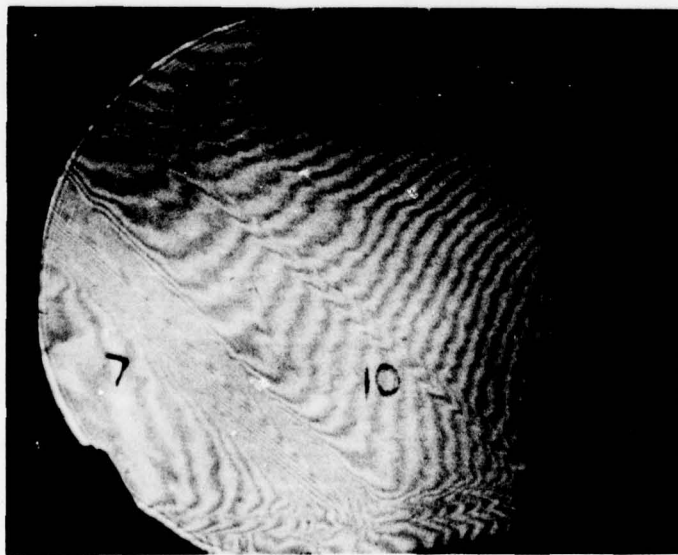
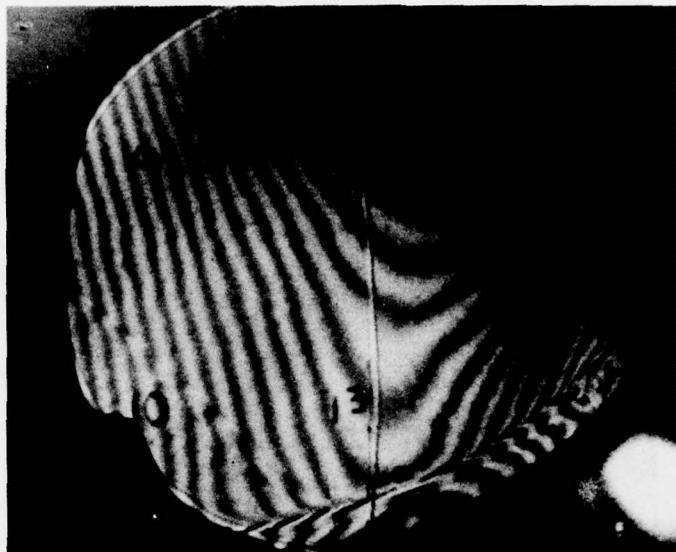
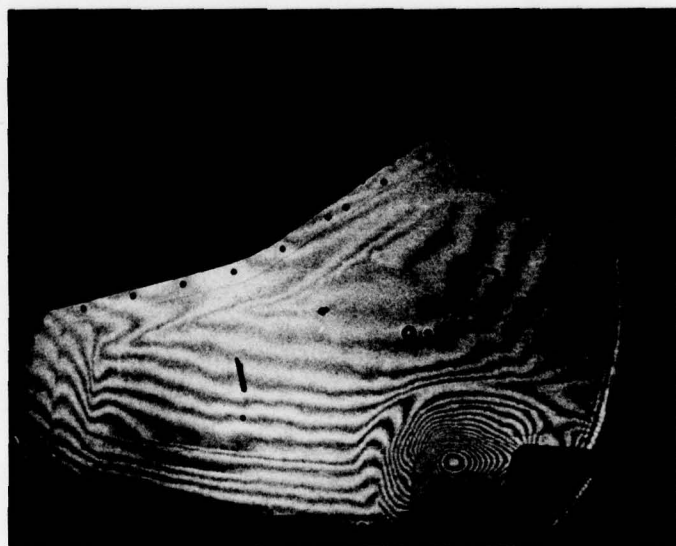
- Fig A11 Line through '6' and '10'.
Possible debonds left of '8', right of '9' and right of '14'. See also main report.
Faint line between frame and '10'.

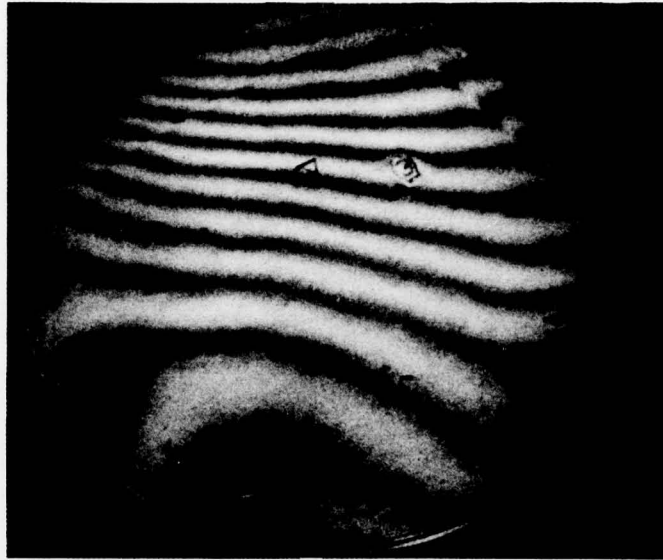
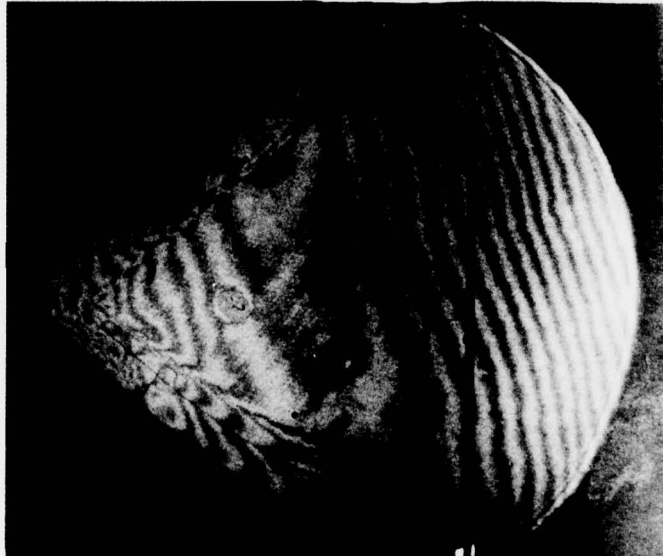
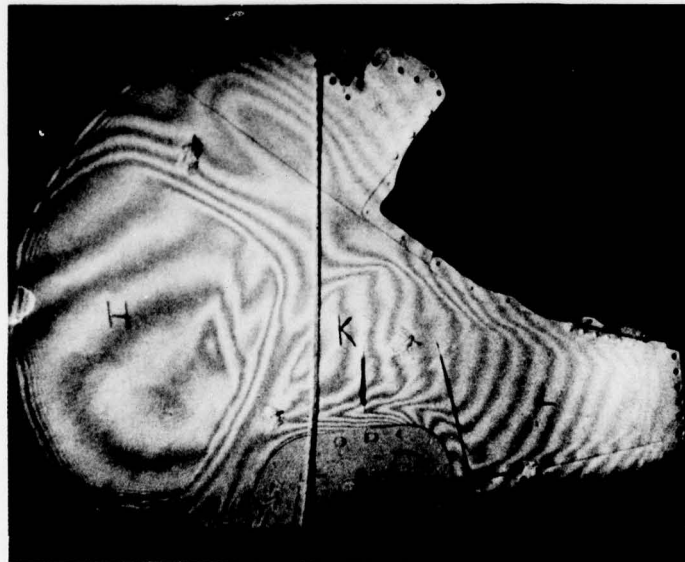
- Fig A12 Vertical faint line left of 'B' and 'D'.
Various small circles left of this line.
Line parallel to frame left of 'F' and 'G'.
Faint diagonal line between 'K' and 'L'.

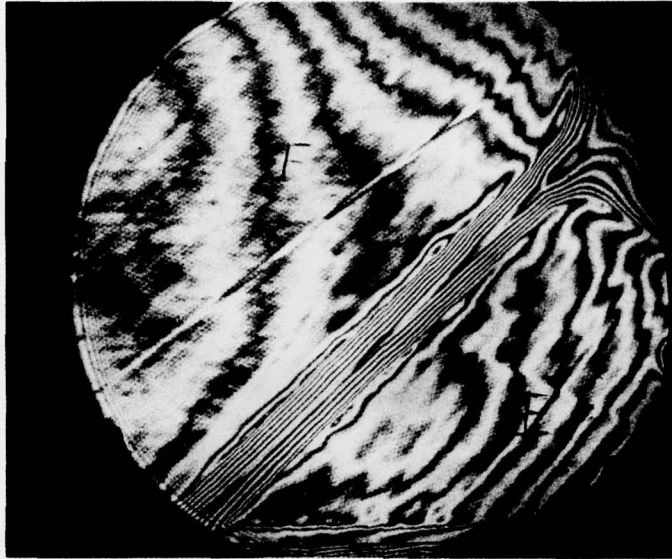
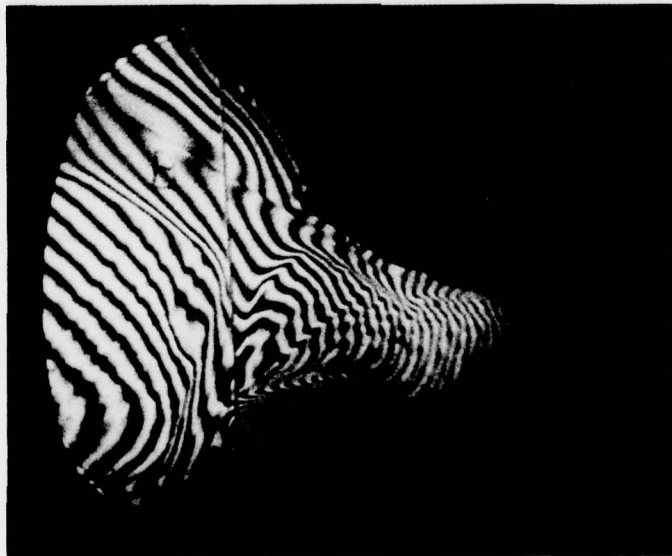
- Fig A15 Line right of 'F' and left of 'H'.
Diagonal lines left and below 'J'.
Diagonal line left of 'K'.
Diagonal line left of 'A'.
Possible debond near 'C'.
- Fig A17 Line left of '6' and right of '7'.
Diagonal lines between '1' and '2'.
Note: photograph (f) was taken an hour later than (e), using fringe control to show detail left of '1' not seen earlier.
- Fig A18 Line right of 'F' and left of 'J'.
Horizontal line below 'C' and 'G'.
Diagonal line left of 'L'.
Vertical line right of 'B' and left of 'E'.
Note: large pattern between 'A' and 'F' corresponds to rear support.
- Fig A20 Line left of 'D', 'E' and 'F'.
Fainter line between rib and this line.
Diagonal line right of 'C'.
Diagonal lines between 'J' and 'K'.
- Fig A21 Line right of 'D', 'E' and 'F'.
Diagonal line left of 'A'.
Complicated pattern on metal edge near 'A'.
Diagonal lines left of 'L'.
