PICATINNY LAKE DAM

NJ 00002

PHASE 1 INSPECTION REPORT
NATIONAL DAM SAFETY PROGRAM

Picatinny Lake Dam (NJ-00002).
Passaic River Basin, Green Pond
Brook, Morris County, New Jersey.
Phase 1 Inspection Report.

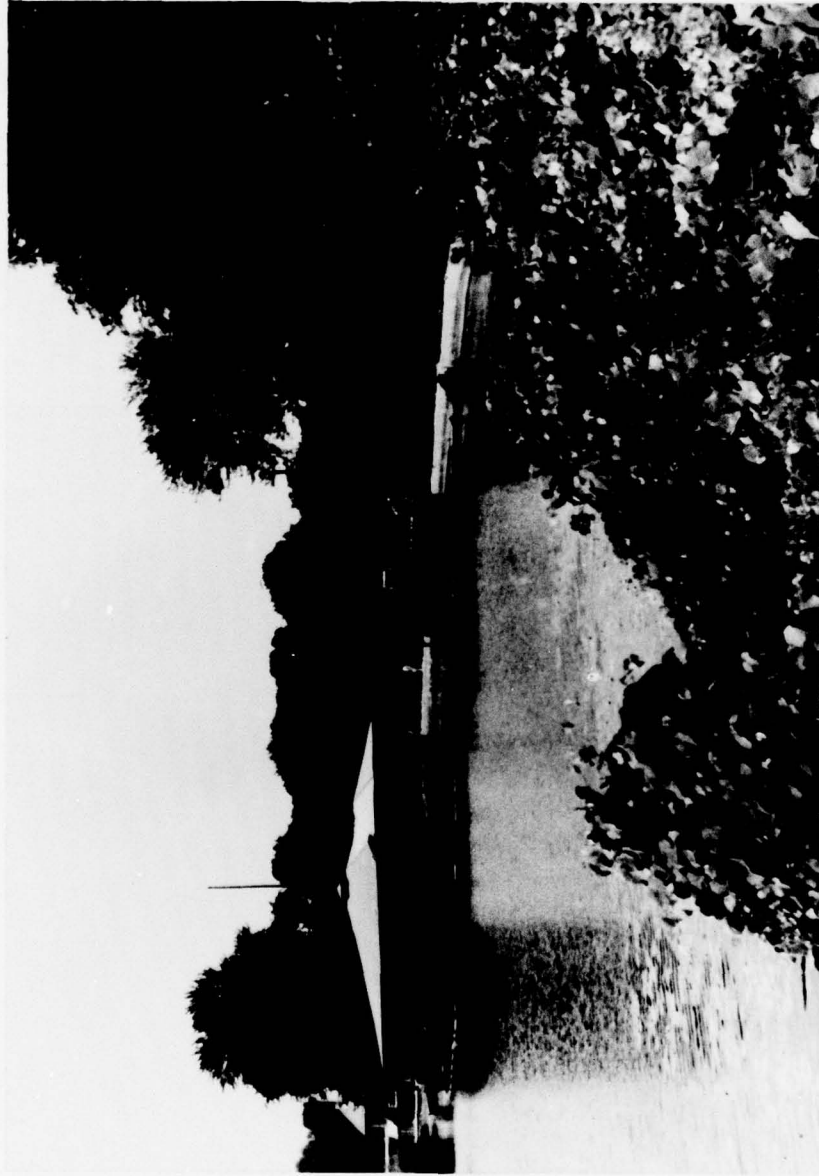
Picatinny Lake Dam
Overall view of upstream face of dam from the right.

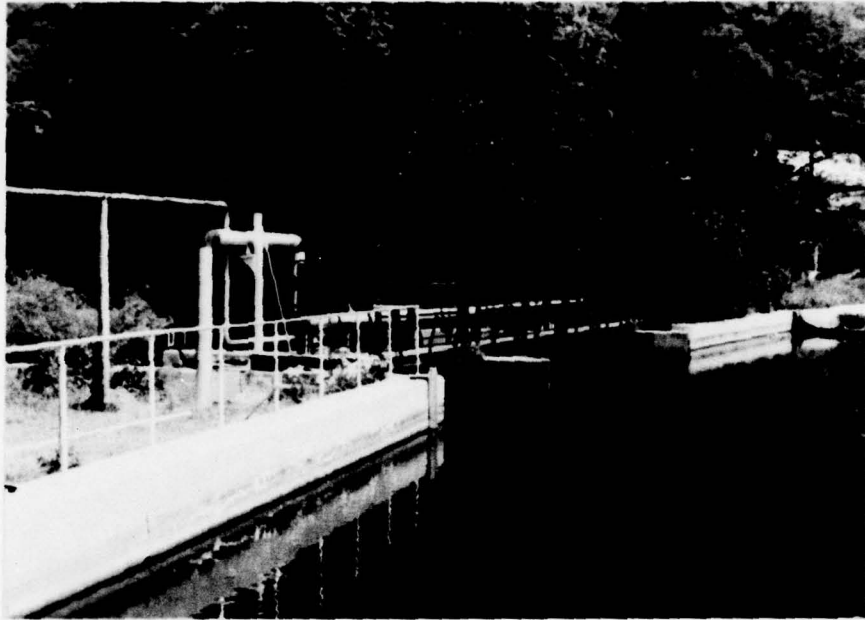
Photo No. 1 - View of upstream face of dam and spillway. Note the oil barrier, headwater gage, and the 5" ϕ steam line and 4" ϕ air line passing across the spillway. The trash/fish screens are totally deteriorated, but deterioration of the spillway structure is surficial only.

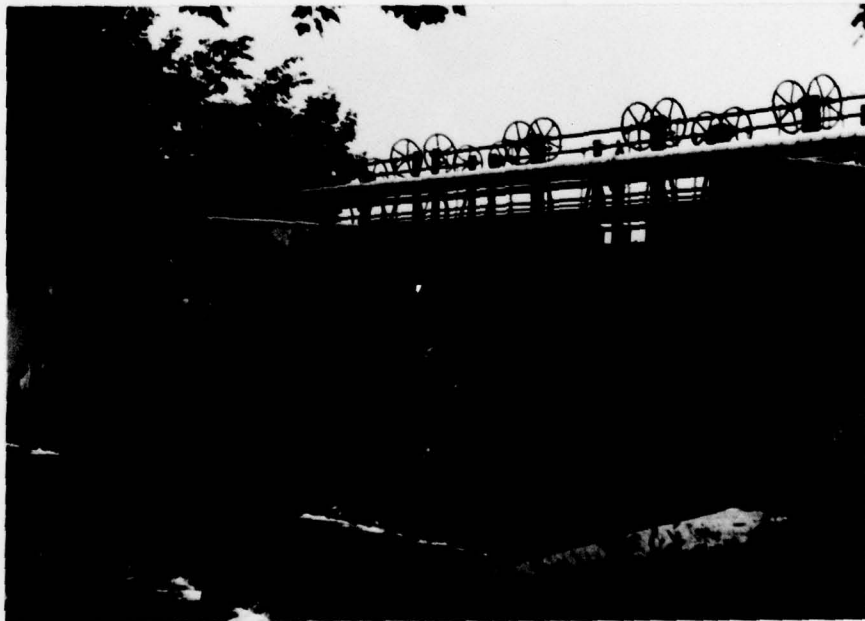
The spillway was basically in good condition. The gunnite refacing exhibited minor shrinkage cracks, a small hole (2" x 4") in the central portion of the ogee and minor erosion at the waterline. No undermining of the toe was apparent and the new masonry wingwalls were sound, apart from being slightly undermined. Flow was predominantly smooth, and was discharging mainly from the side channels. In the central section, flow was concentrated towards the left side, but this was considered to be due to the partially open flashboard and not to any significant horizontal misalignment. No low-level outlet is provided.

Photo No. 2 - View of downstream face of spillway. Note the minor deterioration on the submerged surfaces and the good overall condition.

(5) Repair all eroded, cracked and spalled concrete with epoxy cement.

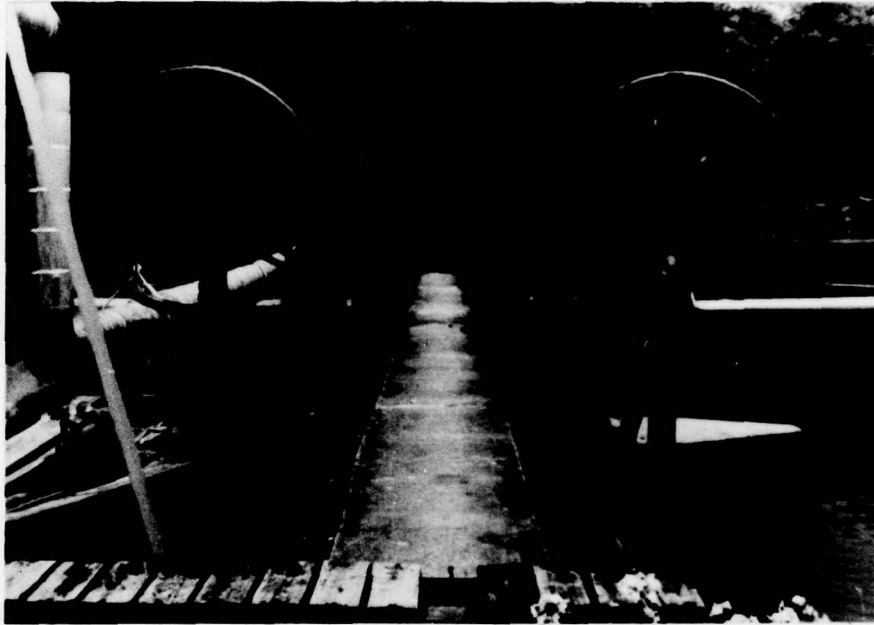
The steel and concrete foot-bridge over the spillway was found to be structurally sound. Surface rusting of the steel stringers and handrailing was noted. On the bridge piers and abutments, minor spalling of concrete was observed, and the steel protection was rusted superficially. The insulated 5" diameter steam line and the 4" diameter air-line appeared to be adequately supported and to present no hazard to the dam.

Photo No. 5 - Detail of the footbridge over the spillway showing the surface deterioration, but good structural condition. The manual lifting devices for the flashboards are to the left of the bridge, and for the fishscreens to the right.

(6) Clean and repaint all the steel-work on the spillway bridge, flashboards and operating mechanisms. Replace missing tie bars on the flashboards, and check the flashboard timbers for rot, replacing as necessary. Replace the missing lifting chain and grease all moving parts of the operating mechanism.

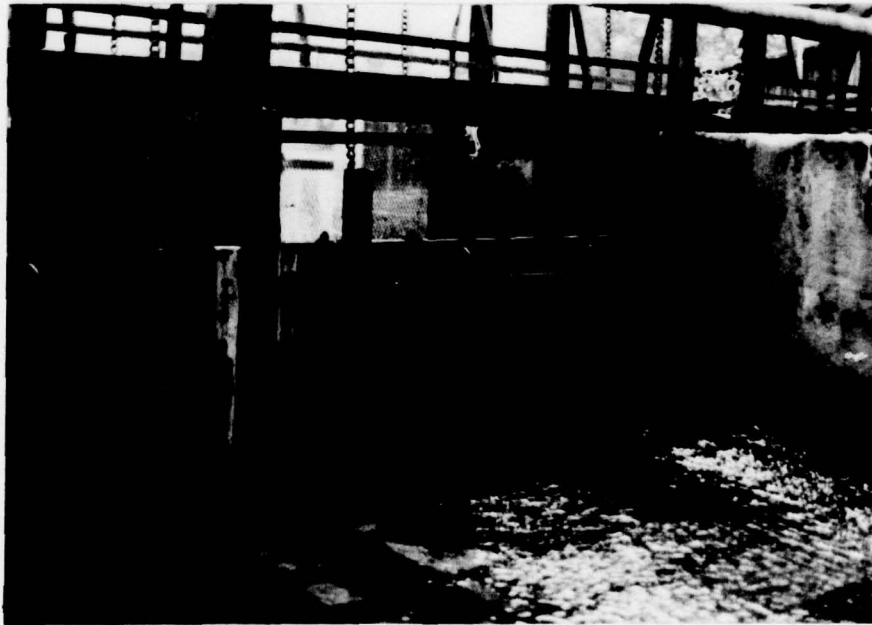
The timber spillway flashboards exhibited minor signs of rot, but this was difficult to verify. Steel reinforcement of the flashboards was rusted and some tie-rods were missing. The steel gate-guides were rusted and somewhat congested with debris, and appeared to be a tight fit.

Photo No. 6 - Typical detail of a flashboard in the center section. The flashboard shown has been raised by 1/2 inch to permit discharge from the lake. Note the missing tension rod, the rusted condition of the guides and steel gate-parts, and the spalled concrete under the footbridge.

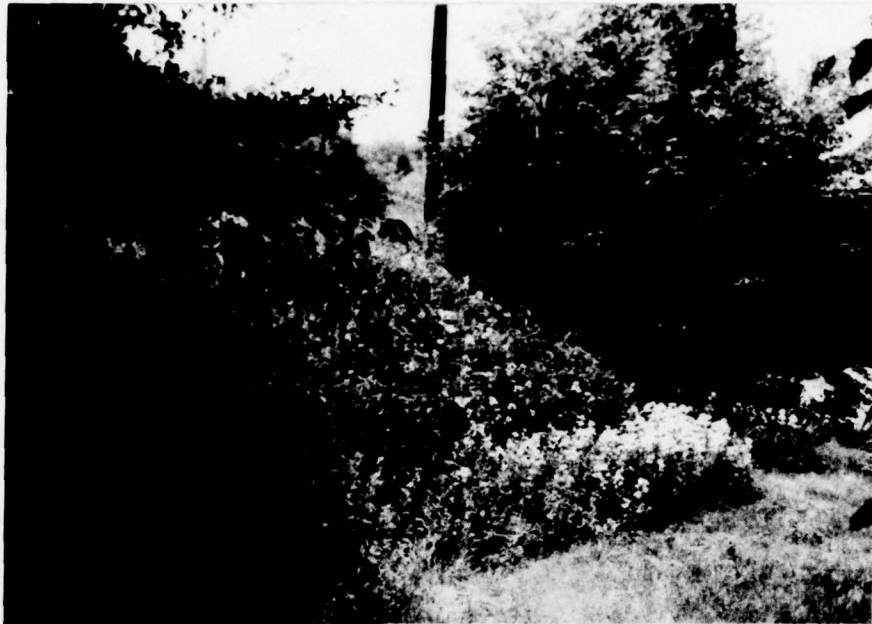
There are no signs of distress in either the earth embankments or the spillway of Picatinny Lake Dam. Horizontal and vertical alignments are good. The slope on the downstream face of 1.5H:1V is considered excessively steep, but no sign of sloughing was noted. No uncontrolled seepage was found in any part of the dam or downstream channel. The controlled drainage from above the old head-races was clear of silt, and has functioned well for 10 years. Undermining of the downstream portion of the right wingwall poses no immediate threat to stability but should be corrected in the near future. The large trees observed growing near the spillway could pose a threat to stability.

Photo No. 9 - Typical view of downstream face of embankment sloped at 1.5H:1V and covered with trees near the spillway. Note the 1" diameter airline on the right of the picture, feeding Building 333.

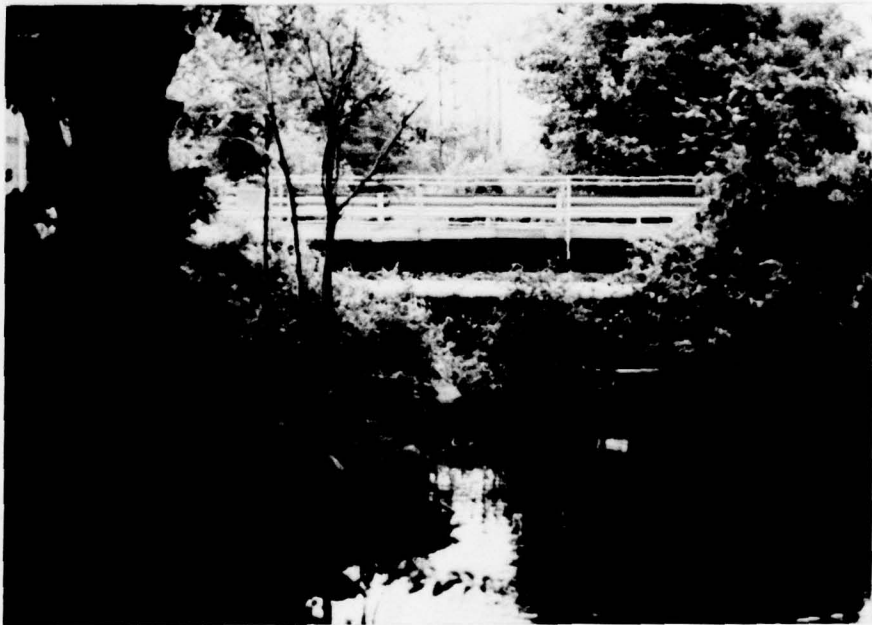
Photo No. 10- View of roadway bridge 350 feet downstream of the spillway, carrying Whittemore Avenue over Green Pond Brook. Note the steam pipe crossing the brook, and the electric cable pylon on the downstream channel bank.

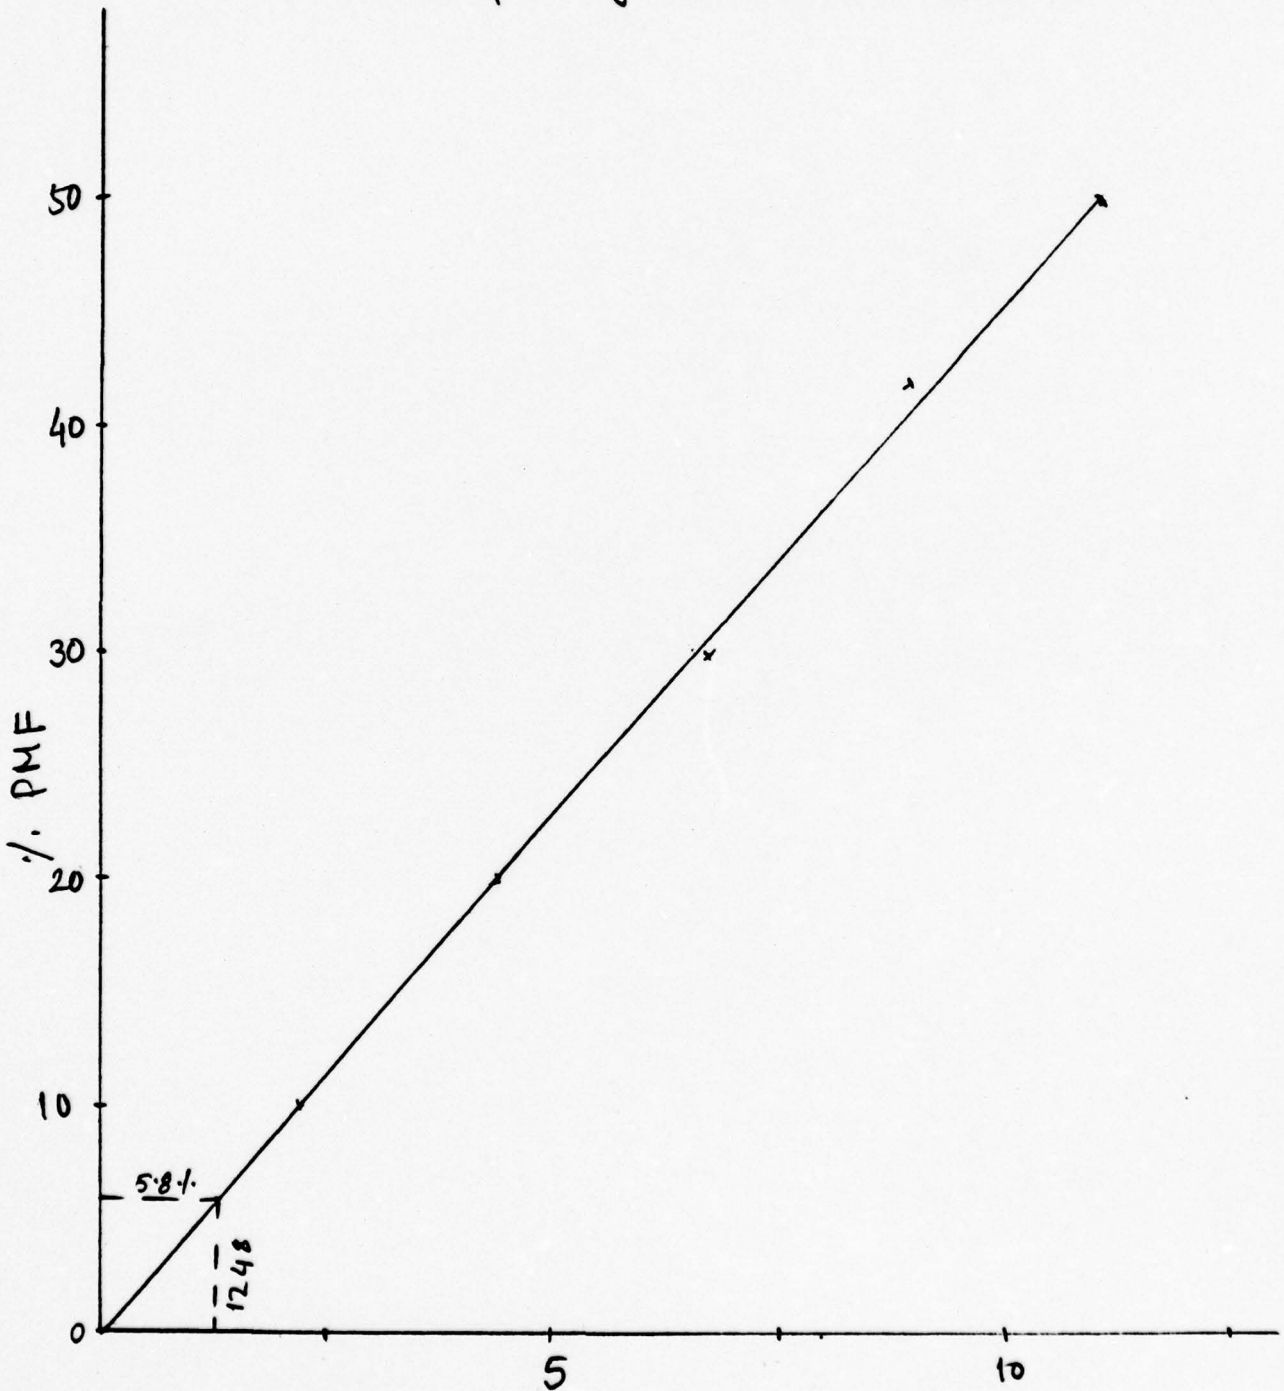
Overtopping Potential of Dam

Overtopping will occur at an elevation of 713.5
 $Q = 1248$ cfs (≈ 6 % PMF)
