# HAMMONTON LAKE DAM NJ 00476

## PHASE 1 INSPECTION REPORT NATIONAL DAM SAFETY PROGRAM.

Hammonton Lake Dam (NJ-00476). Atlantic  
Ocean Basin. Hammonton Creek, Atlantic  
County, New Jersey. Phase 1 Inspection Report.

August 1979

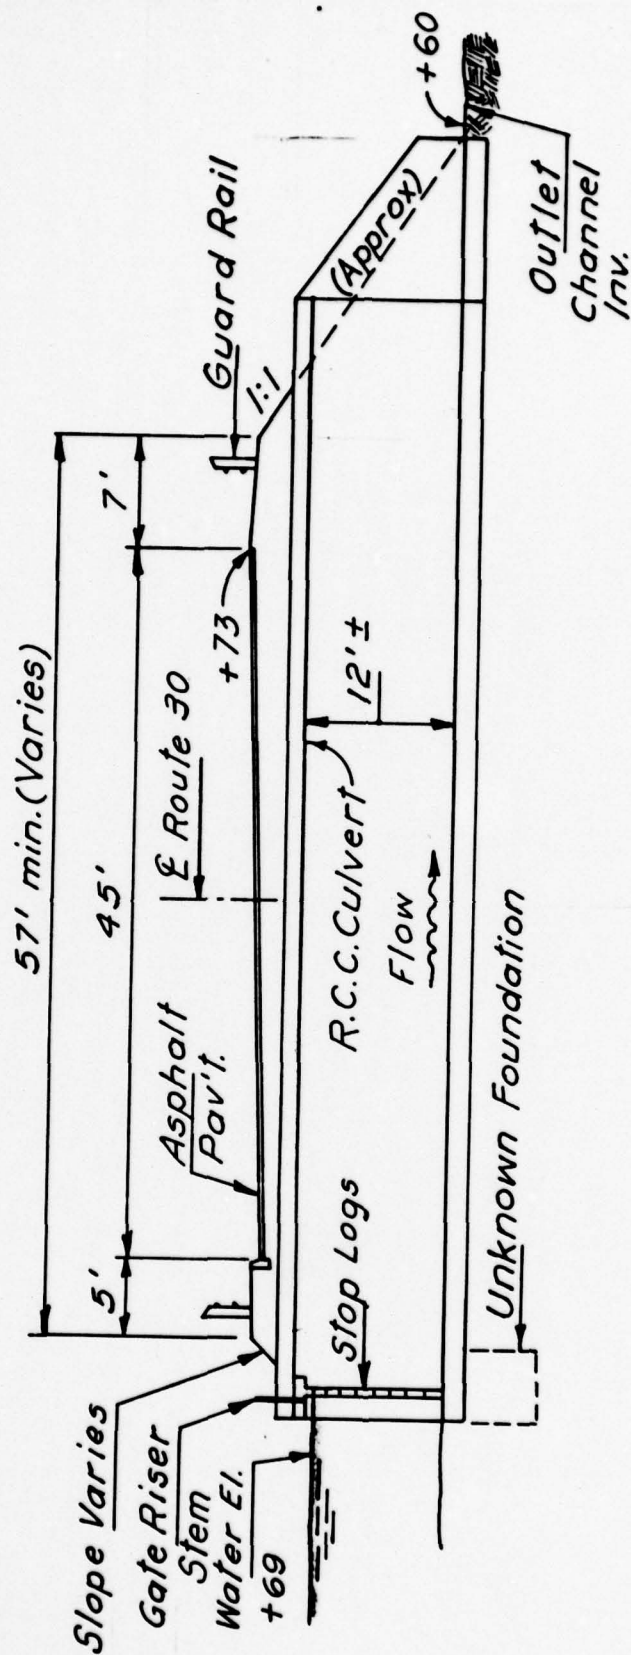
FIGURE 3

SECTION THRU SPILLWAY  
*Not to Scale*
