**KIRKWOOD LAKE DAM**

**NJ 00399**

6 **PHASE 1 INSPECTION REPORT  
NATIONAL DAM SAFETY PROGRAM.**

Kirkwood Lake Dam (NJ-00399), Delaware River Basin. Cooper River, Camden County, New Jersey. Phase 1 Inspection Report.

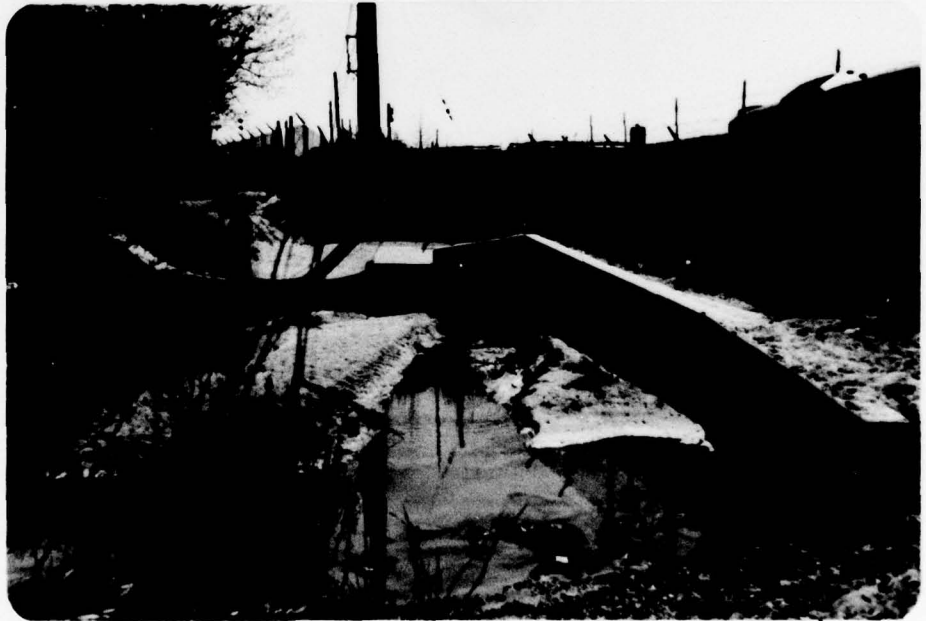
The concrete spillway, although buttressed against the old stone masonry abutment walls is in no immediate danger of collapse unless the embankment is scoured out on each side. Further, during most severe flooding conditions, there is apparently a backwater condition caused by the partially-blocked elliptical CMP culvert under the roadway embankment just 100 feet downstream. However, surface run-off from the crest is slowly scouring out the backslope fill behind the bridge wingwalls and together with the two storm drains from the railroad property have created a stilling basin between the dam and the roadway embankment.

View of Stilling Basin

(4) Heavy stone should be placed in the downstream stilling basin in selected areas to prevent further scouring and preclude the undermining of the bridge structure.
