DELAWARE RIVER BASIN  
RACCOON CREEK, GLOUCESTER COUNTY  
NEW JERSEY

# LAKE GILMAN DAM

## NJ 00431

### PHASE 1 INSPECTION REPORT NATIONAL DAM SAFETY PROGRAM

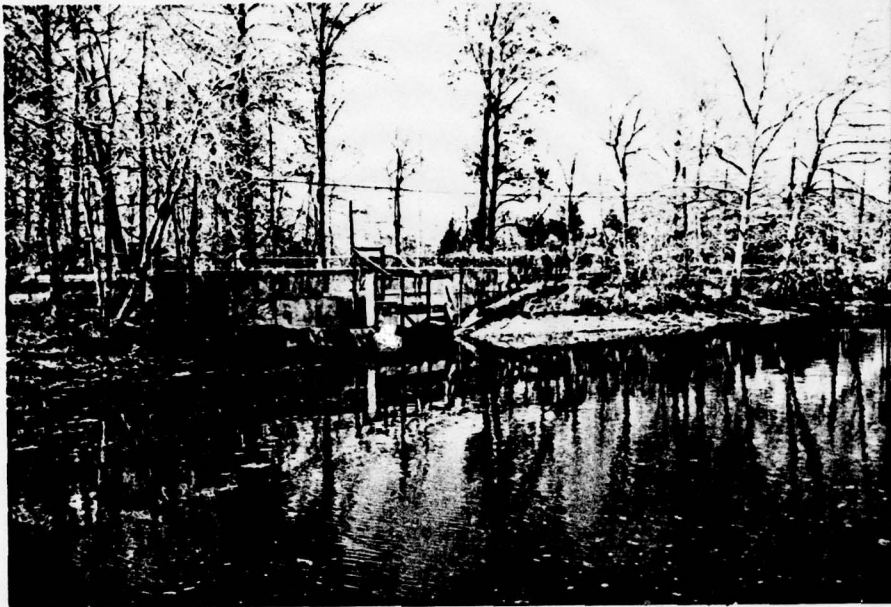
VIEW OF SPILLWAY

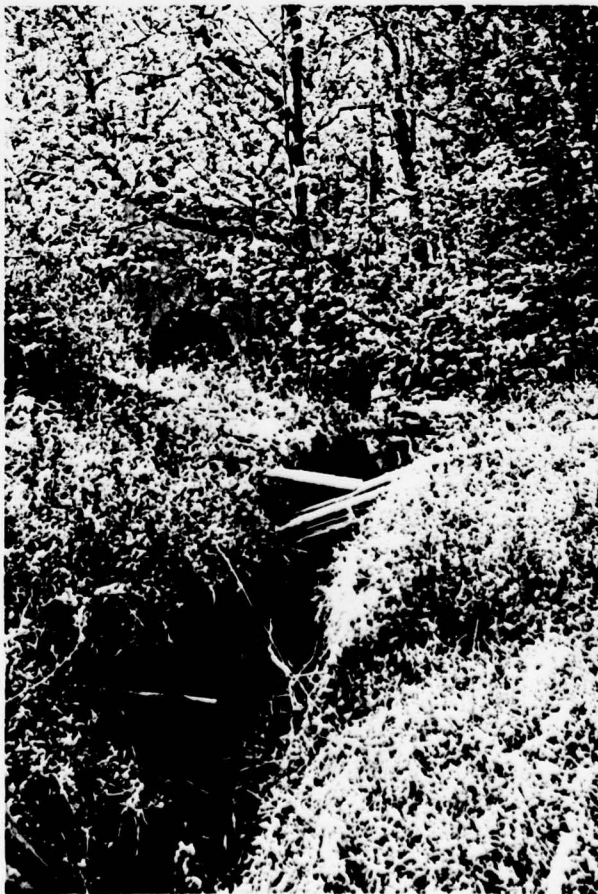
| VISUAL EXAMINATION OF | OBSERVATIONS | REMARKS OR RECOMMENDATIONS |
|---|---|---|
| UNUSUAL MOVEMENT OR CRACKING AT OR BEYOND THE TOE | None observed. | Deeply incised ditch just below bridge (on right side). Caused by discharge from roadway curb inlet. (Undercutting toe of embankment). |

View of Ditch at Right Downstream Toe of Dam

(3). Construct curbs and catch basins along the roadway gutters to better channelize the roadway runoff.
