Name Of Dam: LAKE BRITTLE DAM

Location: FAUQUIER COUNTY

Inventory Number: 06122

PHASE I INSPECTION REPORT NATIONAL DAM SAFETY PROGRAM

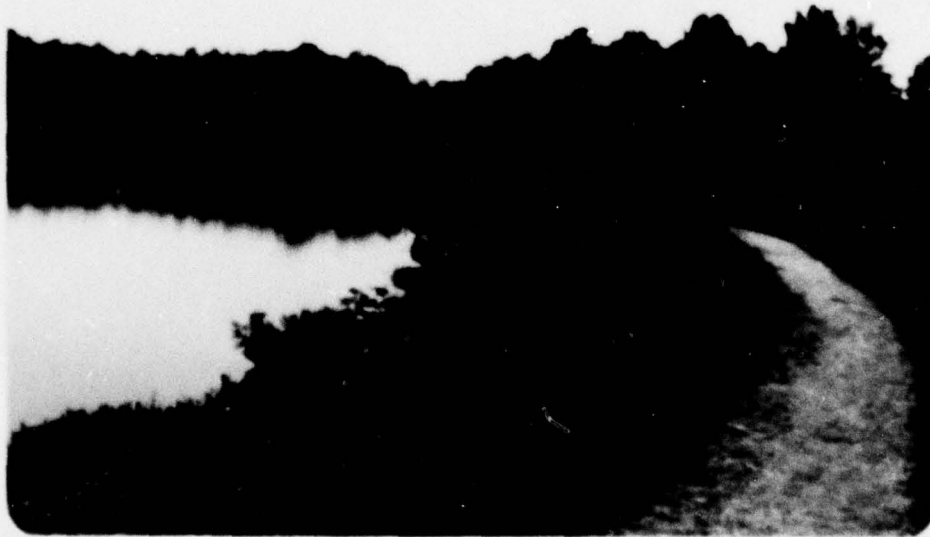
UPSTREAM SLOPE

3.1.2. Dam: The embankment was in fair condition. However, the upstream slope had experienced erosion along the shoreline. It also had little to no vegetative cover. Existing riprapped slope protection had deteriorated. Also, it was noted that the upstream slope had been subjected to a 3 to 4-foot drawdown from normal pool without any detrimental effect to the slope. The crest of the dam served as a foot path. See the overall photographs in the front of the report. The downstream slope was thickly vegetated with brush and locust saplings except for surface erosion that had exposed most of the slope in an area about 150 feet right of the principal spillway, Appendix II, Photo 6 and 4, respectively. A linear wet spot was located in the embankment about 125 feet right of the spillway. Several wet spots with local ponding were located in the downstream area, Appendix II, Photo 5. The embankment seep and the general downstream seepage area are shown on Plate I, Appendix I. However, no sloughing, settlement or misalignment were noted.

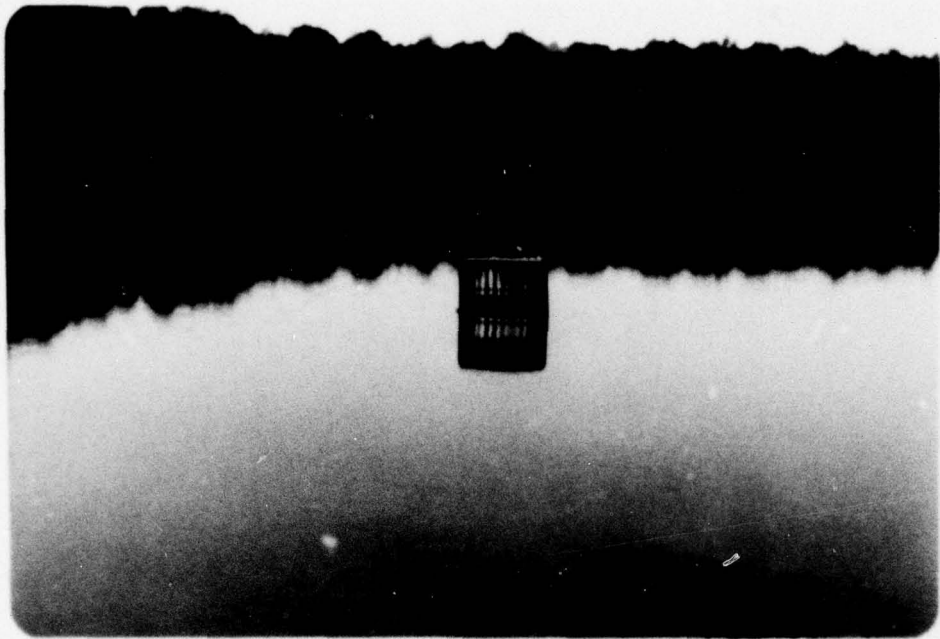
3.1.3 Appurtenant Structures: Observations of the intake structure showed deterioration. However, most of the structure was submerged at the time of the inspection, Appendix II, Photo 1. The principal spillway and discharge channel appeared to be in good condition and showed no signs of deterioration, Appendix II, Photo 2.

PHOTO #1 INTAKE STRUCTURE

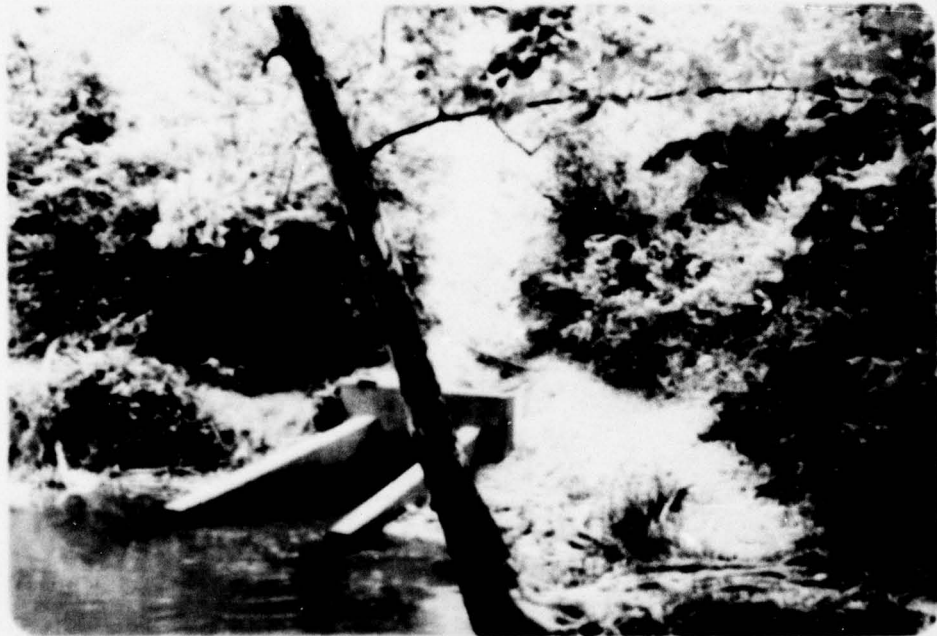
PHOTO #2 OUTLET STRUCTURE

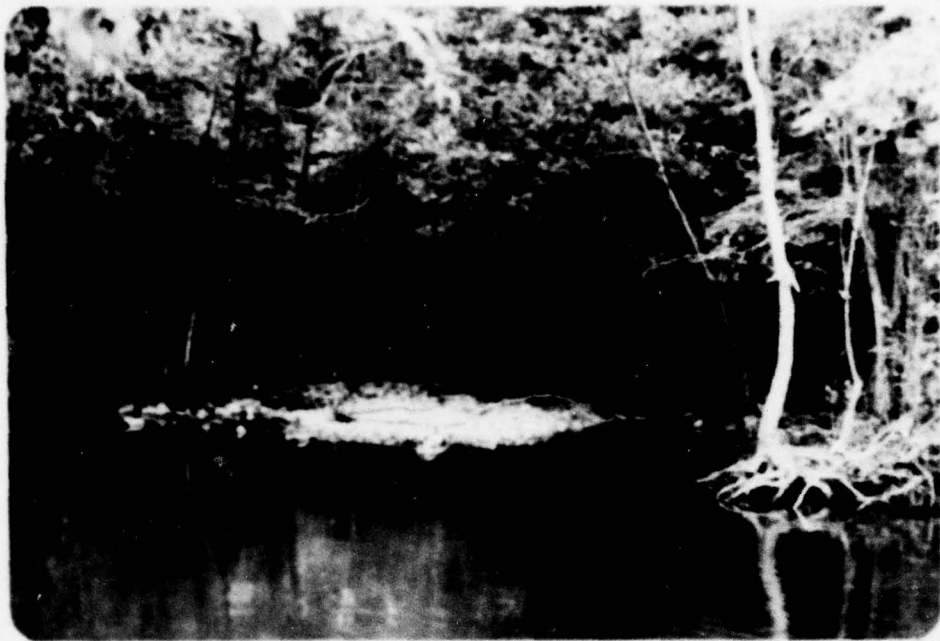
PHOTO # 3 DOWNSTREAM CHANNEL

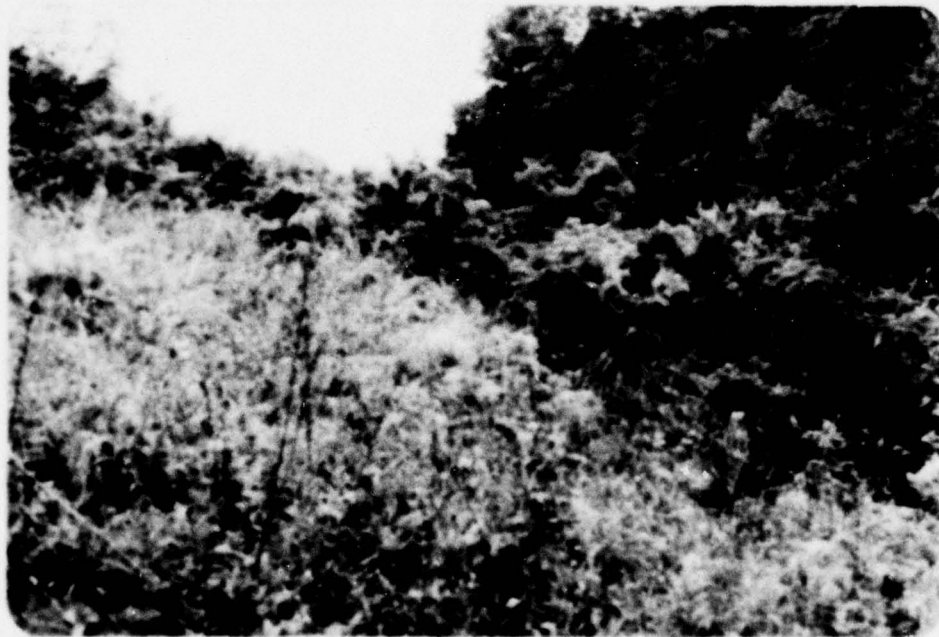
PHOTO * 6 HEAVY VEGETATIVE GROWTH
ON DOWNSTREAM SLOPE

VISUAL EXAMINATION OF	OBSERVATIONS	REMARKS OR RECOMMENDATIONS
SURFACE CRACKS	No surface cracks were found. However, most of the downstream slope is heavily vegetated with brush and locust saplings. The vegetation inhibited the inspection.	The embankment should be completely stripped of brush and trees. Any subsequent holes should be dressed with compacted fill similar to the embankment material.
UNUSUAL MOVEMENT OR CRACKING AT OR BEYOND THE TOE	No unusual movement or cracking was found.	None.
SLOUGHING OR EROSION OF EMBANKMENT AND ABUTMENT SLOPES	No sloughing was found. Surficial erosion has exposed most of the downstream slope about 150 feet right of the outlet works. A footpath leads from the top of the dam to the outlet works. The upstream slope has little or no vegetative cover. It was noted that the upstream slope had been subjected to 3 to 4-foot drawdown from normal pool without any detrimental effect to the slope. The draw-down part of an operational procedure.	After stripping of brush and trees, exposed soil should be protected with a grass cover suitable for preventing surficial erosion. The foot path should be paved for the same reason.

- a. Trim all brush and locust located on the embankment.
- b. Repair the small erosion gully in the upper portion of the discharge channel of the emergency spillway.
