Name Of Dam: FALLING CREEK
Location: BEDFORD COUNTY
Inventory Number: 01910

PHASE I INSPECTION REPORT NATIONAL DAM SAFETY PROGRAM

PREPARED BY
NORFOLK DISTRICT CORPS OF ENGINEERS
803 FRONT STREET
NORFOLK, VIRGINIA 23510

SEPTEMBER 1979

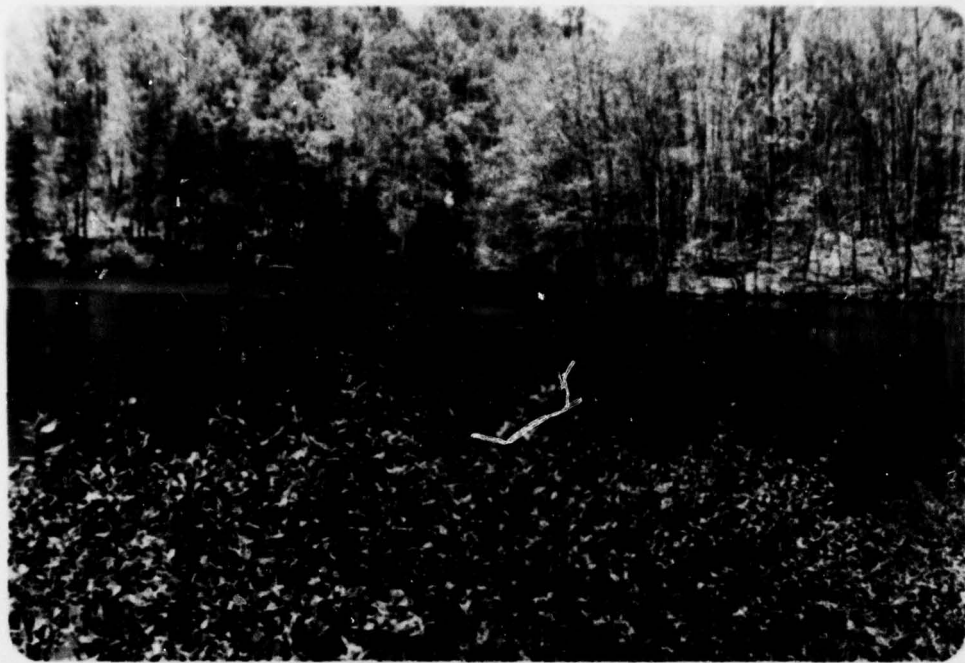
3.1.3 Appurtenant Structures: Observations of the intake structure were impossible, because it was submerged at the time of the inspection, Appendix II, Photo I. However, the 1972 diver's report (Appendix IV) notes some deterioration of the structure.

PHOTO #1 INTAKE STRUCTURE

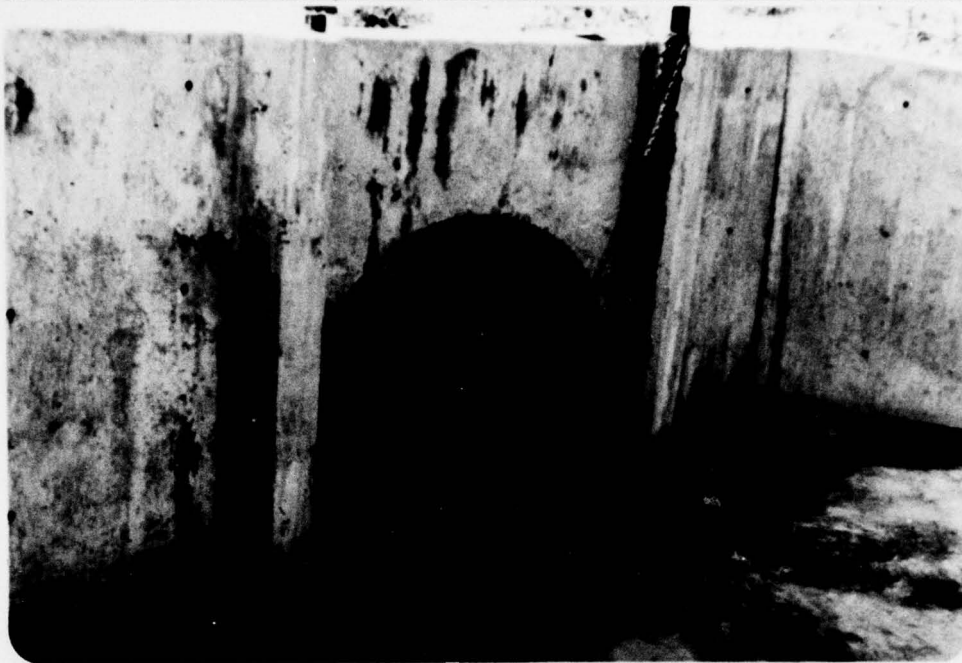
PHOTO # 3 EMERGENCY SPILLWAY

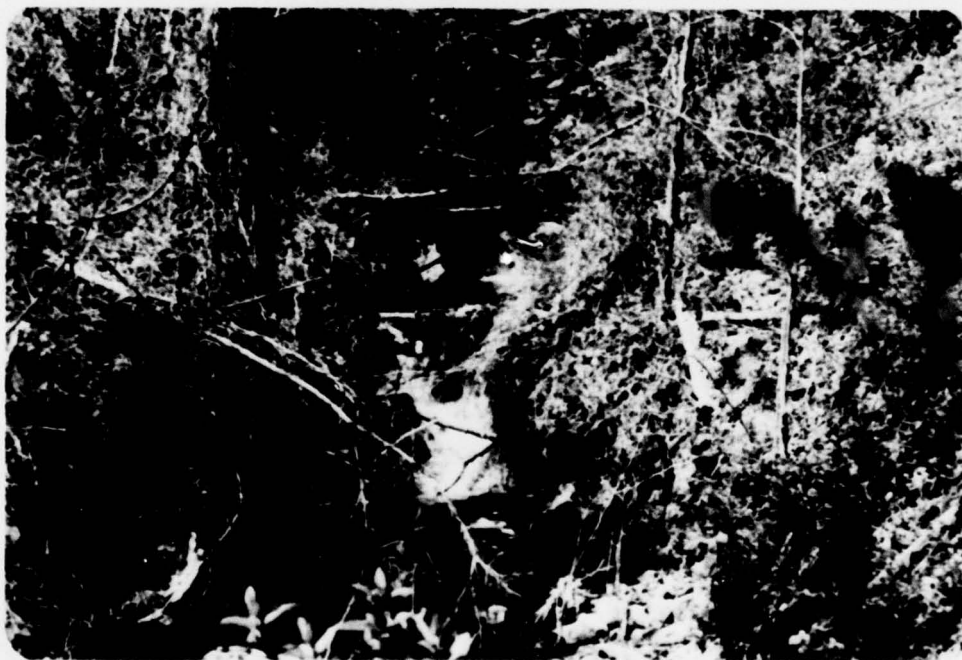
3.1.7 Downstream Channel: No erosion was observed in the downstream area. However, the channel is overgrown with trees and shrubs, Appendix II, Photo 4. The filtration plant is immediately downstream. About 6 to 7 homes and stores are located along Route 635 at the Route 24 intersection, 1.5 miles downstream.

PHOTO # 4 EMERGENCY SPILLWAY
DISCHARGE CHANNEL

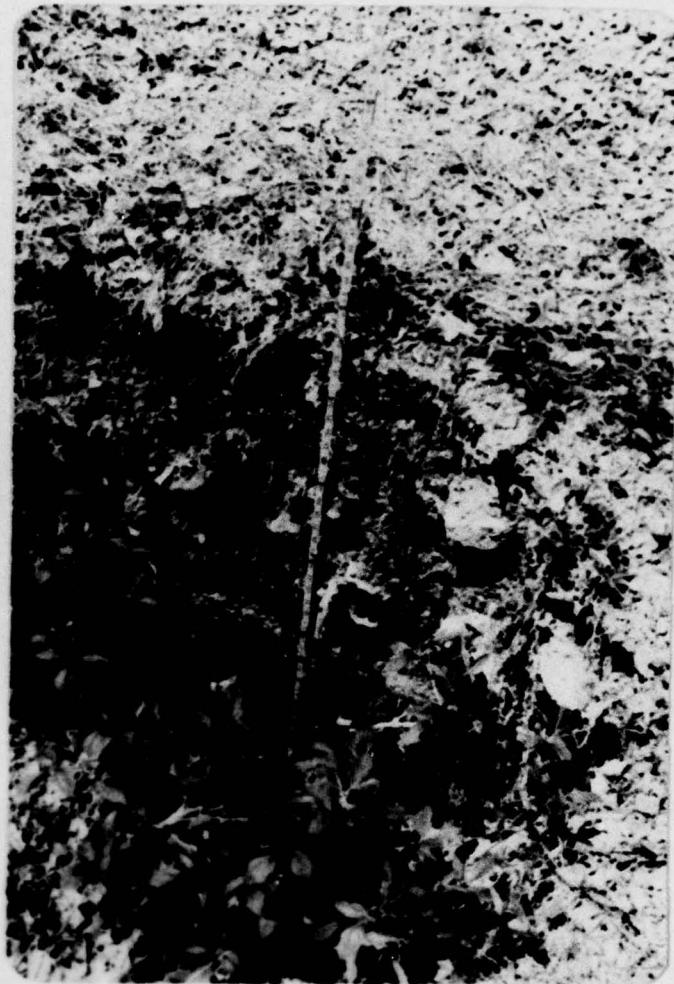
PHOTO # 7 EROSION AROUND DOWNSTREAM
END OF EMERGENCY SPILLWAY

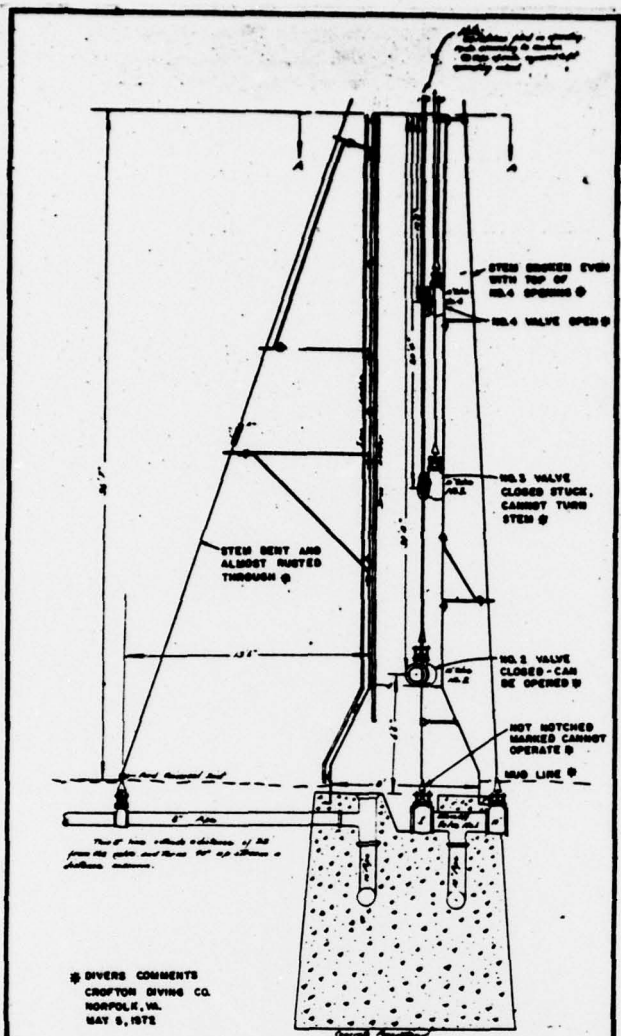
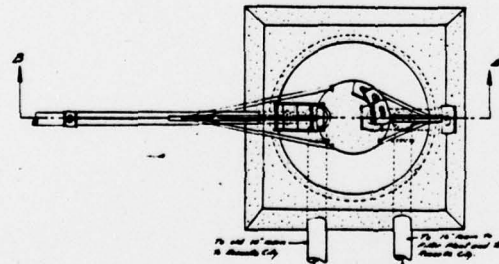
DIVERS COMMENTS
 CROFTON DIVING CO.
 NORFOLK, VA.
 MAY 9, 1978

c. A 1972 diver's inspection report of the intake structure with all comments noted on the drawing in Appendix IV.
