Name Of Dam: UPPER SOUTH LAKE DAM
Location: FAIRFAX COUNTY
Inventory Number: VA. 05913

PHASE I INSPECTION REPORT

NATIONAL DAM SAFETY PROGRAM

**DEWARD M. MARTIN & ASSOCIATES
WILLIAMSBURG, VIRGINIA
AUGUST, 1979**

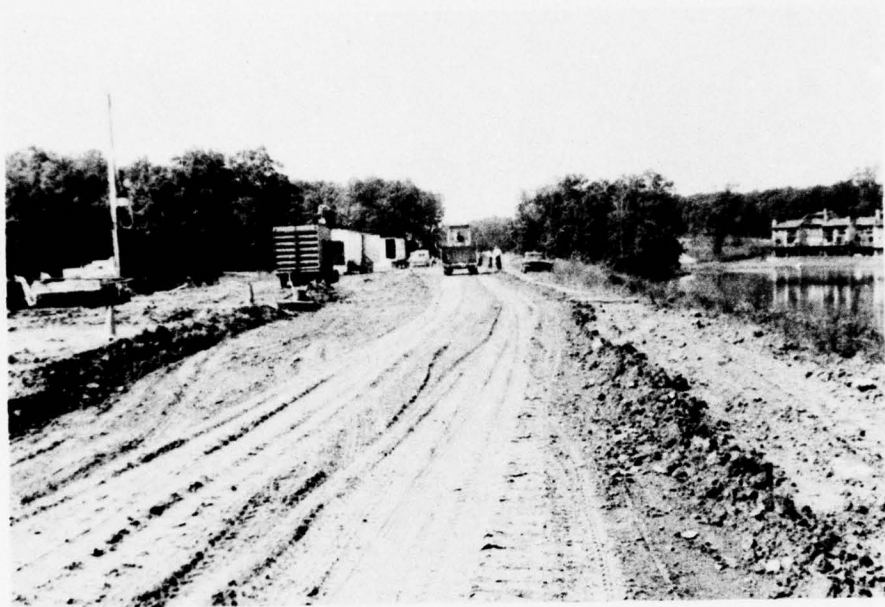
Top of Dam

*3.1.2.1 The dam appeared to be in good condition. The crest is now serving as an unpaved road. There is no indication of settlement of the crest of the dam. The upstream slope was covered with grass and weeds. Small gullies were observed at several locations on the downstream slope, mainly near the center of the slope and adjacent to the road at the left abutment. These appeared to be created by vehicular traffic. Some sloughing was associated with these gullies indicating possible settlement and/or seepage. In some places, sand was noted on top of the riprap.

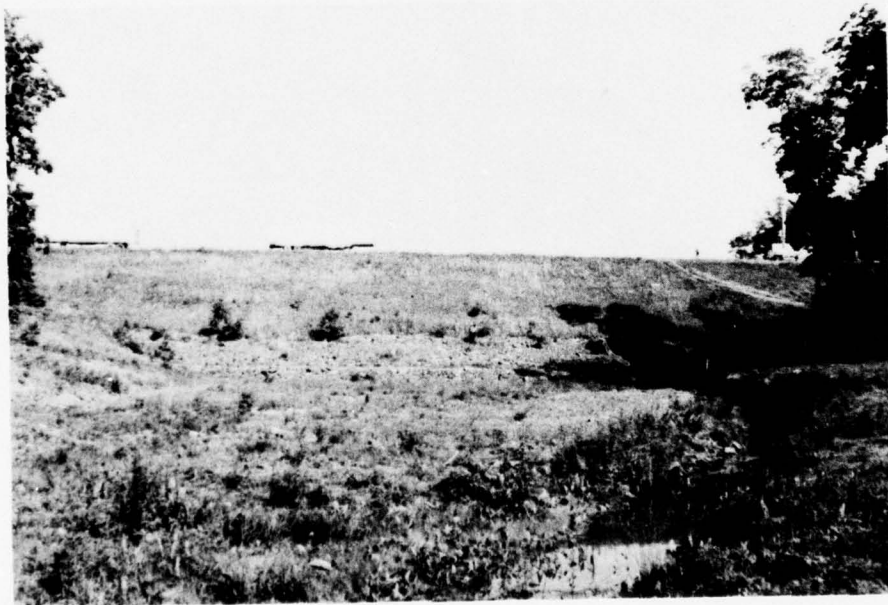
Downstream Face of Dam

At both abutments, runoff has started erosion where the fill meets natural ground. The area downstream of the dam was damp for 200 to 300 feet although no flow was observed.

3.2 Evaluation: The areas where gullies were detected and other signs of erosion should be repaired to prevent further deterioration and action should be taken by the owner to eliminate the vehicular traffic on the embankment and abutments. A grouting program was in progress at the time of the inspection to eliminate the seepage described above, however, it was not complete and the seepage was still occurring.

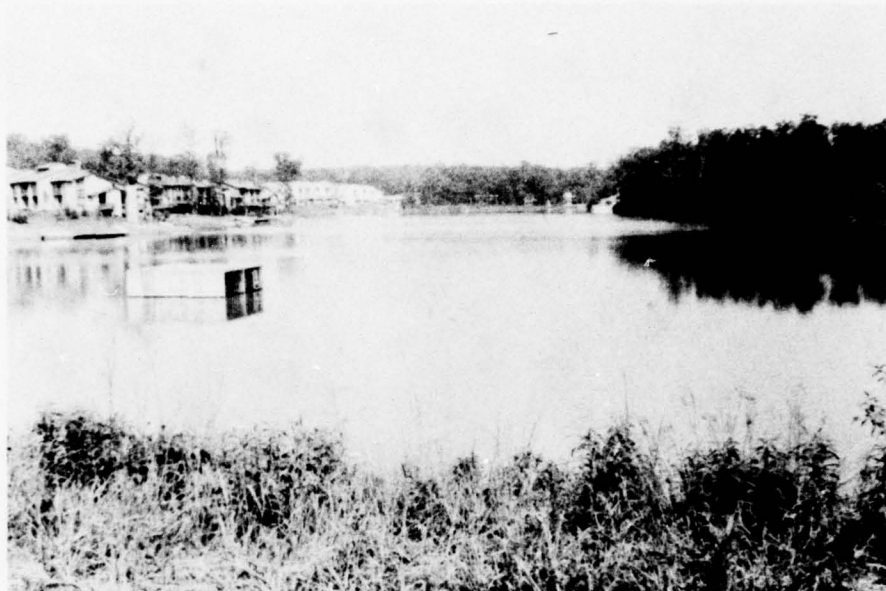
PHOTOGRAPH NO. 1
Outlet Structure

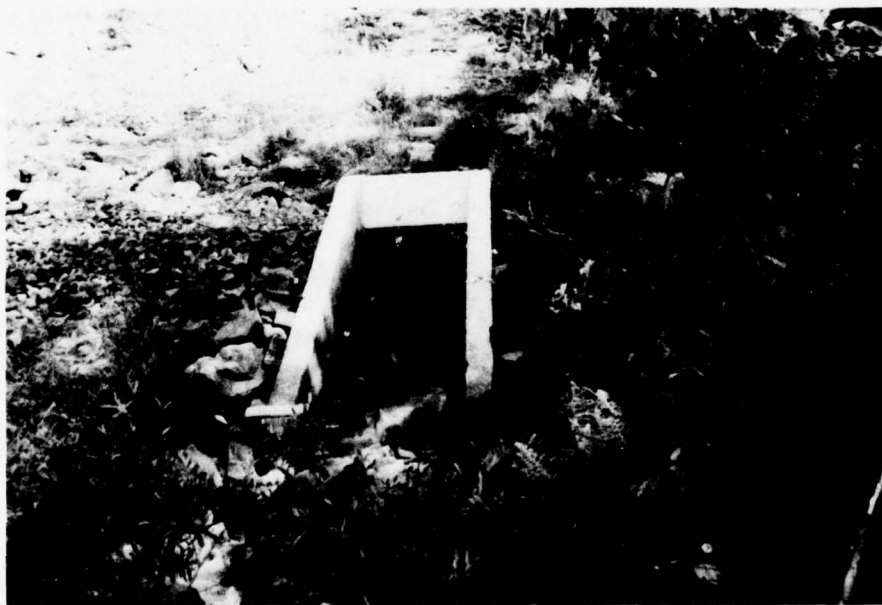
PHOTOGRAPH NO. 2
Discharge Box Culvert

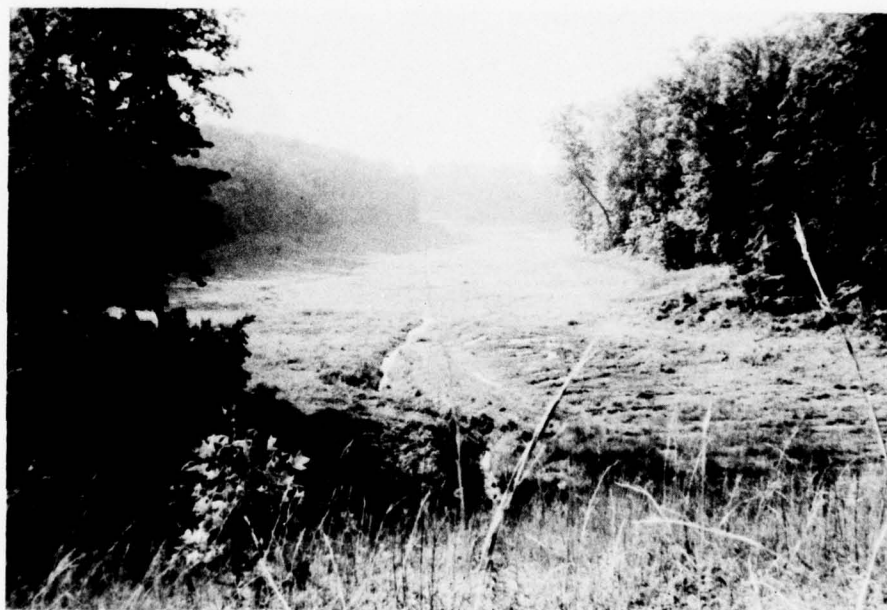
PHOTOGRAPH NO. 4
Downstream
