Name Of Dam: POHICK CREEK DAM SITE NO. 4  
Location: FAIRFAX COUNTY  
Inventory Number: VA. 05922

# PHASE I INSPECTION REPORT

## NATIONAL DAM SAFETY PROGRAM

**DEWARD M. MARTIN & ASSOCIATES  
WILLIAMSBURG, VIRGINIA  
AUGUST, 1979**

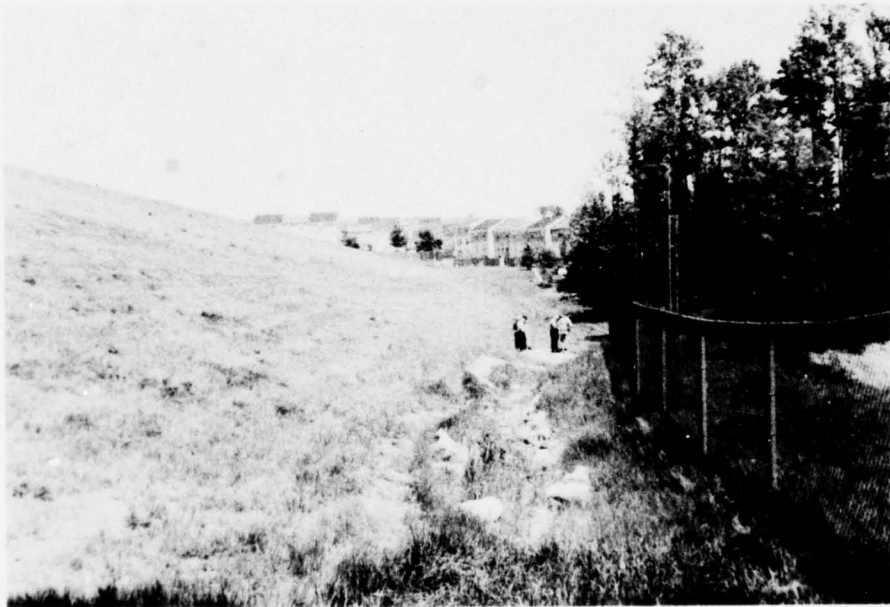
Downstream Face of Dam and Toe Drain

- 1) Install a staff gage to monitor reservoir levels above normal pool.
- 2) The following repair items should be completed as part of the annual maintenance of the dam:
  - a) Correct erosion on the left bank of the reservoir, about 50 feet from the end of the left junction of embankment and abutment.
  - b) Correct erosion in the vicinity of the toe drain at the left end of the dam.

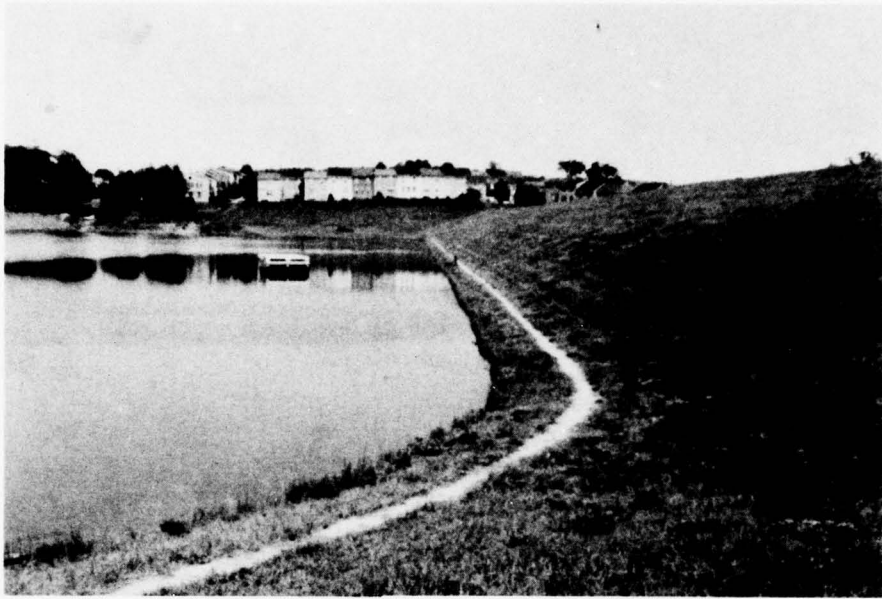
PHOTOGRAPH NO. 1  
Upstream Face of Dam and Principal Spillway Intake Structure

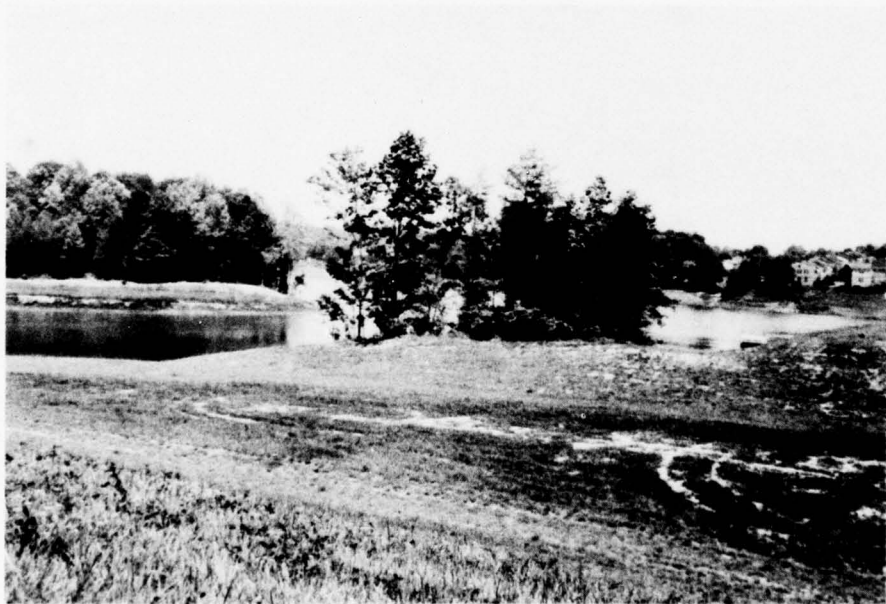
3.1.4 Emergency Spillway: The 100-foot wide vegetated channel is in good condition. The spillway channel is adjacent to a house which is on higher ground and to the right of the spillway. Any undercutting at this point would jeopardize the house.

PHOTOGRAPH NO. 2  
Emergency Spillway Channel

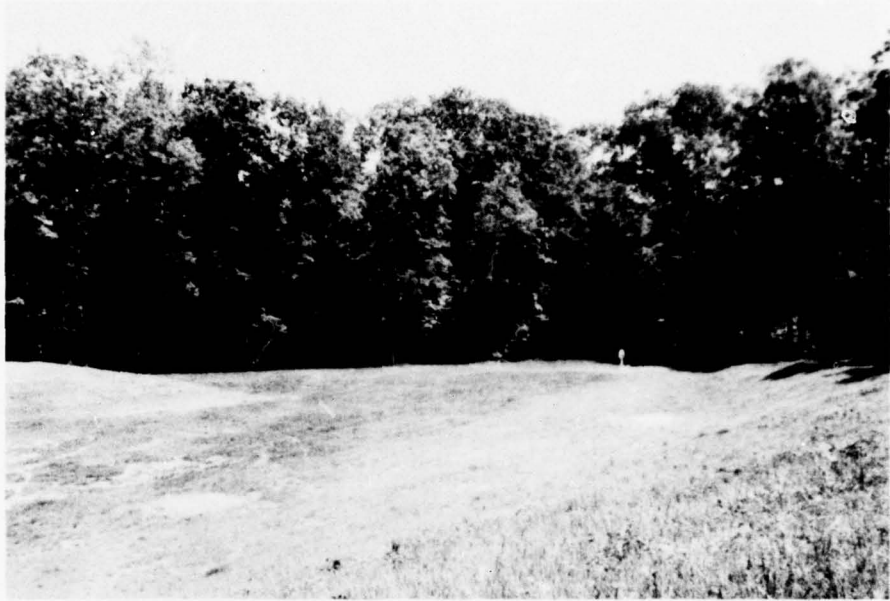
PHOTOGRAPH NO. 3  
Emergency Spillway Outlet

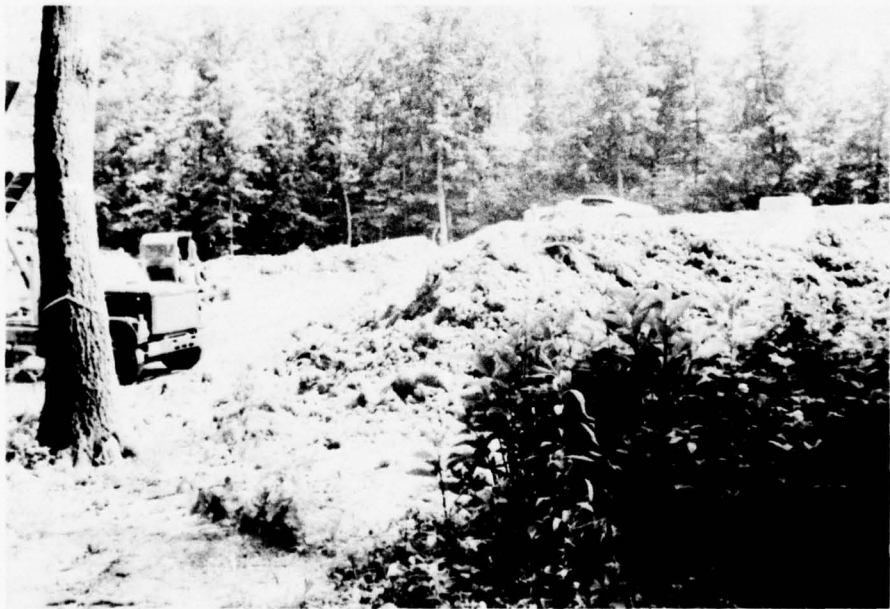
PHOTOGRAPH NO. 4  
New Construction Site Adjacent to Emergency Spillway

It is recommended that the Owner, at his own expense, secure the services of a professional engineer to prepare a program of investigation of the curve in the emergency spillway. The program set up by the owner should be such that he can reach an agreement acceptable to the Commonwealth of Virginia for a reasonable time for the investigation and time of completion of any remedial measures required. The program should be established within 3 months after the date of notification by the Governor of the Commonwealth of Virginia.

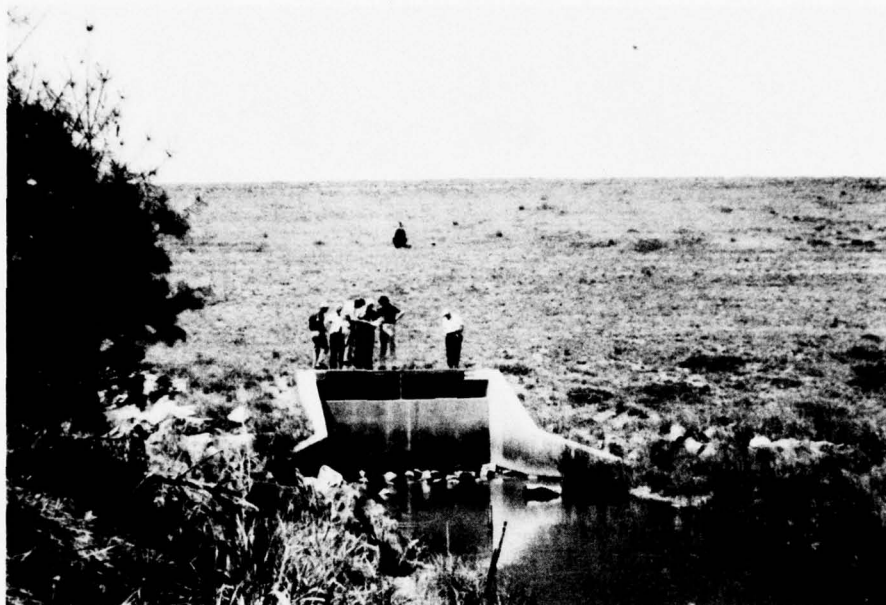
3.1.3 Appurtenant Structures: Observations of the principal spillway concrete riser were made from the embankment and no deterioration was noted. The impact basin is in good condition with no deterioration noted.

PHOTOGRAPH NO. 5  
Principal Spillway Outlet Structure

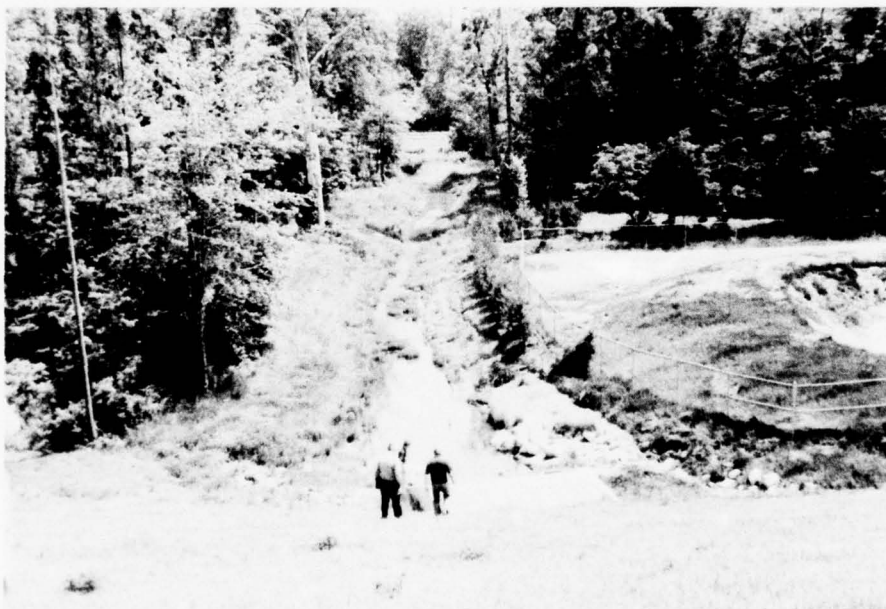
PHOTOGRAPH NO. 6  
Downstream
