4. TITLE (and Subtitle) Phase I Inspection Report National Dam Safety Program WHITE OAK CREEK DAM (ZARHEMLA) Dickenson County, VA		5. TYPE OF REPORT & PERIOD COVERED Final

17. DISTRIBUTION STATEMENT (of the abstract entered in Block 20, if different from Report) National Dam Safety Program. White Oak Creek Dam (Zarahemla) (05104), Big Sandy River Basin, Dickenson County, Virginia. Phase I Inspection Report.		15. SECURITY CLASS. (of this report) Unclassified

Name of Dam: White Oak Creek  
State: Virginia  
County: Dickenson  
USGS Quad Sheet: Jenkins East  
Stream: White Oak Creek  
Date of Inspection: 12 June 1979

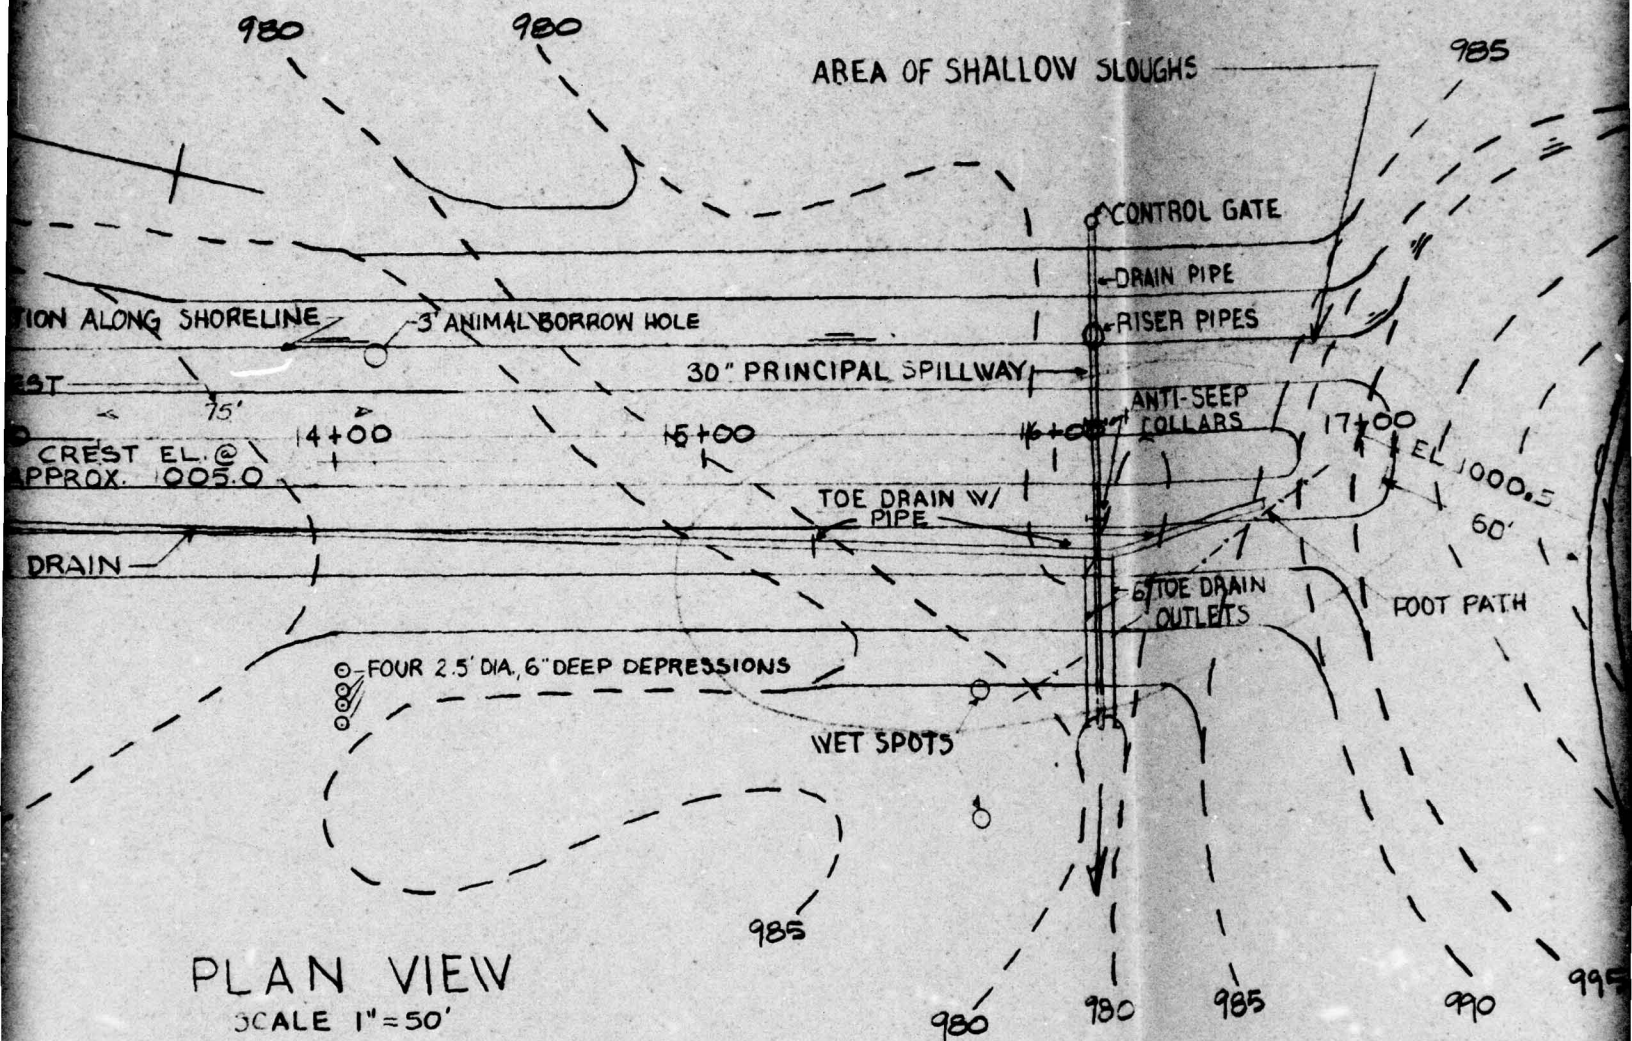
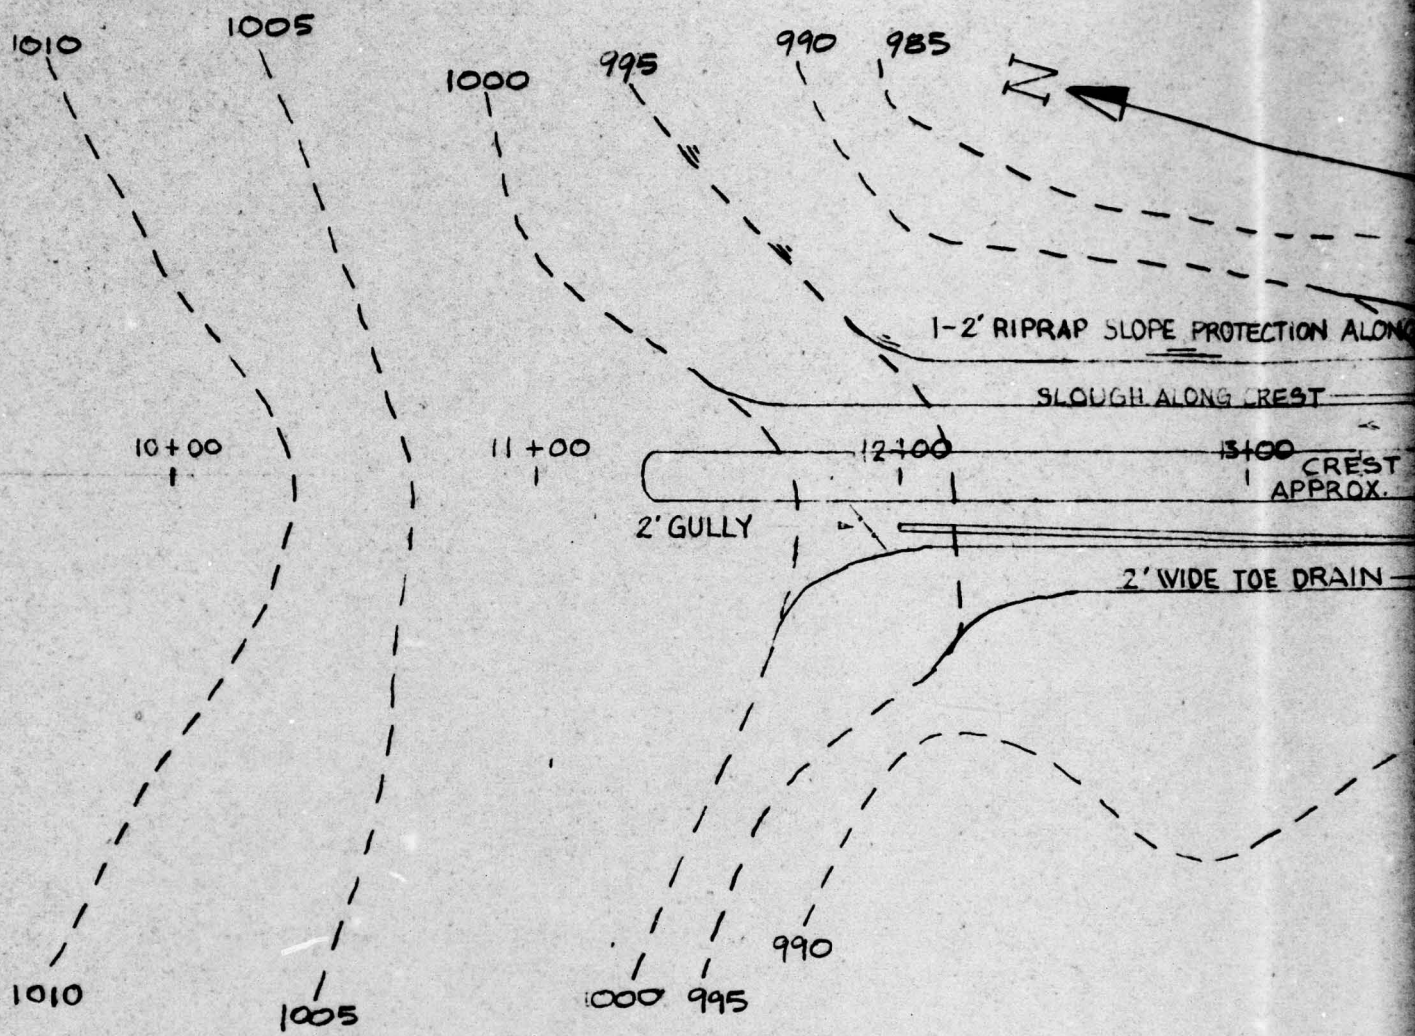
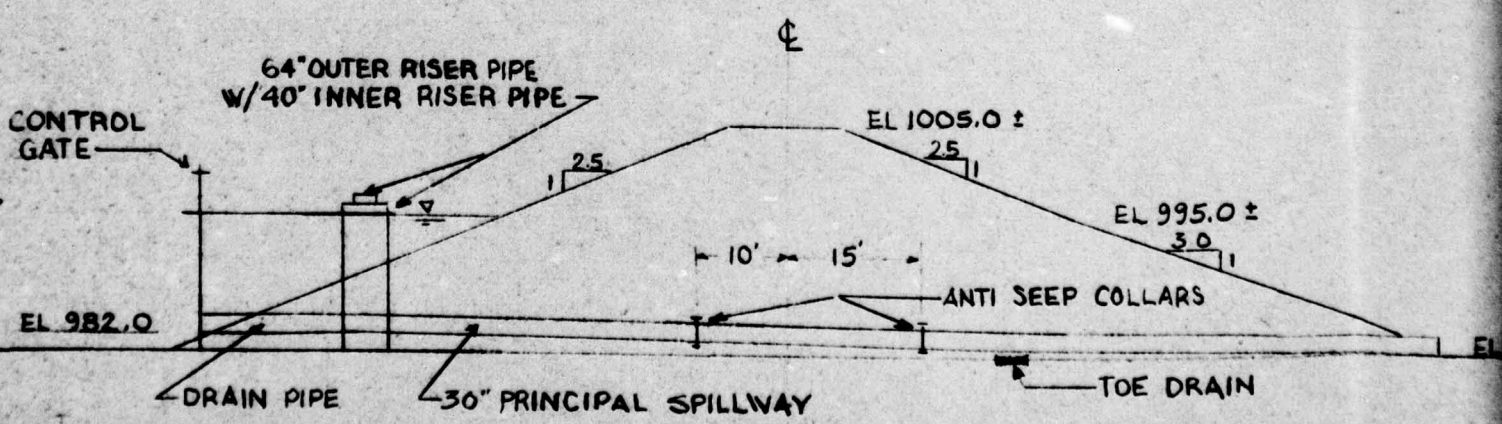
PLAN VIEW  
SCALE 1" = 50'

At STA 14+00, 10, 15, 20, and 25 feet downstream of the toe, four 2.5 foot diameter, 6-inch deep depressions were found. The depressions are located on plate II, appendix I. The ones at 15 and 20 feet were filled with water. About 3 other similar depressions were located left of these, but were dry. One small wet spot was located on the downstream toe at STA 15+75. About 35 feet downstream of this area is another wet spot.
