Name Of Dam: KENNEDY DAM
Location: STAFFORD COUNTY
Inventory Number: 17910

PHASE I INSPECTION REPORT NATIONAL DAM SAFETY PROGRAM

PREPARED BY
NORFOLK DISTRICT CORPS OF ENGINEERS
803 FRONT STREET
NORFOLK, VIRGINIA 23510

SEPTEMBER 1979

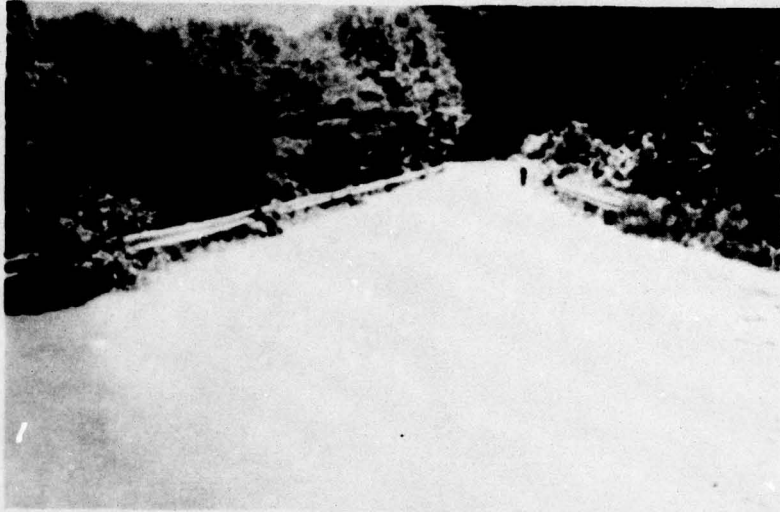
PHOTO #1 CREST OF DAM

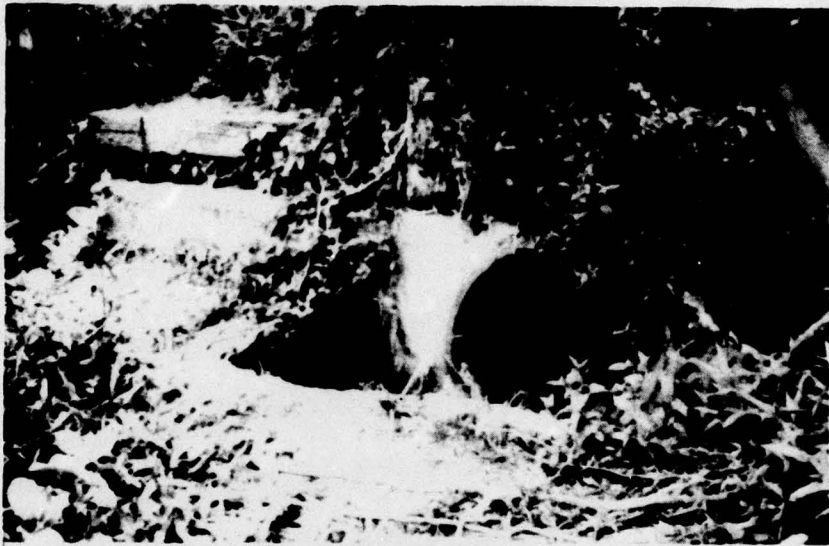
3.1.3 Appurtenant Structures: The orifices for both the concrete spillway culverts were cracked and deteriorating. The top edges of the two concrete drop inlets were severely cracked and spalled, Appendix II, Photos 3 and 4. The secondary spillway outlet was obstructed by vegetation, Appendix II, Photo 2. The discharge channel was eroded at the base of the spillway outlets, Appendix II, Photo 5. There was no emergency spillway.

PHOTO #3 SECONDARY SPILLWAY INTAKE

d. Perform cosmetic repairs to the two deteriorating concrete drop inlets to prevent further deterioration. Also, remove debris from the drop inlets.
