# PHASE I INSPECTION REPORT

## NATIONAL DAM SAFETY PROGRAM

COLEMAN FALLS DAM  
AMHERST COUNTY, VIRGINIA  
INVENTORY NO. 05918

Name of Dam: Coleman Falls Dam  
State: Virginia  
County: Amherst County  
USGS Quad Sheet: Big Island, Virginia  
Stream: James River  
Date of Inspection: July 12, 1979

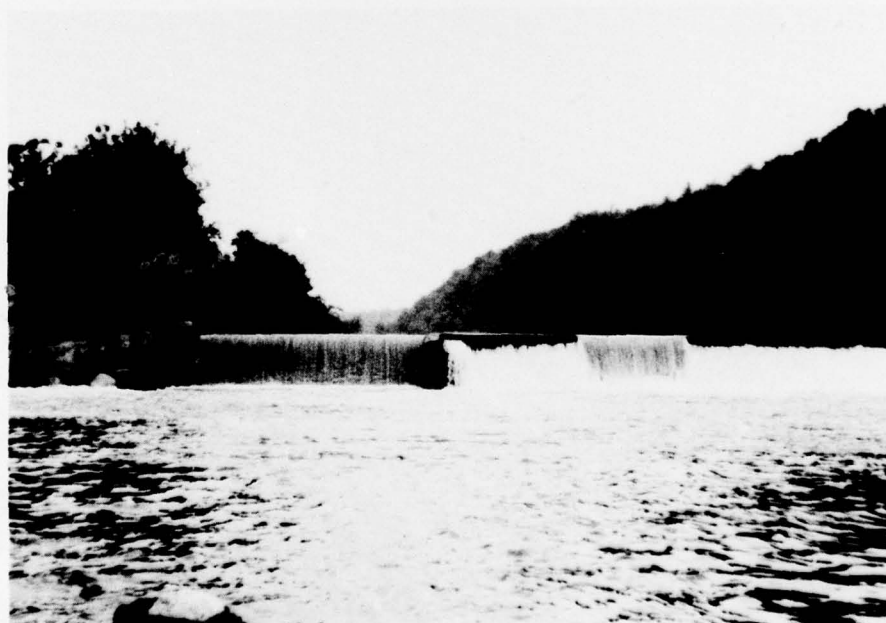
PHOTOGRAPH NO. 2  
Front View

3.1.2 Dam: The dam appears to be in good condition. A crack and several missing stones were noticed in the dam about 65 feet from the remains of the turbine building where the dam makes a 90° turn. The seepage through this crack is significant (approximately 5 gpm), however, due to its inaccessibility no measurement of flow was made (see Photograph No. 2, Appendix II.)

3.2 Evaluation: The dam appears to be in good condition with the notable exception of the crack and missing stones in the spillway. It is recommended that the owner monitor the leakage as part of his regular maintenance program and prior to converting the dam for hydroelectric use, the owner should initiate a more thorough inspection to insure that no other significant deterioration has occurred.

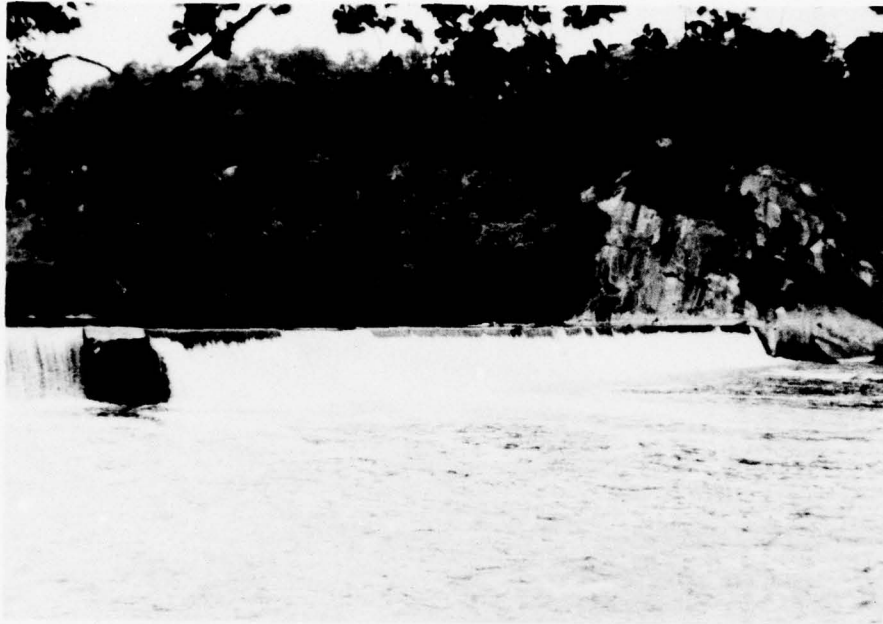
PHOTOGRAPH NO. 1  
Spillway

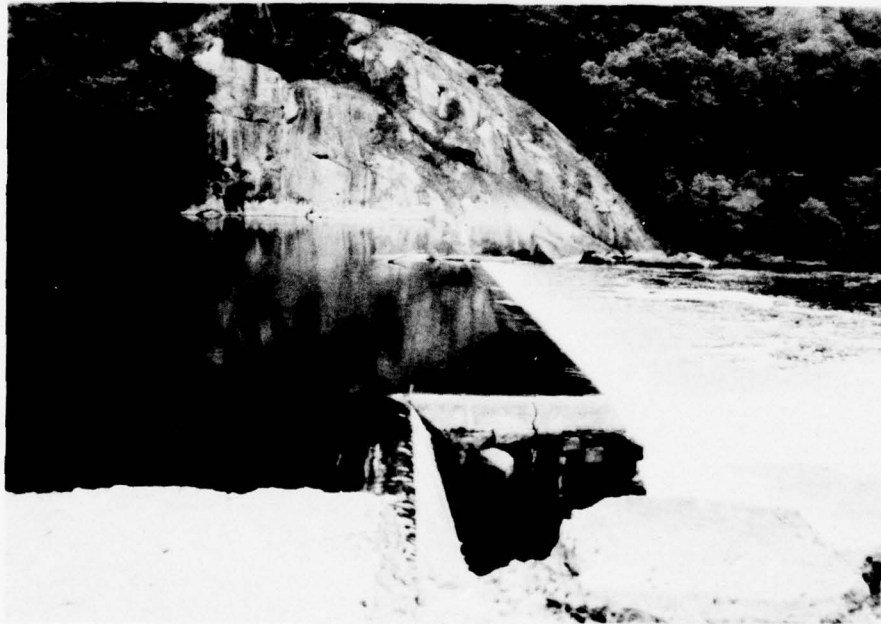
PHOTOGRAPH NO. 2  
Left Abutment

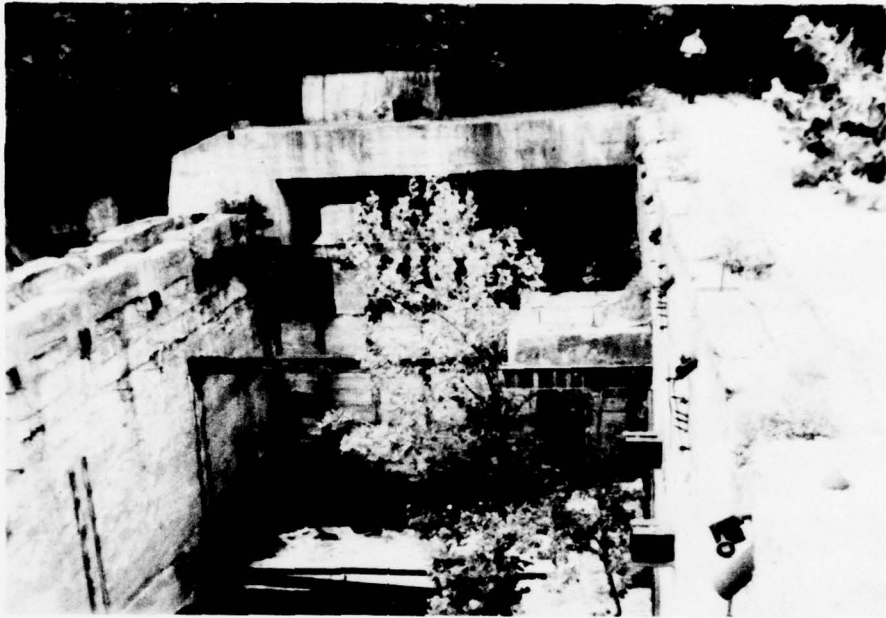
3.1.3 Appurtenant Structures: The remains of the old turbine building are located adjacent to the right abutment. Water is seeping through the headgate openings into the turbine pits, however, there is no apparent seepage around the dam near the building. There is no means, at present, of operating these gates.

PHOTOGRAPH NO. 3  
Old Mill Structure

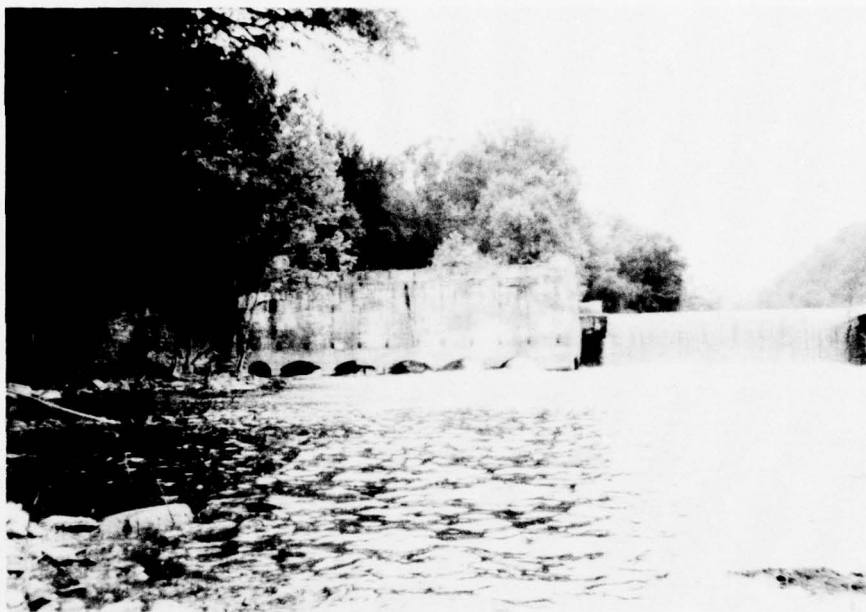
PHOTOGRAPH NO. 5  
Outlets from Mill Structure

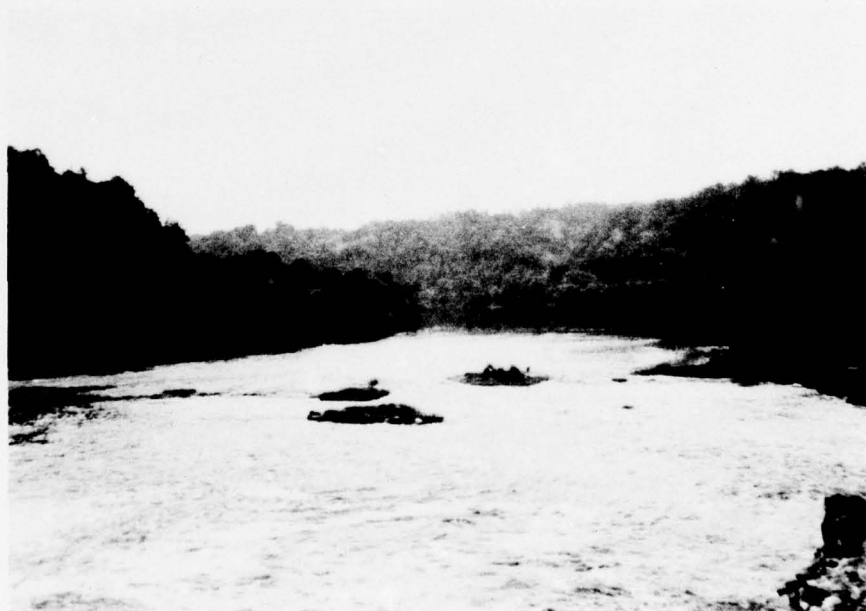
PHOTOGRAPH NO. 6  
Downstream
