# PHASE I INSPECTION REPORT

## NATIONAL DAM SAFETY PROGRAM

AUGUST, 1979

SCOTTS MILL DAM  
CITY OF LYNCHBURG, VIRGINIA  
INVENTORY NO. VA 68001

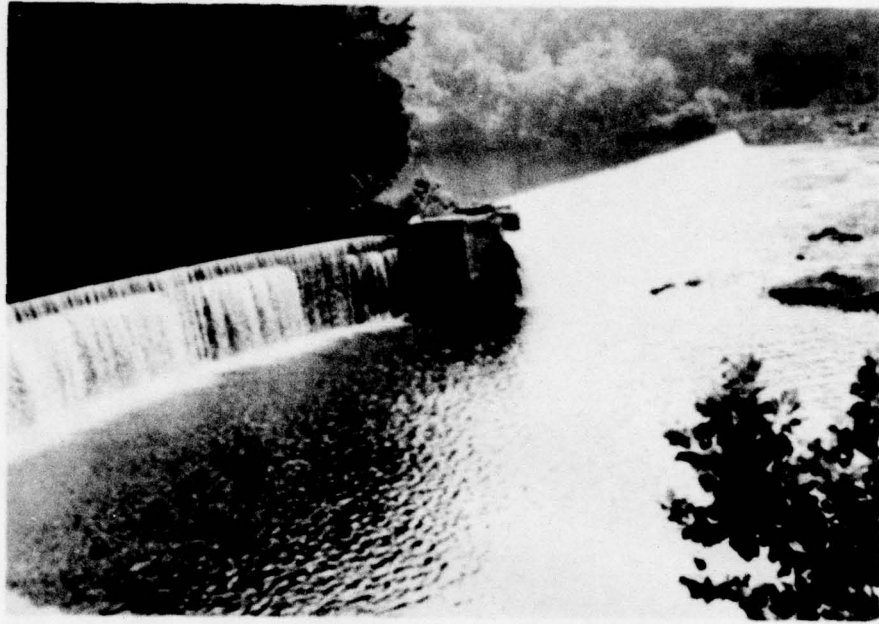
PHOTOGRAPH NO. 1  
The Straight Spillway

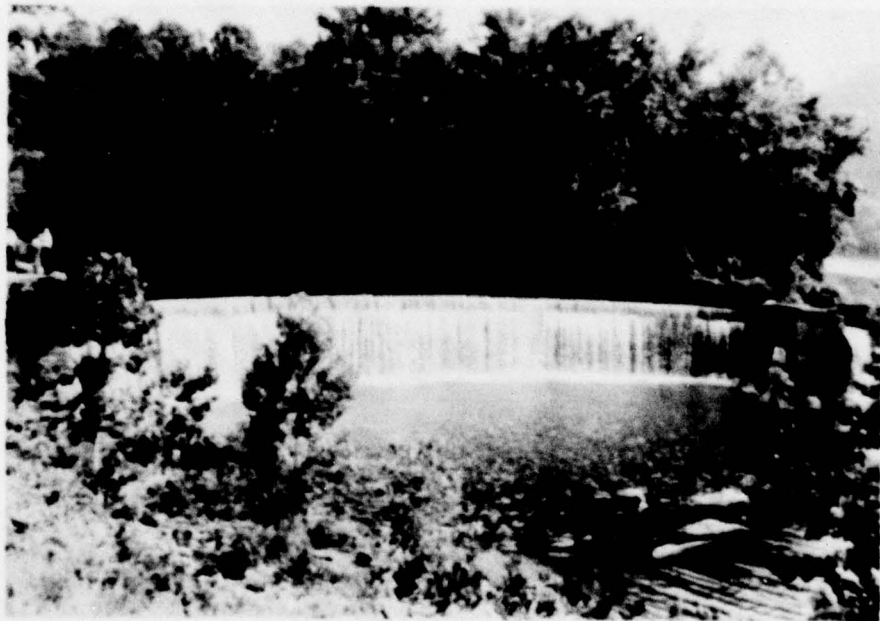
PHOTOGRAPH NO. 2  
The Arc Spillway

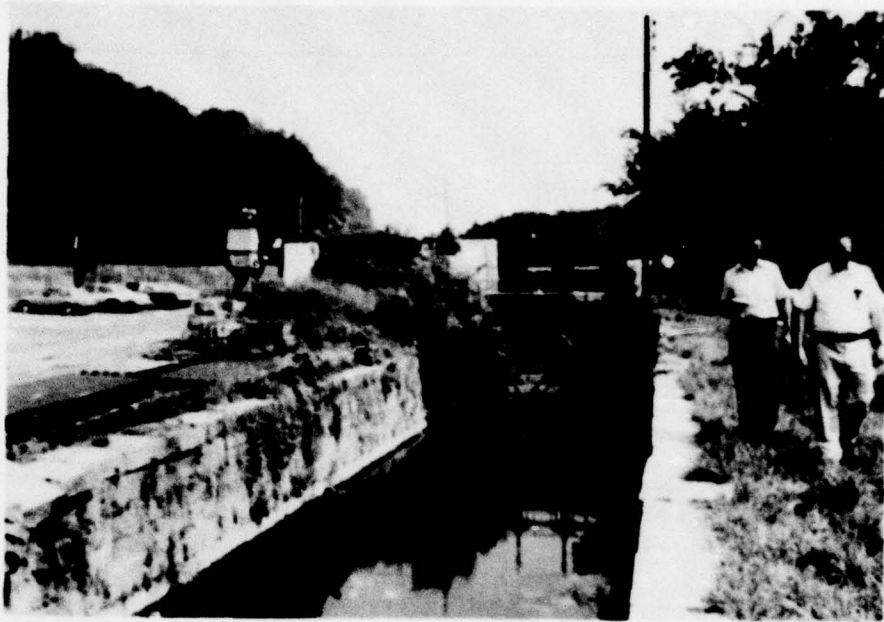
PHOTOGRAPH NO. 3  
Canal and Gates

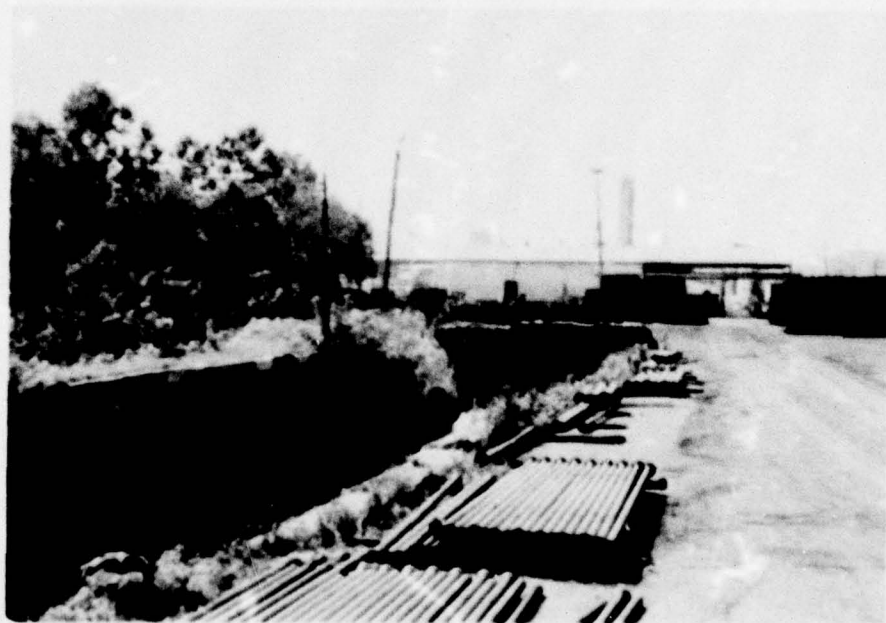
PHOTOGRAPH NO. 4  
Griffin Pipe Company  
Plant on the Downstream Shore

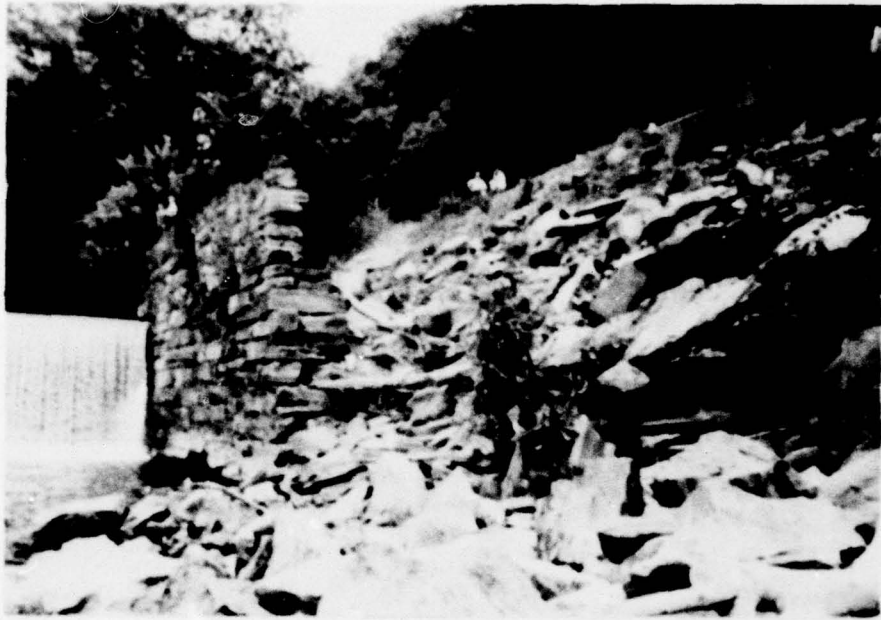
PHOTOGRAPH NO. 5  
Left Abutment

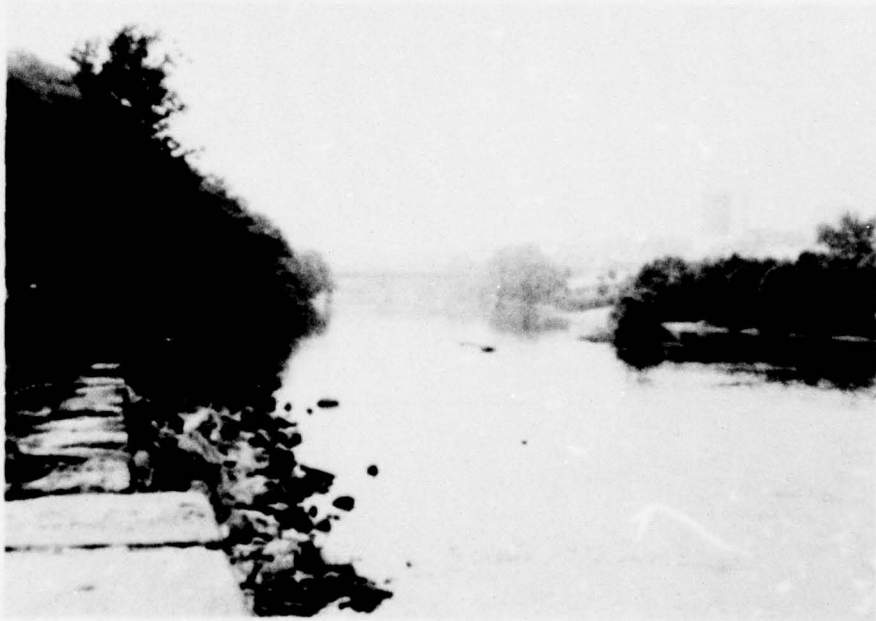
PHOTOGRAPH NO. 6  
Downstream
