Name Of Dam: —TIMBER LAKE DAM
Location: FAIRFAX COUNTY
Inventory Number: VA. 05918

PHASE I INSPECTION REPORT NATIONAL DAM SAFETY PROGRAM

BY
DEWARD M. MARTIN & ASSOCIATES
WILLIAMSBURG, VIRGINIA
AUGUST, 1979

TIMBER LAKE DAM
FAIRFAX COUNTY, VIRGINIA
INVENTORY NO. VA 05918

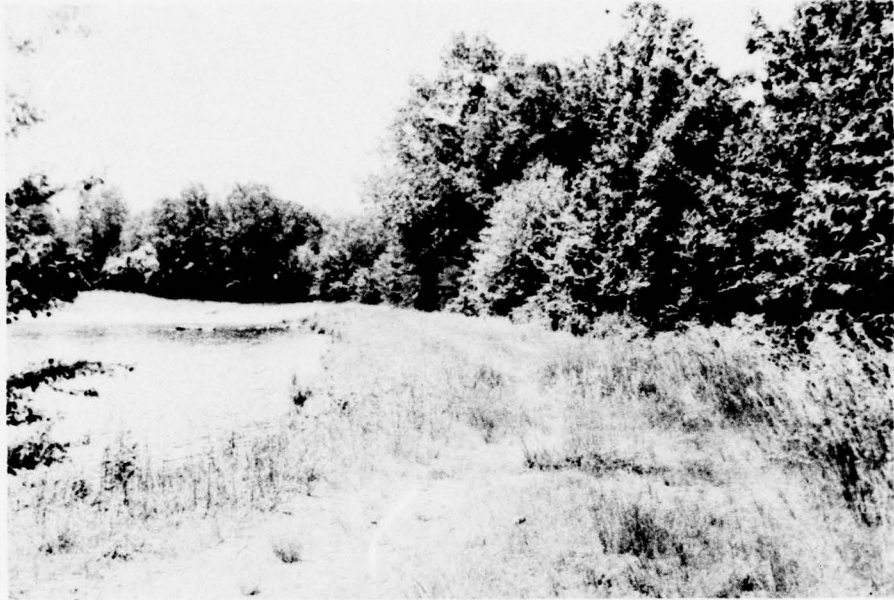
Top of Dam

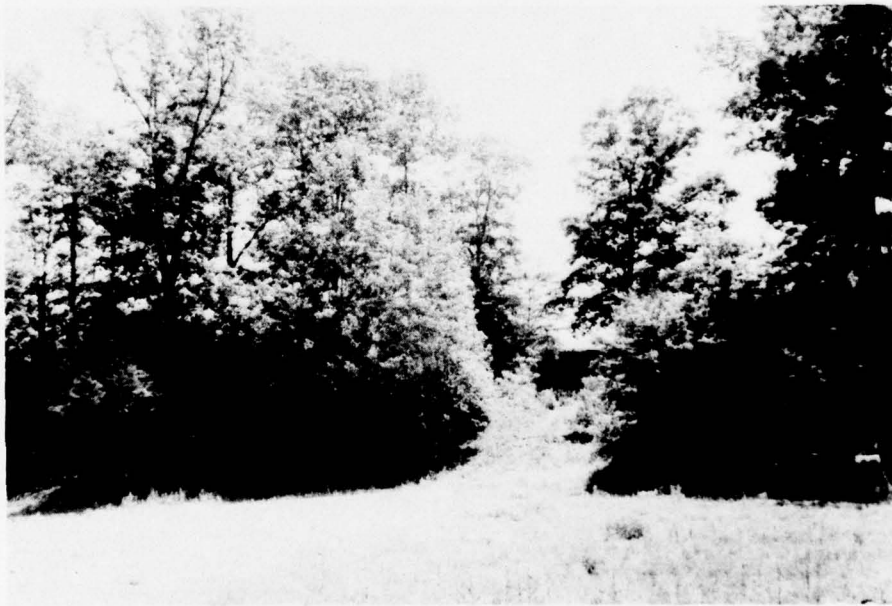
Downstream Face of Dam

About 100 feet from the right abutment a very wet area was observed on the downstream slope of the dam, about equidistant from the toe and the crest. This area was about 8-feet x 3-feet, the longer dimension being parallel to the axis of the dam. There is evidence of sloughing in this wet area. Other smaller wet areas and sloughs were observed elsewhere on the downstream slope, generally on the lower half of the slope indicating that the phreatic surface exists along the downstream slope about halfway down from the crest.

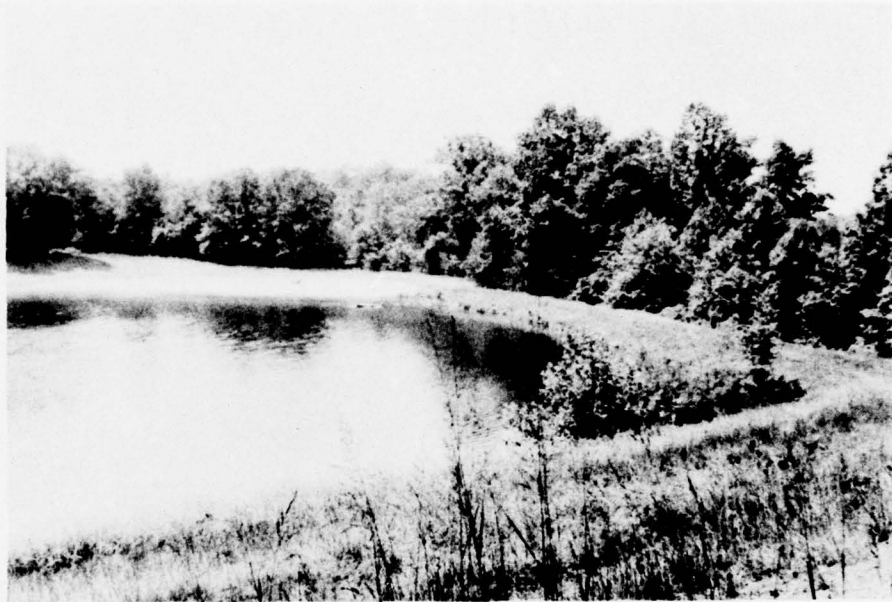
PHOTOGRAPH NO. 1
Upstream Face of Dam

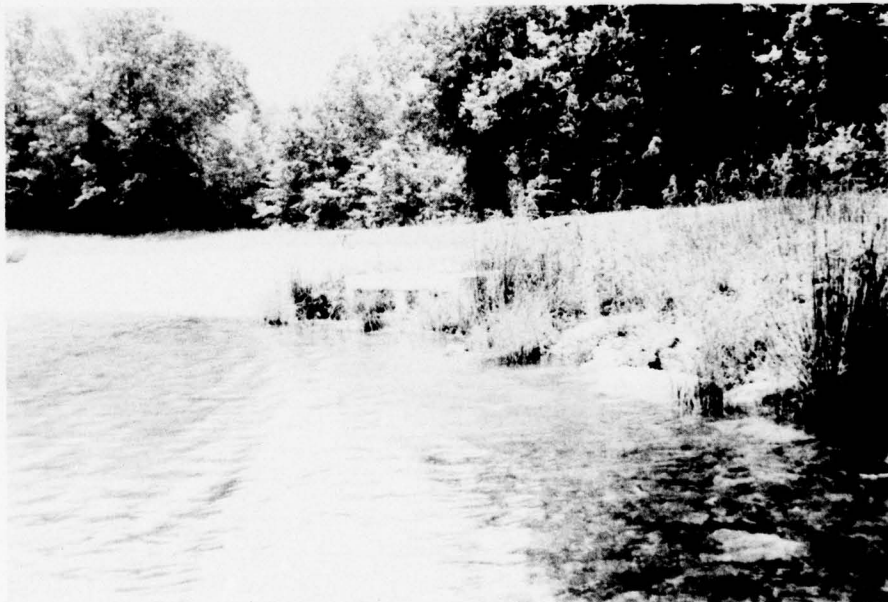
3.1.3 Spillway: The principal spillway consists of a concrete drop inlet with 1-foot x 2-foot openings (at elevation 341.0) on each of three sides. Two 24-inch diameter concrete pipes run from the drop inlet through the dam.

PHOTOGRAPH NO. 2
Principal Spillway Intake Structure

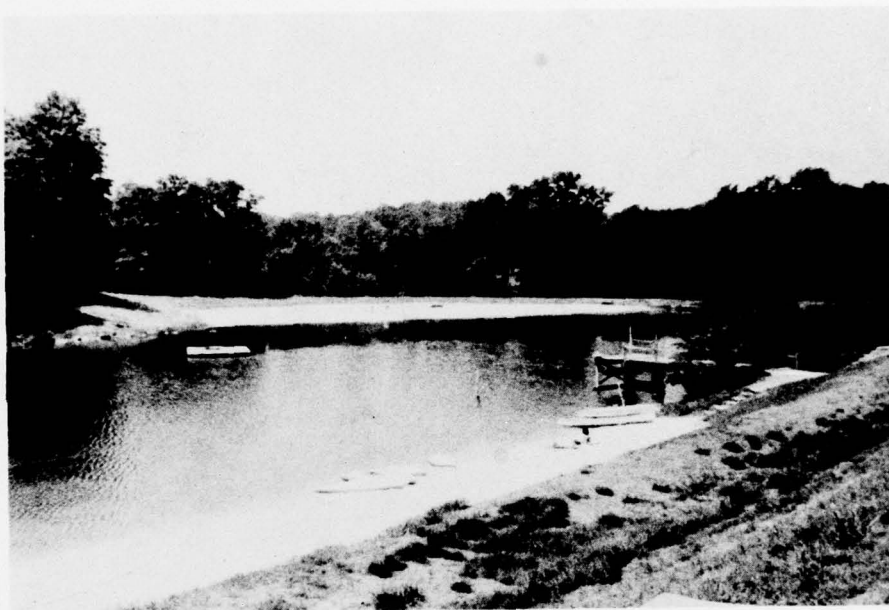
An emergency spillway is located to the left of the dam. This spillway is approximately 150 feet wide with an elevation 6 inches lower than the crest of the dam (see Plate 1, Appendix I). The spillway is covered with grass, except along the shoreline where sand has been placed for use as a beach.

PHOTOGRAPH NO. 3
Emergency Spillway

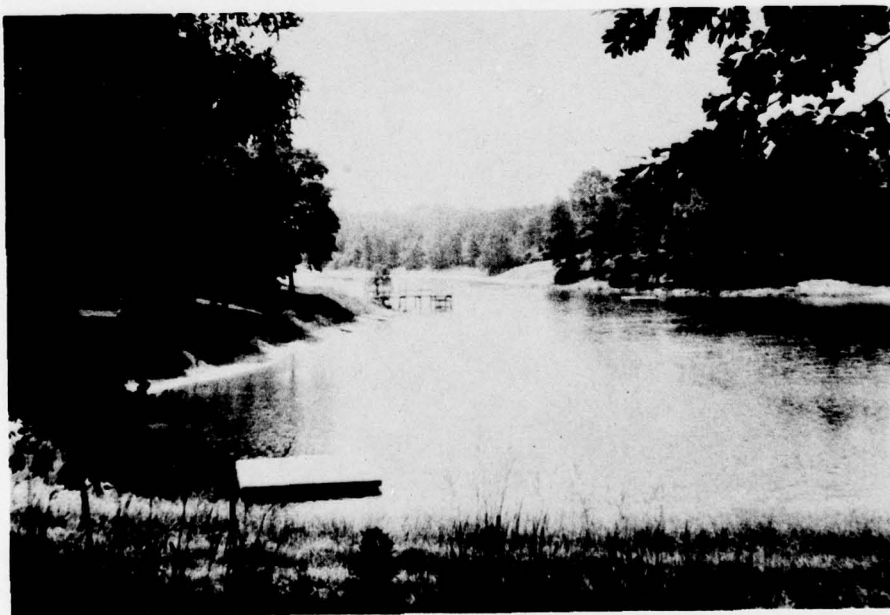
PHOTOGRAPH NO. 4
View of Lake

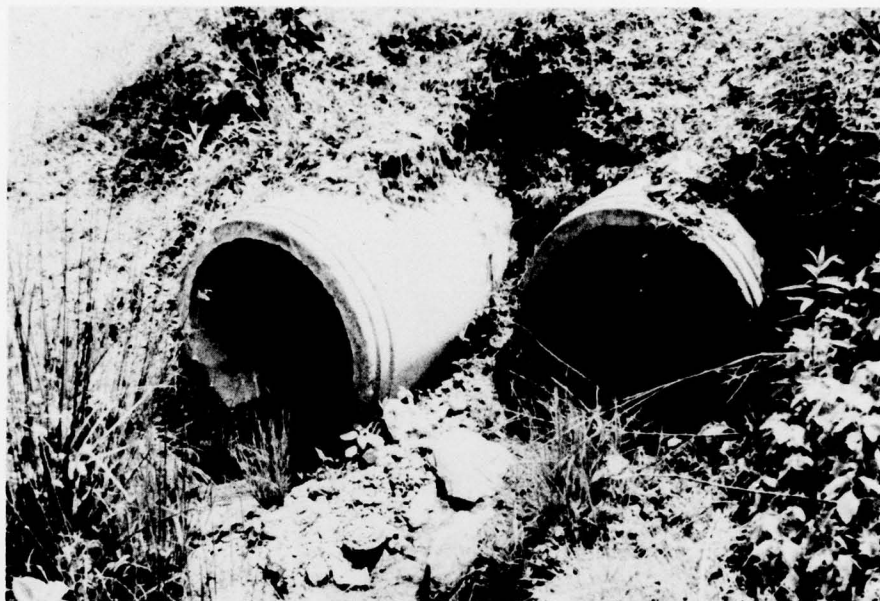
PHOTOGRAPH NO. 5
Principal Spillway Outlet Pipe
