Name Of Dam: LAKE VIEW DAM  
Location: CHESTERFIELD COUNTY  
Inventory Number: VA. 04119

# PHASE I INSPECTION REPORT

## NATIONAL DAM SAFETY PROGRAM

LAKE VIEW DAM  
CHESTERFIELD COUNTY, VIRGINIA  
INVENTORY NO. 04119

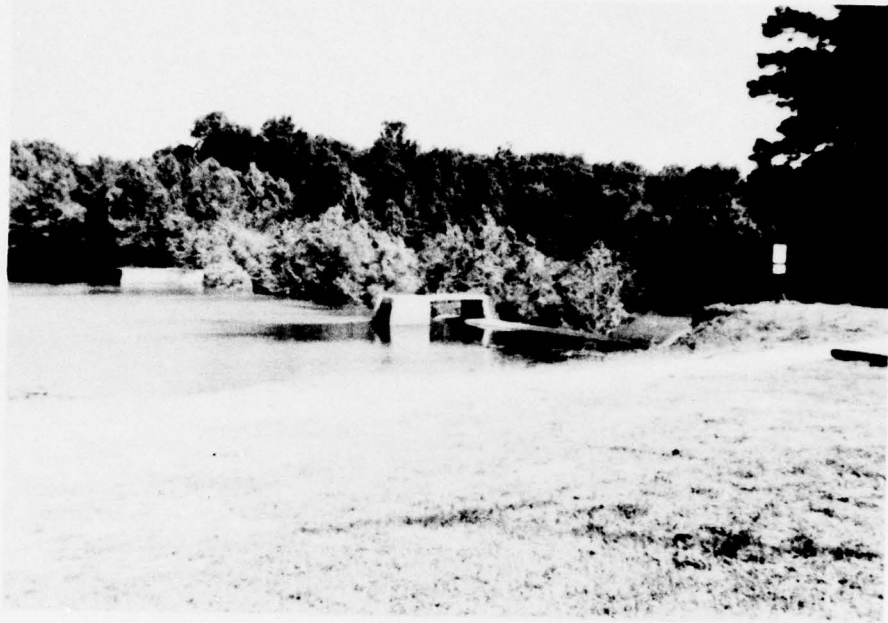
Overview of Dam

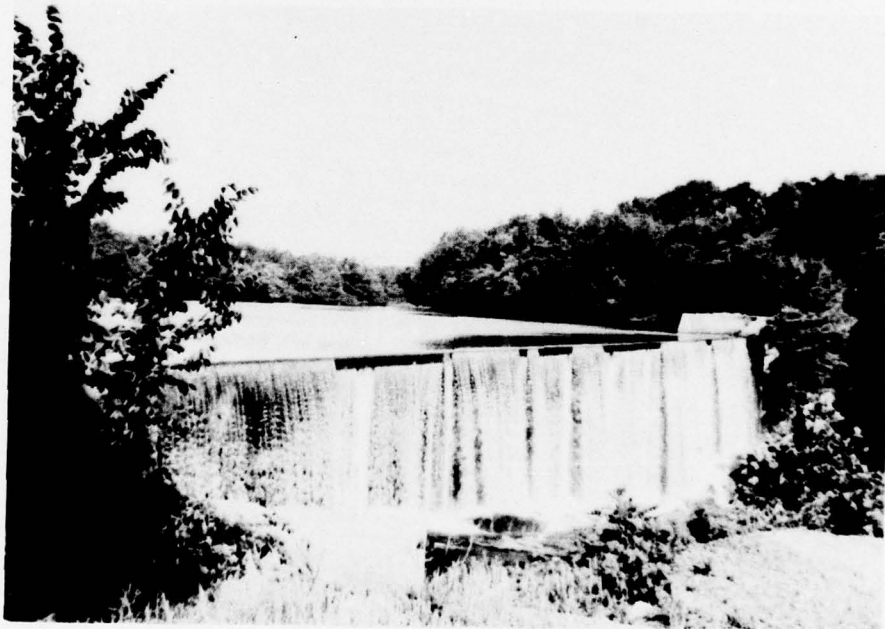
Front View of Dam

3.1.4 Spillway: At the time of inspection, water appeared to be flowing over the spillway crest at different elevations (see Photograph of the front view of the dam, page iii.) This may have been due to minor variations in the elevation of the crest of the spillway, however, the fact that water was flowing over the crest of the spillway made it difficult to accurately determine the cause for the irregularity of flow.

- (1) The numerous leaks and cracks in the dam as shown on Plate No. 1, Appendix I.
- (2) The weathered bedrock in the panels right of the spillway.
- (3) The possible deterioration of the spillway crest.

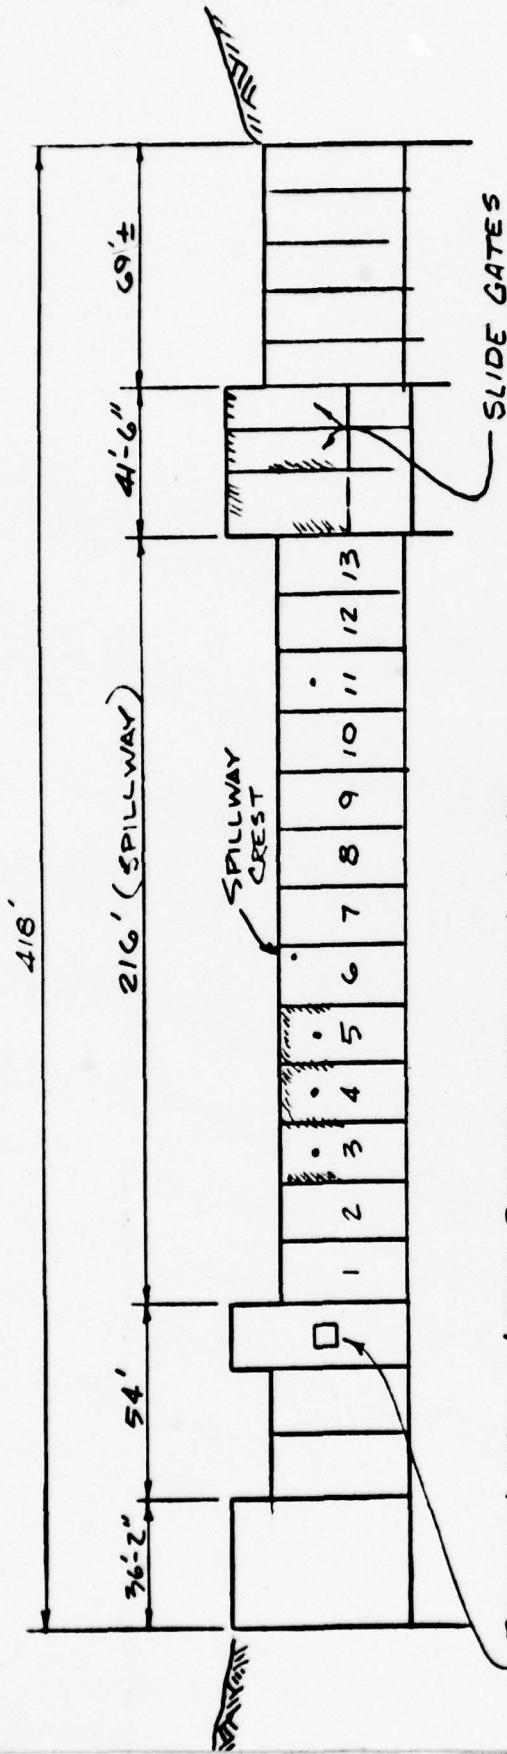
LAKE VIEW DAM  
 CHESTERFIELD, VA.  
 PLATE No. 1  
 NOT TO SCALE

3.1.2 Dam: There were no obvious misalignments in the dam although numerous cracks and holes were detected. Flow varies through these cracks from a minor seep to an excess of 5 gpm in the slide gates. A number of cracks were noted in the construction joints and seepage was observed in these areas (see Appendix I, Plate No. 1). The dam appears to bear on granite bedrock, however, some of the bedrock at the bottom of the three panels to the right of the spillway is severely weathered and several pieces were easily broken by hand. Seepage (approximately 1 gpm) was observed at the toe near the right abutment adjacent to an area of weathered rock.

- BROKEN BOX - WATER SPOUT THROUGH CONC.
- #3 SPAN - DAMPNESS - 3/4" HOLE DRIPPING FAST
- #4 SPAN - DAMPNESS - 3/4" HOLE DRIPPING FAST
- #5 SPAN - DAMPNESS
- #6 SPAN - SMALL LEAKAGE AT JOINT
- #8 SPAN - 2 - 1 1/2" PIPES LEAKING
- #9 SPAN - DAMPNESS
- #11 SPAN - HOLE DRIPPING

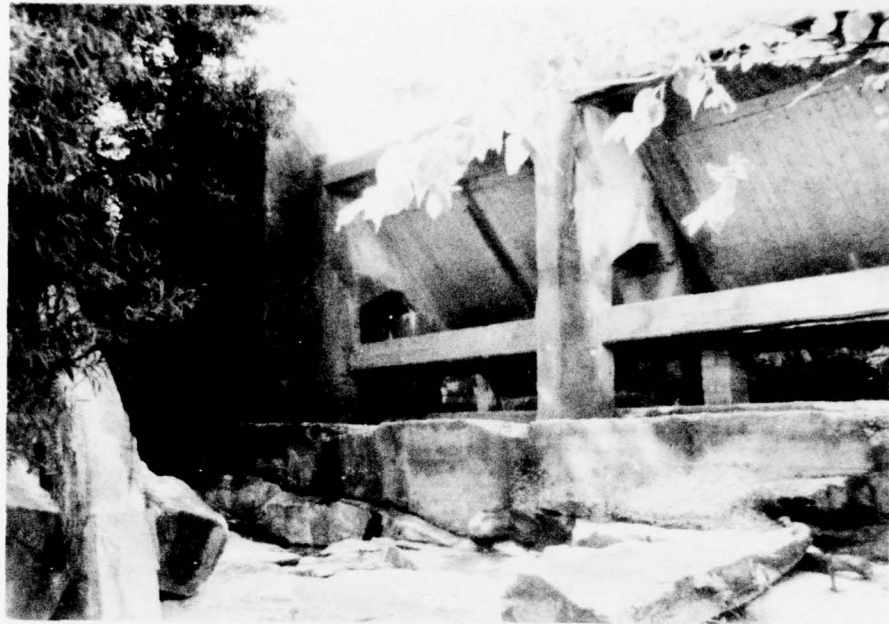
PHOTOGRAPH NO. 1  
Right Abutment  
and  
Part of Concrete Structure

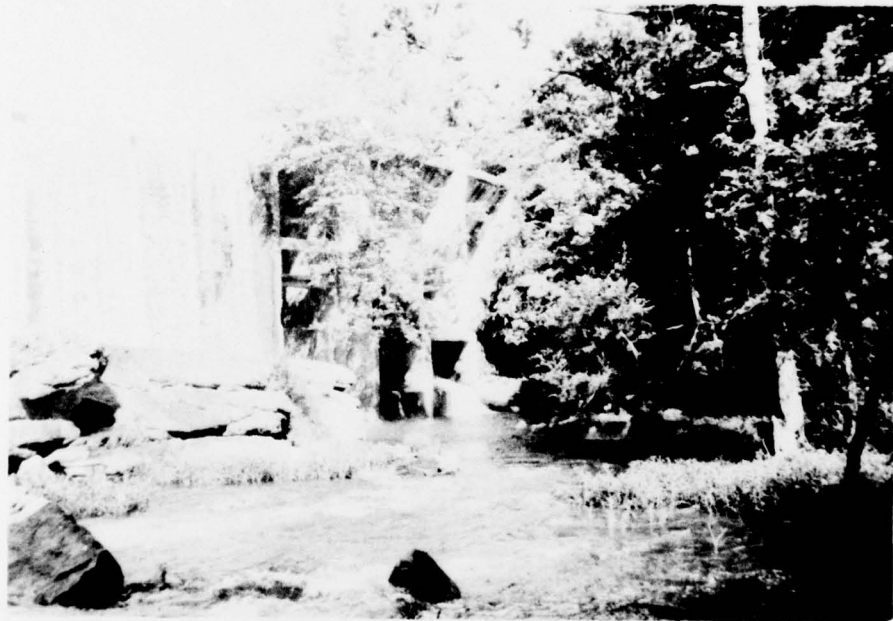
PHOTOGRAPH NO. 2  
Left Abutment  
and  
Part of Concrete Structure

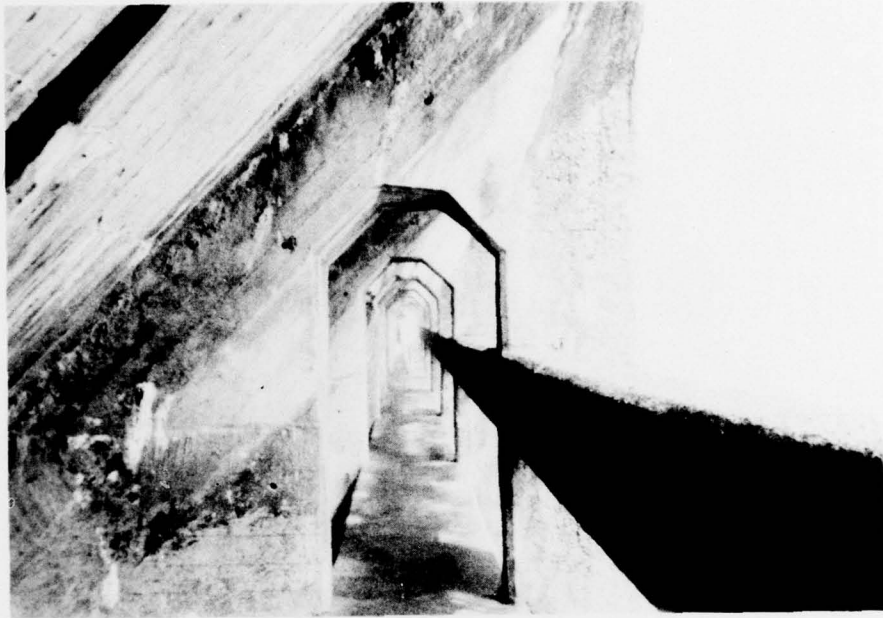
1.2.1 Dam and Appurtenances: The Lake View Dam is a concrete dam 418 feet long and 38.6 feet high with a crest elevation of 60.6 feet.\* The upstream slope of the dam is 1(H):1(V). The downstream side of the dam has a system of walls, normal to the crest, on 18-foot centers. These walls have concrete struts between them and openings through which a walkway passes, just behind the crest of the dam (see Appendix II, Photograph No. 3).

PHOTOGRAPH NO. 3  
Catwalk

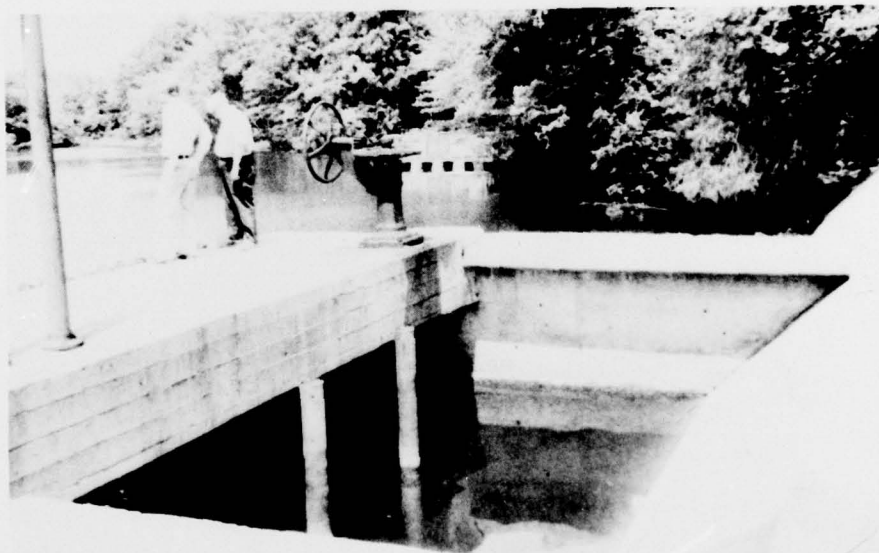
PHOTOGRAPH NO. 4  
Slide Gate

VISUAL EXAMINATION OF	OBSERVATIONS	REMARKS OR RECOMMENDATIONS
CRACKING AND SPALLING OF CONCRETE SURFACES IN OUTLET CONDUIT	N/A	
INTAKE STRUCTURE	Concrete structure near left abutment with a slide gate.	See photograph No. 4, Appendix II.
OUTLET STRUCTURE		
OUTLET CHANNEL	The natural stream.	
EMERGENCY GATE	Slide gate.	Not completely closed at time of inspection - flow estimated at over 5 gpm/

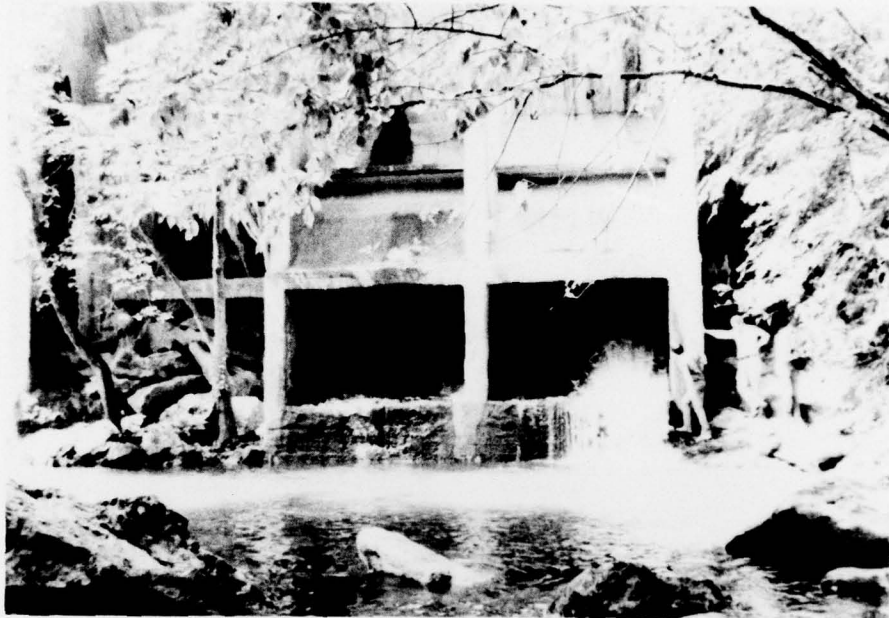
PHOTOGRAPH NO. 5  
Discharge from Slide Gate

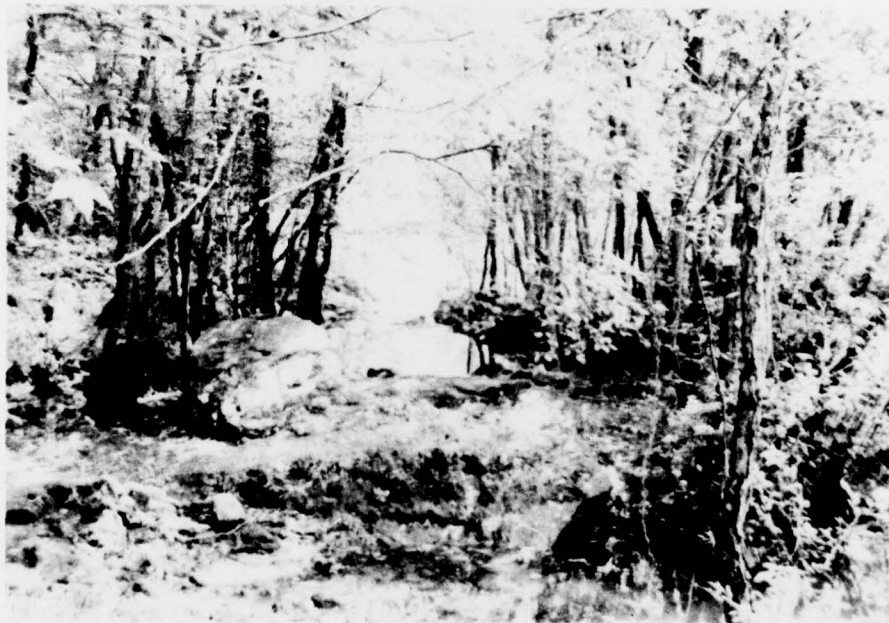
PHOTOGRAPH NO. 6  
Downstream

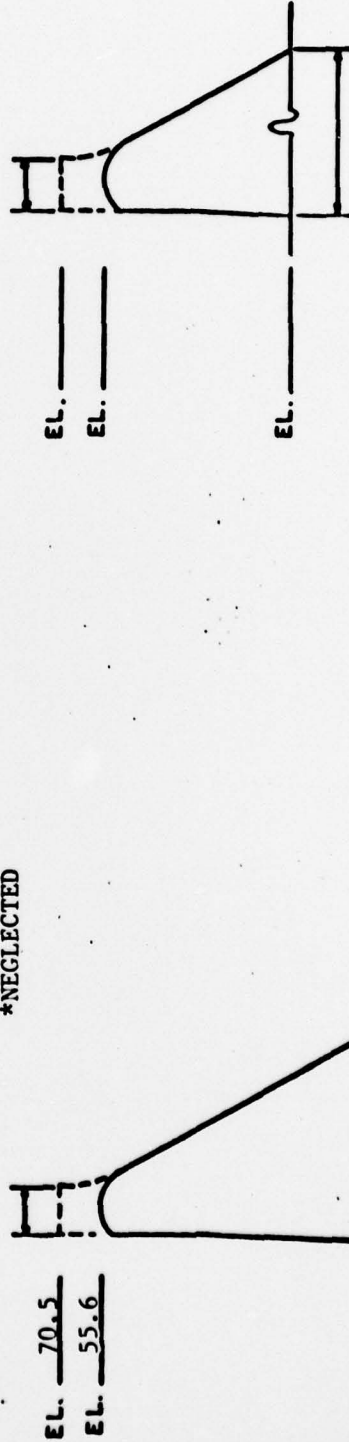
LOADING CASE	ELEV. HEAD WATER	ELEV. TAIL WATER	ΣV	ΣH	ΣM ΣV	LOCATION RESULTANT FROM TOE	% BASE IN COMPRESSION	FACTOR SAFETY SLIDING	FOUNDATION PRESSURE	
									TOE	HEEL
NORMAL POOL	55.6	24.0*	36.5 <sup>k</sup>	35.3 <sup>k</sup>	0.97	16.8'			1.1 ksf	1.1 ksf
1/2 PMF	70.5	45.0	28.0 <sup>k</sup>	57.0 <sup>k</sup>	2.04	18.5'			0.6 ksf	1.1 ksf

THIS ANALYSIS IS BASED ON THE ASSUMED GEOMETRIC CONFIGURATION SINCE NO DRAWINGS WERE AVAILABLE TO VERIFY THE DIMENSIONS OF THE DAM.
