Name Of Dam: GREGORY'S POND DAM  
Location: CHESTERFIELD COUNTY  
Inventory Number: VA. 04122

# PHASE I INSPECTION REPORT

## NATIONAL DAM SAFETY PROGRAM

GREGORY'S POND DAM  
CHESTERFIELD COUNTY, VIRGINIA  
INVENTORY NO. 04122

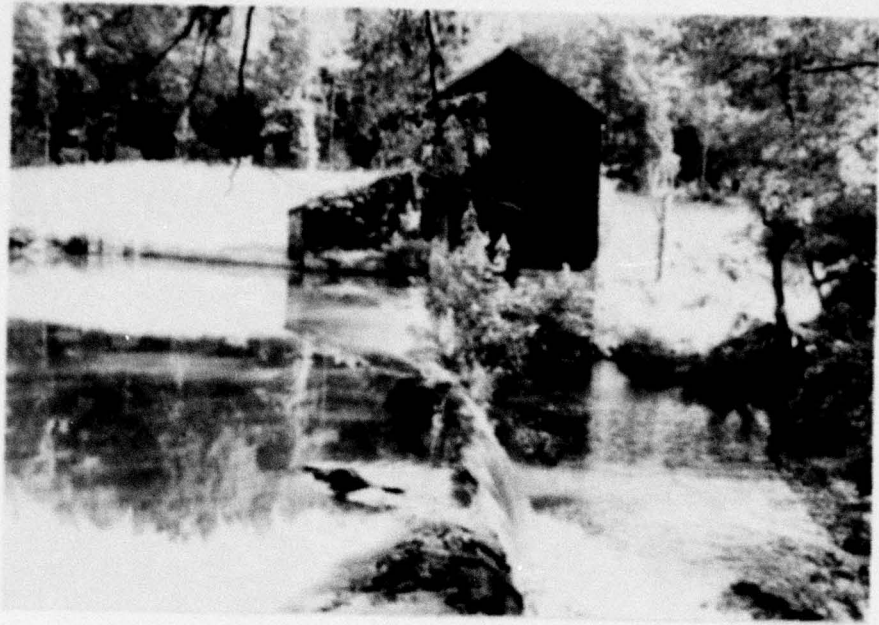
Overview of Dam

VISUAL EXAMINATION OF	OBSERVATIONS	REMARKS OR RECOMMENDATIONS
SURFACE CRACKS CONCRETE SURFACES	N/A	
STRUCTURAL CRACKING	N/A	
VERTICAL AND HORIZONTAL ALIGNMENT	Small displacements on both vertical and horizontal alignment.	See photographs, overview of dam on page iff and No.'s 1 & 2.
MONOLITH JOINTS	N/A	
CONSTRUCTION JOINTS	None observed.

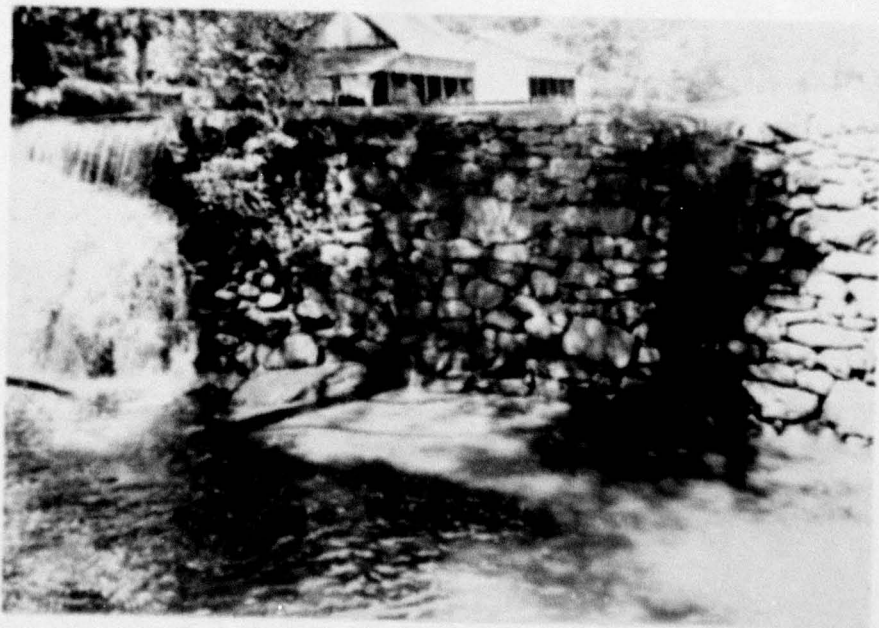
Downstream Face

VISUAL EXAMINATION OF	OBSERVATIONS	REMARKS OR RECOMMENDATIONS
SEE PAGE ON LEAKAGE	Leaks at bottom in the mill house wall and in front of the dam where natural rock ends at tailwater.	See page iii, Downstream face picture for the natural rock and leakage.
STRUCTURE TO ABUTMENT/EMBANKMENT JUNCTIONS	No obvious settlement, no erosion visible.	
DRAINS	No drains were observed during the inspection.	
WATER PASSAGES	None.	
FOUNDATION	Masonry gravity type foundation

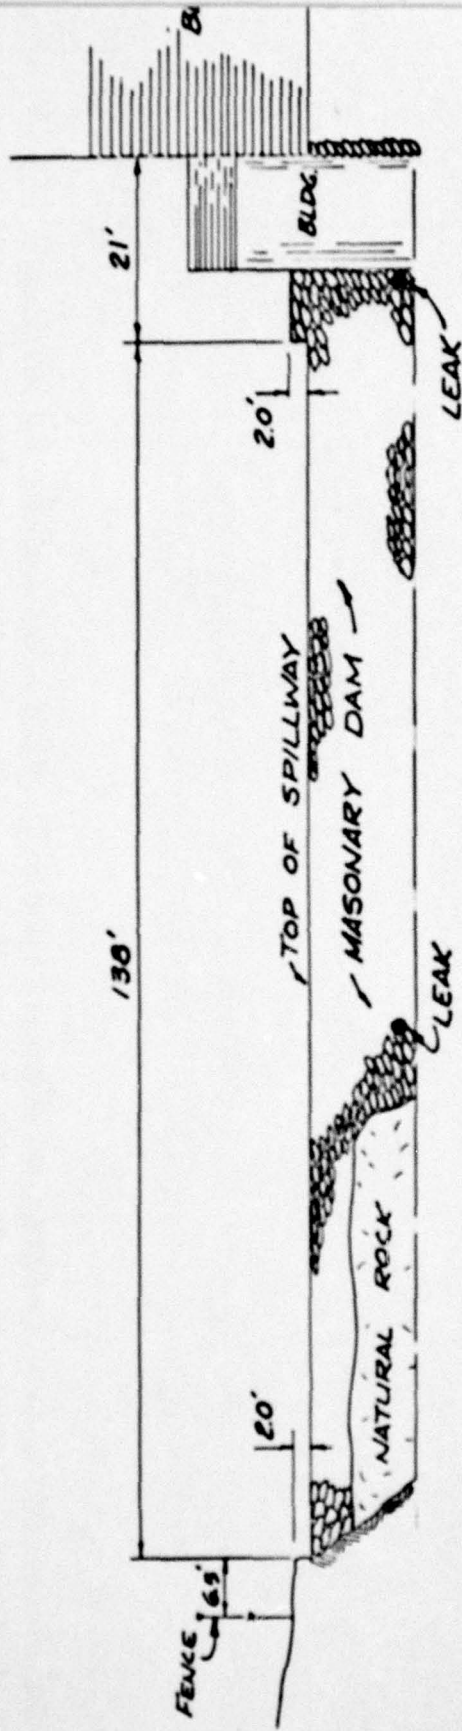
GREGORY POND DAM  
 SCALE : 1" = 20'  
 PLATE NO. 1

The dam is constructed of large rocks laid without mortar. On the upstream face of the dam there is parging from the crest down to the base of the dam. (See sketch on Plate 1, Appendix I.)

\*Seepage was observed at several locations through the dam. Two sizable leaks were observed, each estimated to be more than 10 gallons per minute. The first leak was located near the base of the dam just left of the rock outcropping to the right side of the dam. A second sizable leak was observed at the left abutment near the dam's contact with the mill. (See Plate No. 1, Appendix I). The leaks did not reflect any noticeable deterioration in the dam.

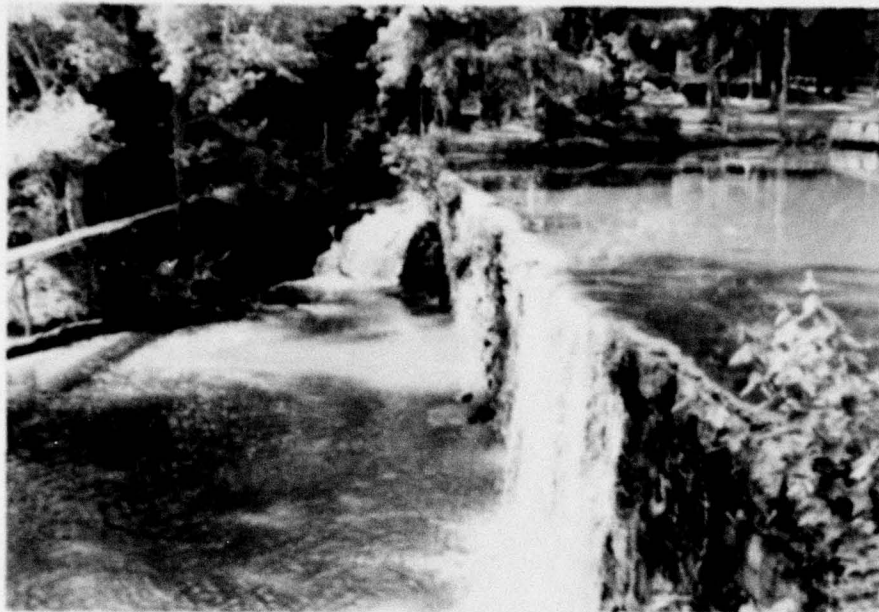
PHOTOGRAPH NO. 1  
Dam and Pond

3.1.4 Spillway: This spillway is a masonry structure 138 feet long with a crest elevation of 167.0 feet. There appeared to be a slight bulge in the spillway (about 1 foot) midway along the crest (see Appendix II, Photographs 1, 2 and 4.)

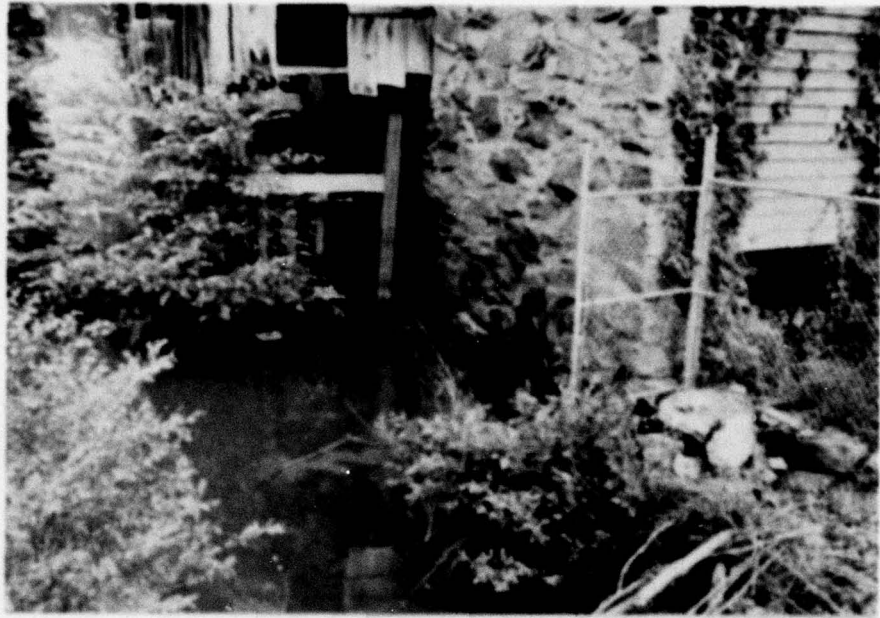
PHOTOGRAPH NO. 5  
2-foot x 2-foot Box Culvert

3.1.3 Appurtenant Structures: There is a 2-foot x 2-foot concrete box culvert located at the base of the mill house which can be used to drain the pond. This culvert can be opened by a manually operated slide gate which is inside the mill. Both the gate and the culvert seem to be in good condition.

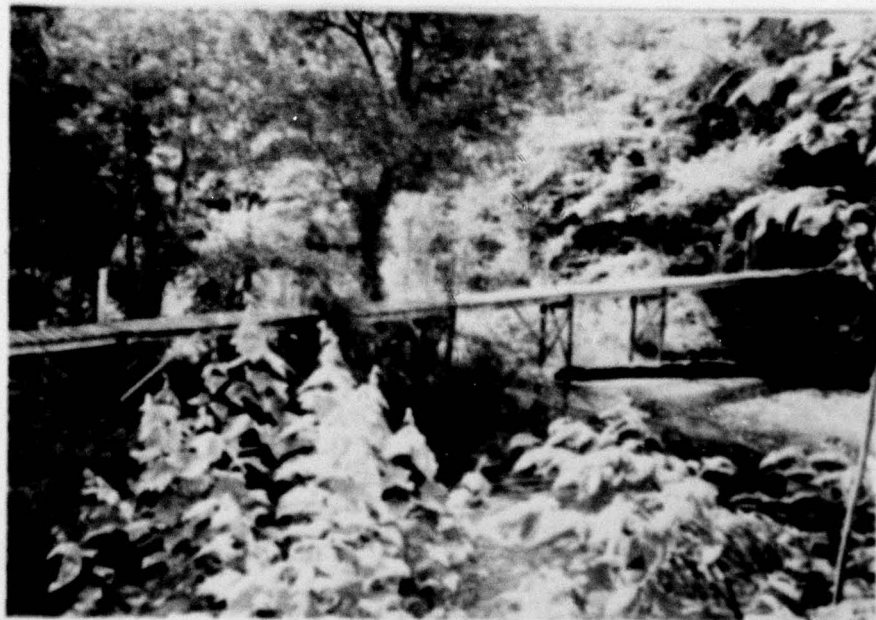
PHOTOGRAPH NO. 6  
Downstream

3.1.7 Downstream Channel: The downstream channel is the natural stream. It is approximately 100 feet wide with relatively flat slopes. There are no structures immediately downstream. About a mile downstream, however, there are two homes in the Falling Creek Subdivision and five in the Longwood Acres Subdivision.
