VISIT TO JAPAN TO OBSERVE DAMAGE WHICH OCCURRED DURING THE NEAR IZU OSHIMA EARTHQUAKES JANUARY 14 AND 15, 1978

William F. Marcuson III

Geotechnical Laboratory

Final Report

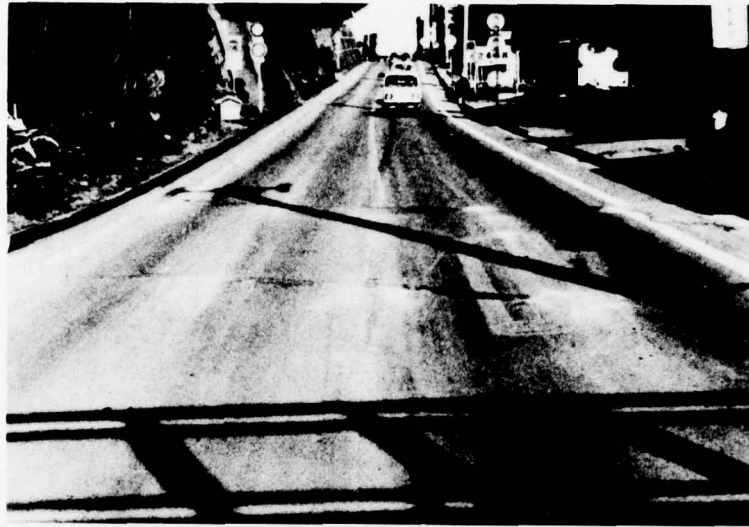
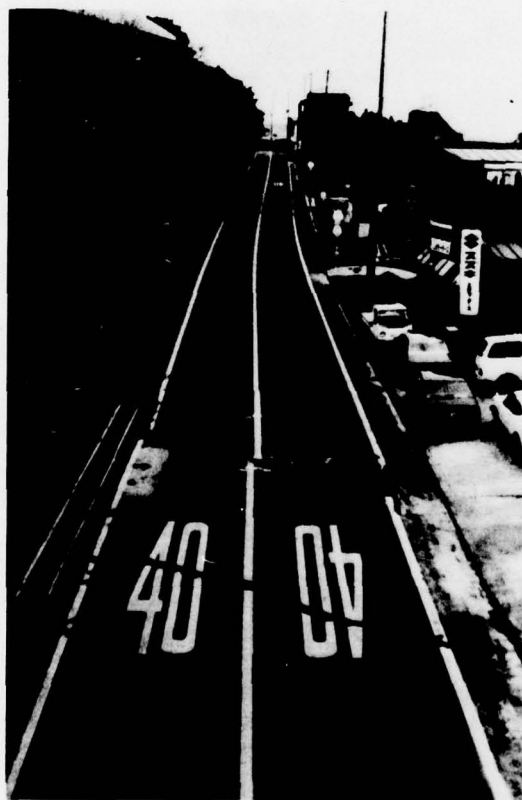
Figure 13. Photos showing Inatori fault offset

11. During the main shock the Inatori Fault, shown in Figure 5, was subjected to right lateral movement. The maximum offset on the Inatori Fault was about 18 cm; Figure 13 shows photographs of this 18-cm offset along the Inatori Fault as it crosses a highway in the town of Inatori. Various Japanese engineers and scientists reported horizontal movement of as much as 60 cm; however, no displacements larger than 18 cm were actually observed.

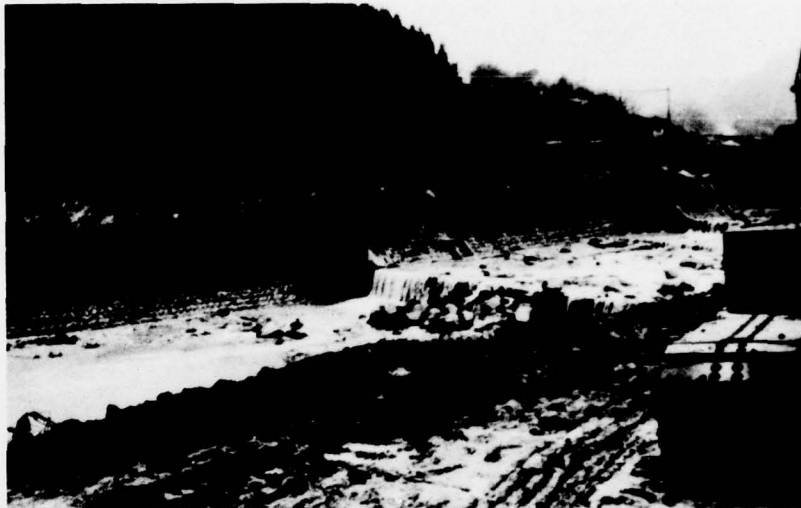
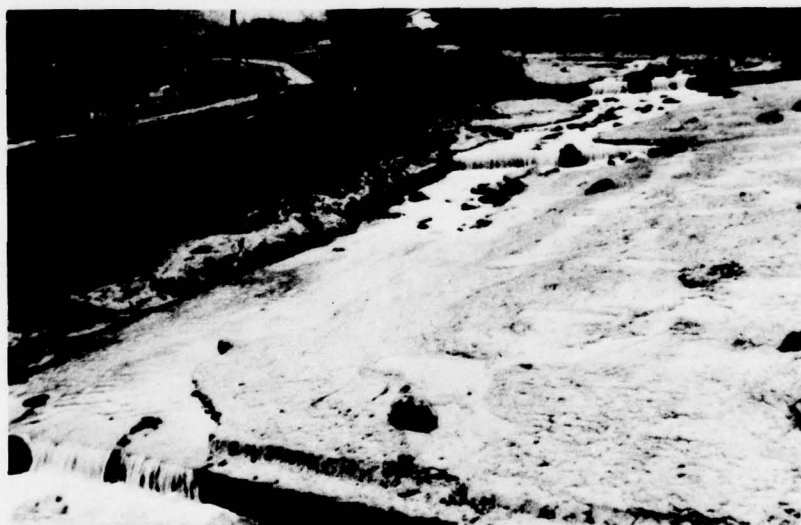
Figure 19. The streambed about 1 km downstream of the tailings dam - after the failure

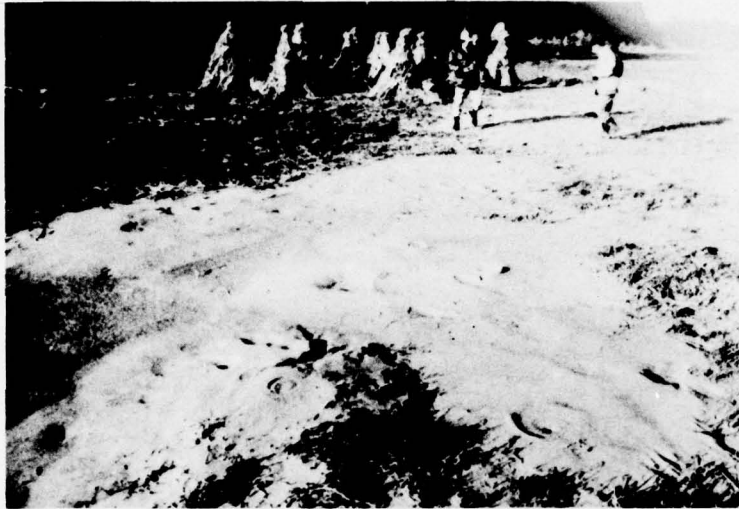
21. About 15 min after the main shock, sand boils occurred in the old tailings deposit areas (those used prior to 1965). This area had had about 1/3 m of fill deposited on the surface of the tailings and grass had been planted and the area is now used for grazing cattle. Figure 22 shows pictures of the tailings material after it had boiled up as a result of the earthquake.

Figure 22. Soil boils in old tailings deposits

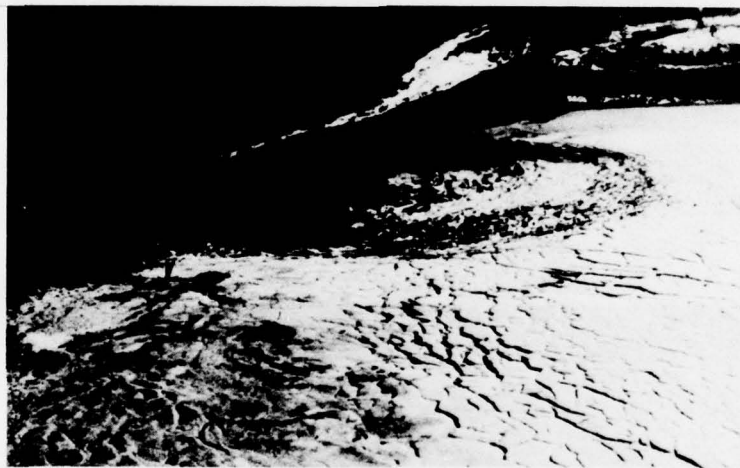
22. Aftershock. The largest aftershock, which occurred on January 15 at 7:32 a.m., registered a magnitude of 5.7. It is believed to have triggered the failing of the second tailings dam; however, an aerial photograph exists, supposedly taken at 10:00 a.m. on January 15, which shows the second dam intact. Mochikoshi Mining Co. officials believe that the second dam failed at around 12:30 to 1:00 p.m. on January 15. At this time about 3000 cu m of liquefied material broke the second dam and flowed down the mountainside. Again (as in the first dam failure) the base or main portion of the No. 2 Dam remained stable. It was the small dikes used for stacking tailings that became unstable and allowed the dam failure. Figure 23 shows photographs of the second dam after it had failed.

27. Considering the second dam, which failed approximately 24 hr after the main event and 5 hr after the largest aftershock, one can assume that large pore water pressures were developed in the tailings during the shaking. This is confirmed by the sand boils which were manifest on the surface. It is possible to postulate that after the earthquakes straining occurred along a shear zone. The materials in this shear zone tended to dilate. Because of the high excess pore water pressures existing in the surrounding material, it is possible that the material in the shear zone actually sucked in pore water, leading to a

decrease in shear strength. This in turn would allow the material in the shear zone to again deform with more dilation. This would lead to an increase in water content in the shear zone and a decrease in shear strength. It is the author's opinion that such a hypothesis is possible and that this sequence of events was probably the mode of failure of the second dam.

Figure 23. No. 2 tailings dam after failure

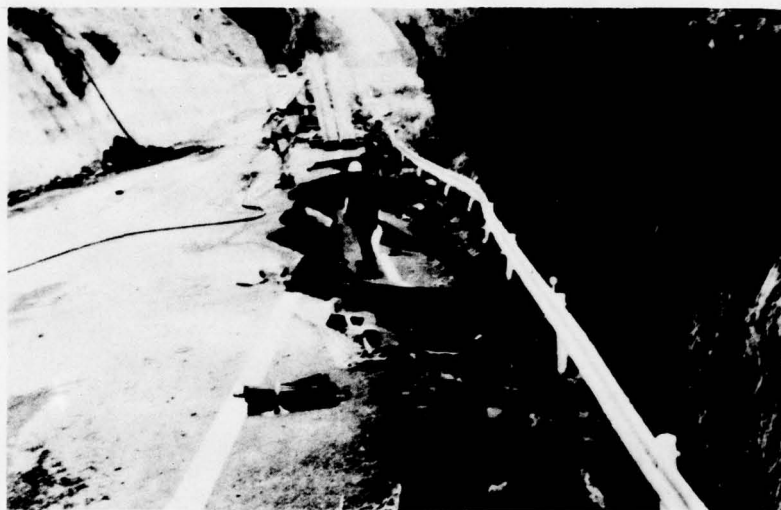
28. If one travels the highway leading from the damsite in a southerly direction to the coast (see Figure 26) many landslides and rockfalls can be seen. As stated previously, the Izu Peninsula is primarily volcanic in origin. The area is very rugged and mountainous. As a result most of the damage resulted from landslides and rockfalls. Where cut and fill operations had been used to construct highways along the mountainside the fill portions occasionally slumped. This is seen in Figure 27. Figures 28 and 29 are photographs showing landslides and rockfalls that occurred along this highway.

Figure 27. Examples of failures where the highways had been constructed using cut and fill techniques

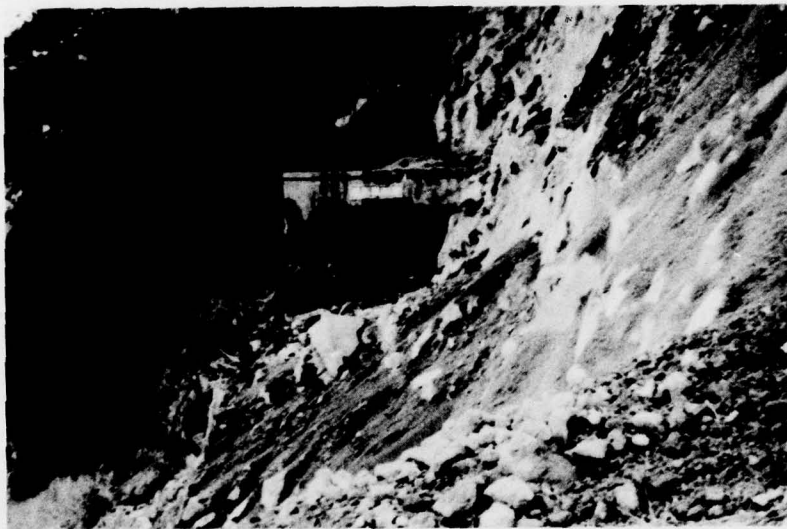
29. If one travels the coastal highway up the eastern coast of the Izu Peninsula many rockfalls and landslides are seen. Figure 30 shows aerial photographs of some of these slides. Immediately north of the town of Inatori, the road goes through three tunnels. Landslides carried away the highway which connected the three tunnels. Figure 31 is an aerial view of these landslides. Figure 32 was taken standing at one tunnel looking toward another.

Figure 32. View of tunnel after earthquake

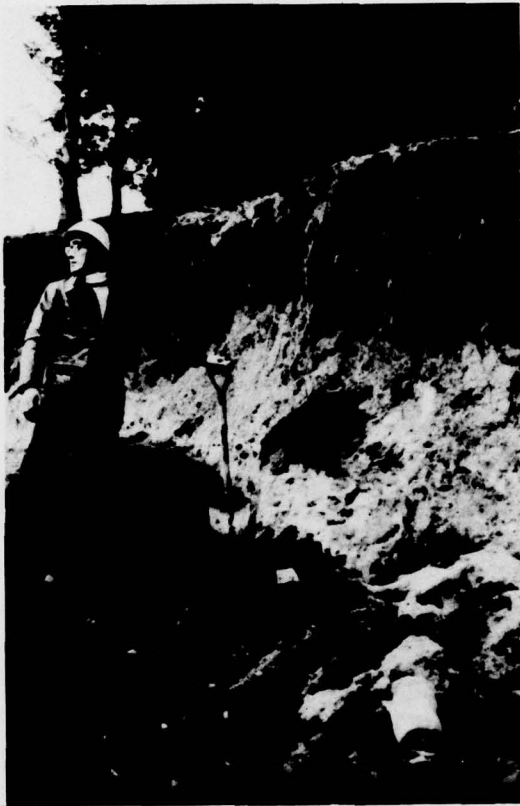
turned and flowed down the valley. Figure 34 is a photograph taken of the scarp remaining after the slide. The surficial deposits were composed of loam and weathered volcanics. Immediately below this is a layer of scoria. Immediately below the scoria is a volcanic tuff which is hard to chip with a shovel. Below this layer of volcanic tuff is a soft layer of plastic clay (visually classified CH). This can be seen in the photographs in Figure 35. There are two schools of thought concerning the failure plane of this slide. One school says that the failure plane is in the scoria. The other school of thought, which appears to be more logical, is that the failure plane is located in the soft clay below the volcanic tuff. This appears more logical because of the large chunks of tuff which slid during the earthquake (see Figure 36). This soft clay, was found at the head of the slide and also at the existing surface toward the center of the slide area. Figure 37 is a photograph taken of this material in the center of the slide area. It is believed that this layer of soil was continuous over the entire slide surface.

Figure 34. View of scarp
of landslide

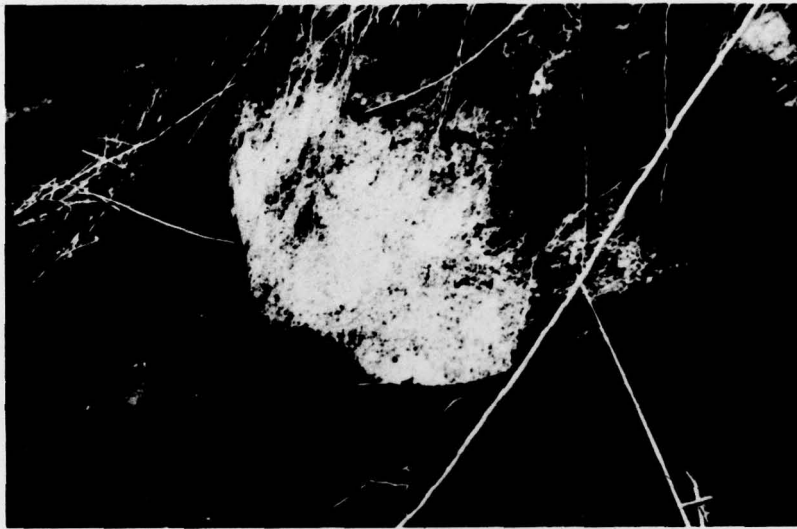
Figure 35. View of postulated zone of weakness

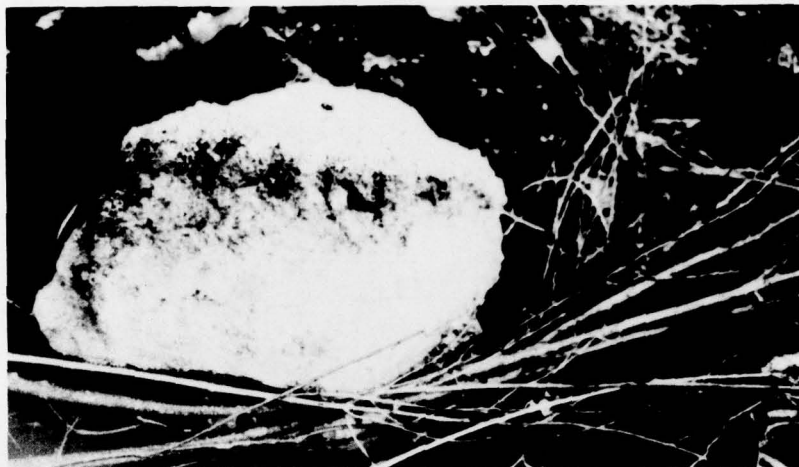
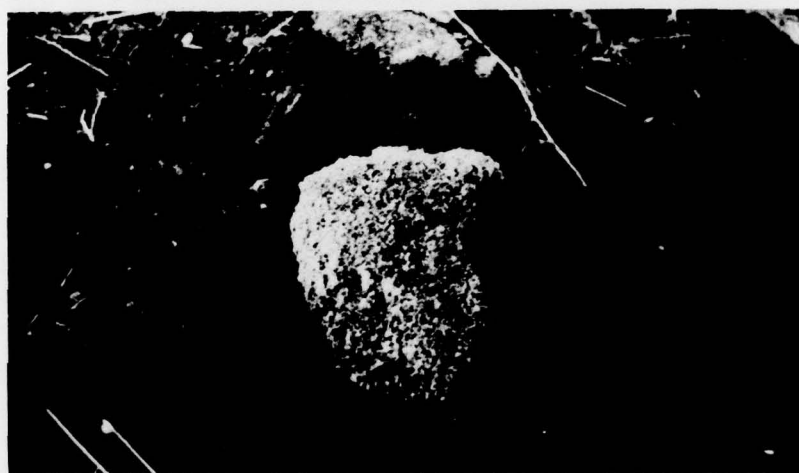
Figure 36. Photos of material of the slide
