YANKEE LAKE DAM  
SULLIVAN COUNTY, NEW YORK  
INVENTORY No. NY 332

## PHASE I INSPECTION REPORT NATIONAL DAM SAFETY PROGRAM

PHASE 1 INSPECTION REPORT  
NATIONAL DAM SAFETY PROGRAM  
YANKEE LAKE DAM I.D. No. NY 332  
DEC #163D-168 DELAWARE RIVER BASIN  
SULLIVAN COUNTY

Name of Dam: Yankee Lake Dam (I.D. No. NY 332)  
State Located: New York  
County Located: Sullivan  
Stream: Pine Kill (a tributary of the  
Basher Kill and Neversink River)  
Dates of Inspection: October 20 and 24, 1978

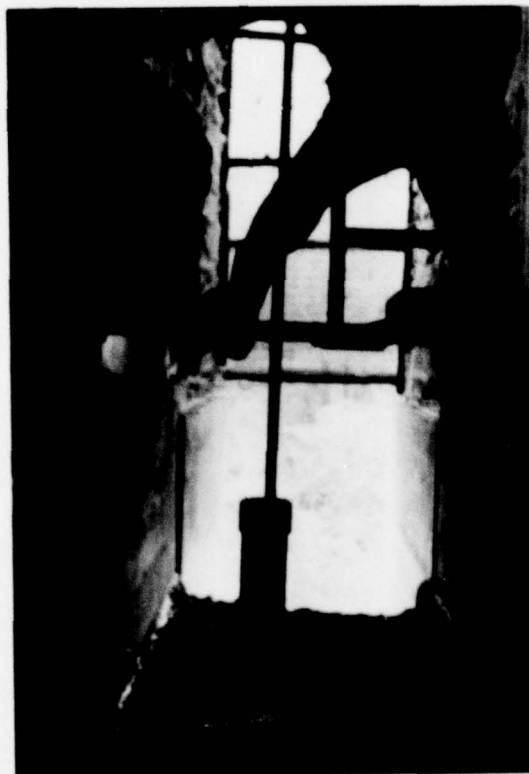
Photograph #10

There is no regular program of repair and maintenance and no operation and maintenance manual is available. The spillway channel and the walls were resurfaced with concrete up to a height of 2 feet from the channel bottom in 1978. Additional spillway repair and seepage control was undertaken in 1924, 1964 and 1967.

Spillway channel viewed from inside dam looking downstream  
Note: New concrete walls and stoplogs on platform
