DELAWARE RIVER BASIN

ST. JOSEPHS LAKE DAM

SULLIVAN COUNTY, NEW YORK
INVENTORY No. NY 324

PHASE I INSPECTION REPORT
NATIONAL DAM SAFETY PROGRAM

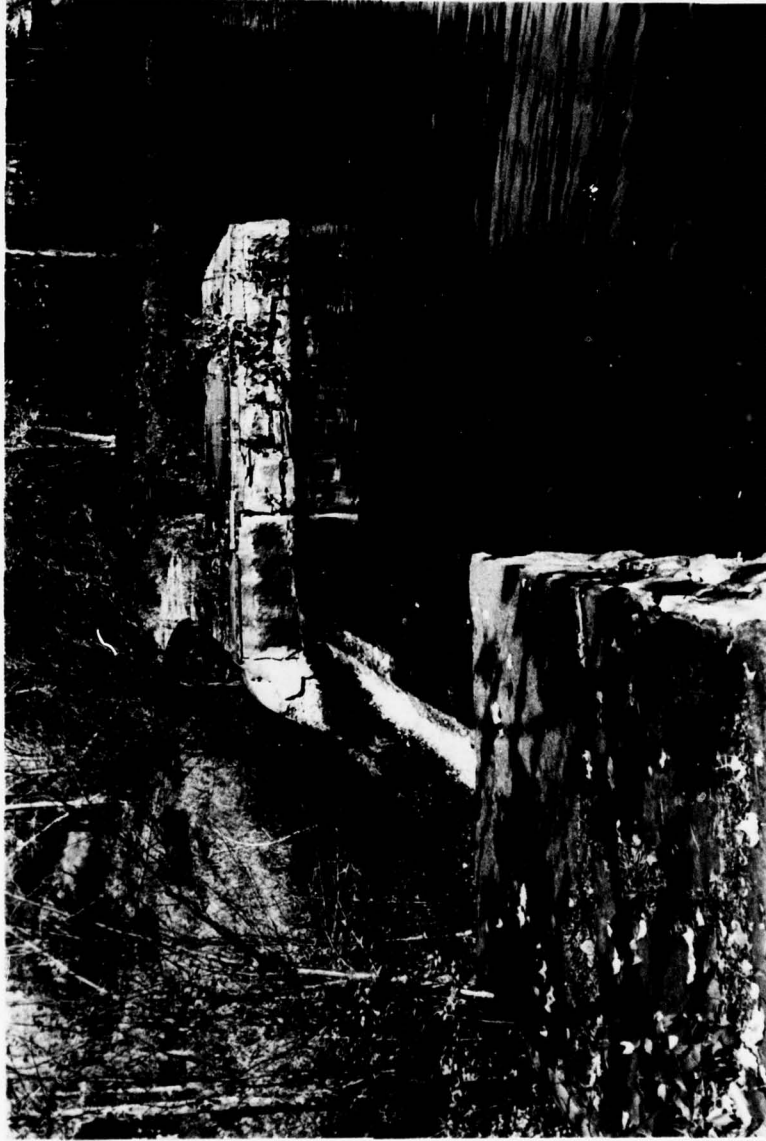
Overview of St. Josephs Lake Dam
Looking North

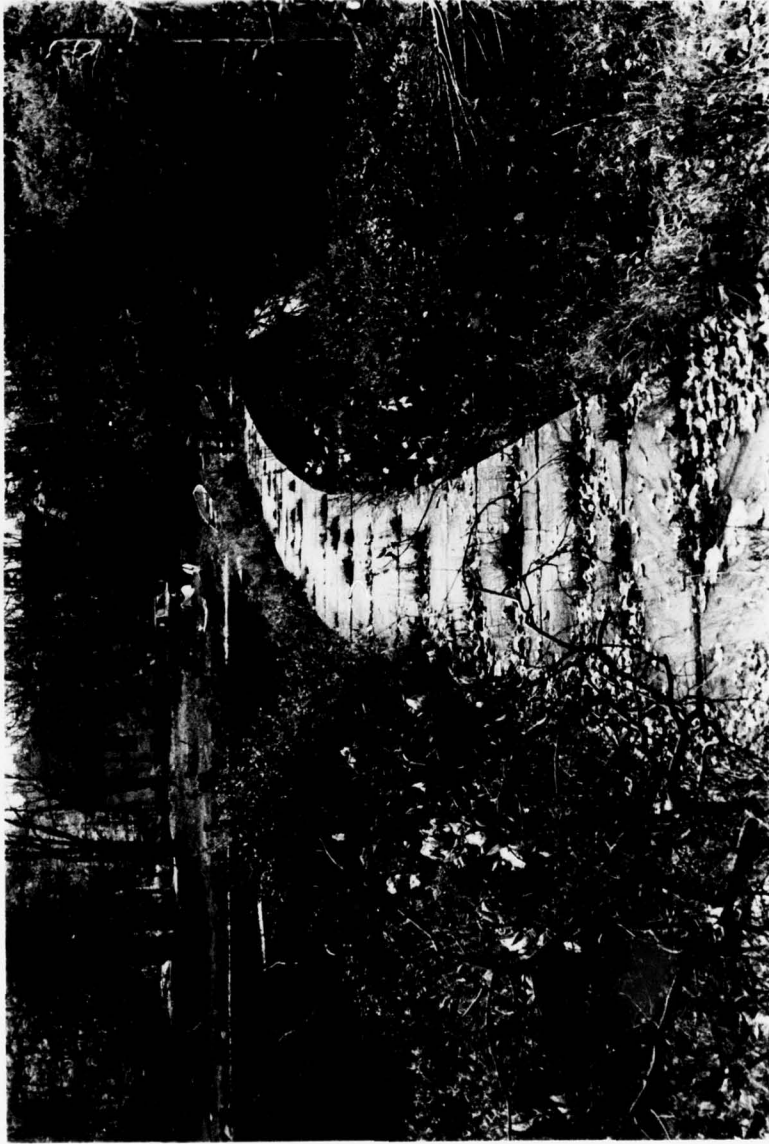
Overview of St. Josephs Lake Dam
Looking South

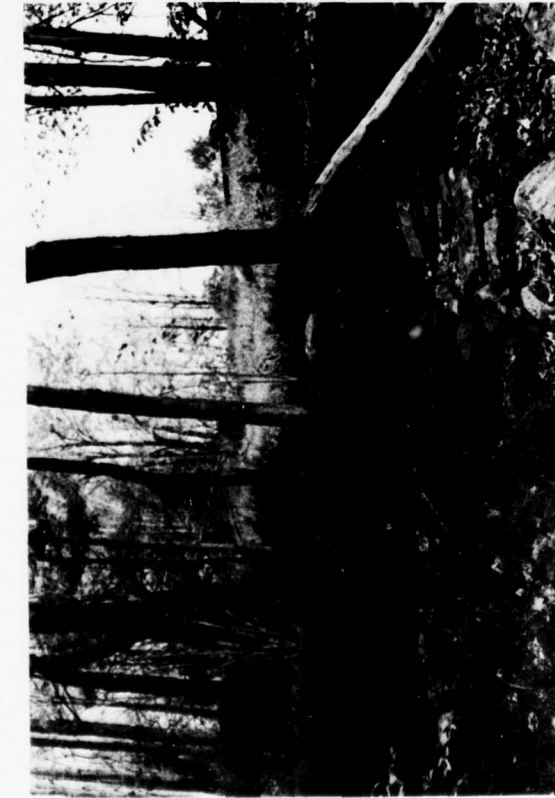
Photo #1
Earth Embankment & Abandoned Hydroelectric Supply Conduit
Looking East

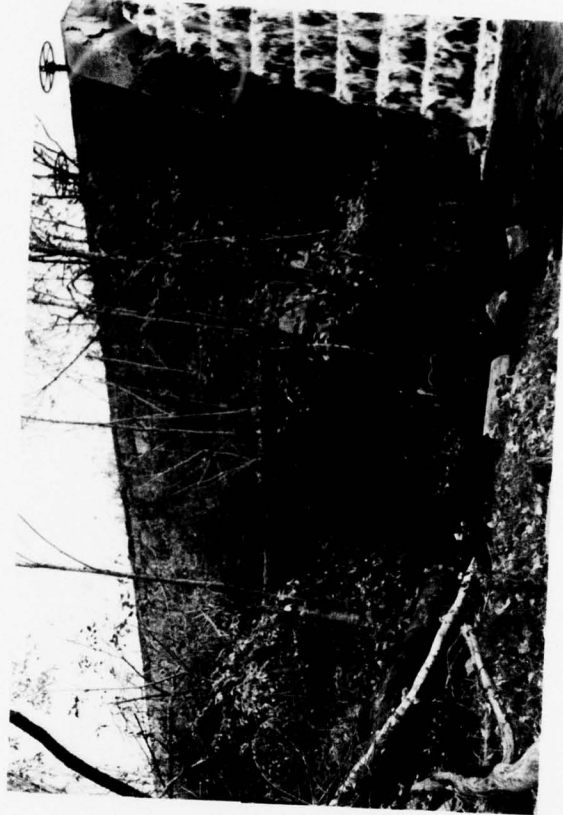
Photo #2
Earth Embankment & Low Level Outlets
Looking East

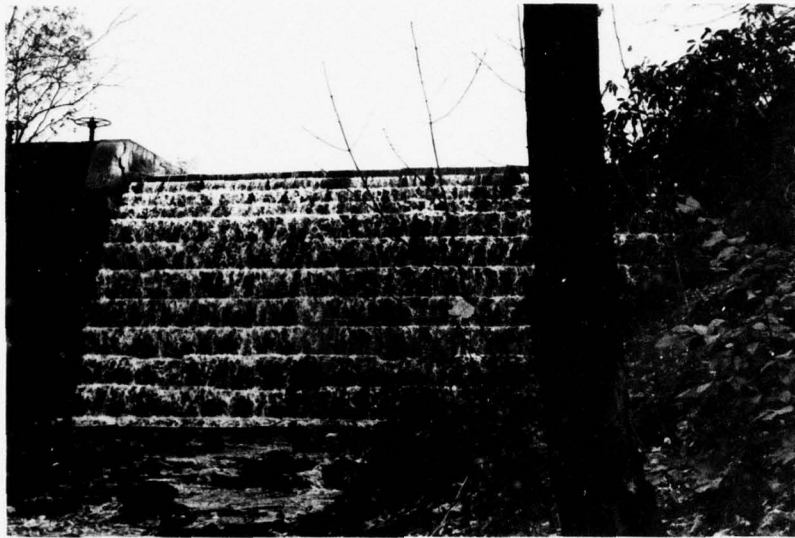
Photo #3

The spillway is constructed of stepped sandstone masonry blocks of varying heights forming somewhat of an ogee shape. Flow over the spillway prohibited complete inspection of the spillway surfaces and the immediate downstream area. Two concrete buttresses form the north and south extremities of the spillway. The top of the buttress is 2.5 feet above the spillway crest. The buttresses are severely deteriorated, however, little seepage from the spillway discharge was evident flowing through the buttresses. The crest is composed of 6 feet long and 3 feet wide masonry blocks; the joints of which are deteriorated and require recaulking. The tailrace channel is generally flat and wide, relatively free of debris with some riprap lining. Some large trees are present in the downstream channel. The area directly below the spillway appears to be eroded from the spillway discharge, to a width of 6 feet on the south side and a width of 10 feet on the north side. The depth could not be determined due to spillway discharge.

Spillway, Looking East

4. Investigation of the spillway when the reservoir is drawn down to observe the condition of the spillway and also the erosion area at its base. The NYS Department of Environmental Conservation, Dam Safety Section will be available to assist in this investigation (Tel: (518) 457-6310).

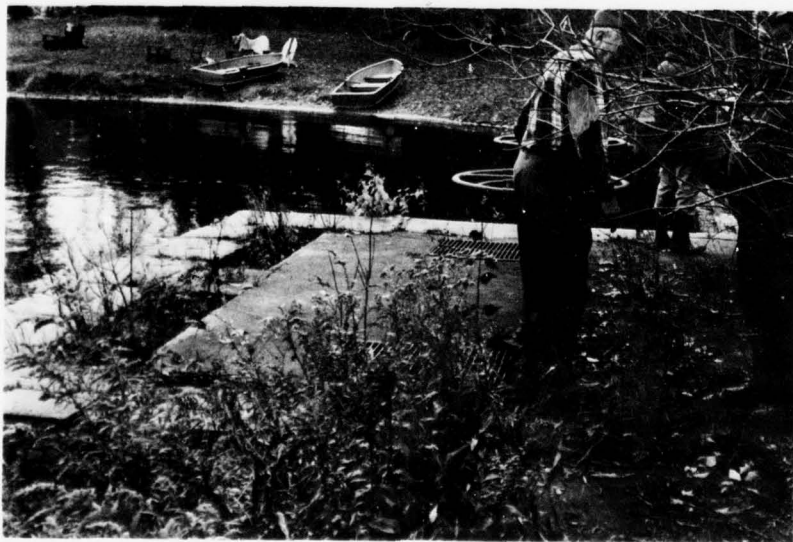
Photo #4

Gate Valve Platform, Looking South

- n. Intake Structures _____ concrete gate valve structure is cracked
and deteriorated, particularly the top slab - this
_____ structure is located north of the north buttress
_____ and is part of the north non-overflow masonry section
- o. Stability _____ no visual problems observed

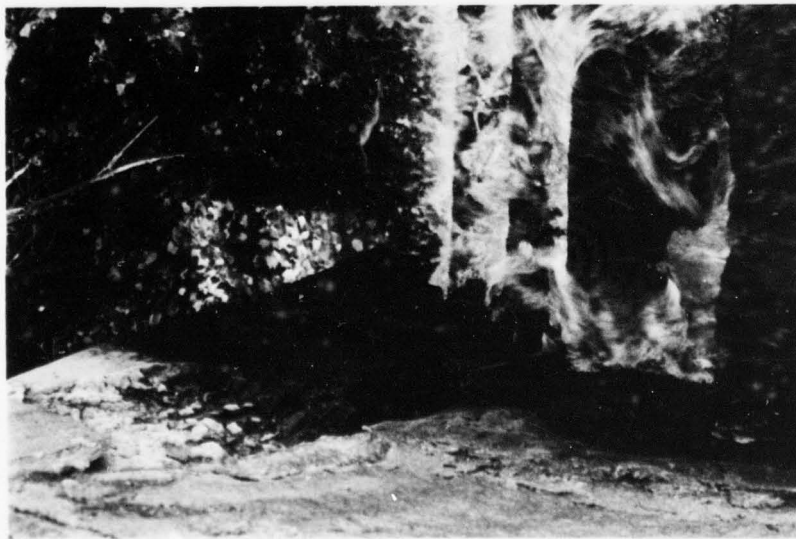
The sandstone block masonry structure is generally in good condition, except the mortar of the joints has deteriorated substantially. The areas of primary concern are to joints at the spillway crest and the area south of the spillway where seepage was observed. Considerable moss growth approximately 10 feet south of the spillway and 2 feet below the lake level was evident. Adjacent to the moss area (approximately 3 feet south of the spillway) seepage was flowing through the joints at a rate of 2 to 5 gallons per minute. This flow appeared to be related solely to the joint deterioration and should be easily controlled by repointing the area (see photograph # 7). The concrete buttresses located at each end of the spillway have extensively cracked and spalled. The south buttress deterioration has progressed so far that a void near the spillway crest exists through the entire width of the buttress (see photograph # 5 & 8).

Photo #5
South Spillway Buttress
Looking West and Down at Spillway

- b. Structural Cracking cracked and spalled buttresses located
at each end of the spillway - they have been repaired
in the past but have deteriorated again - south buttress, could
see thru buttress because crack was so large, near top of spillway

- c. The mortar joints of the masonry blocks at the spillway crest and adjacent to the spillway on the south downstream face require re-pointing.
- d. The spillway buttresses require repair to prevent further deterioration.

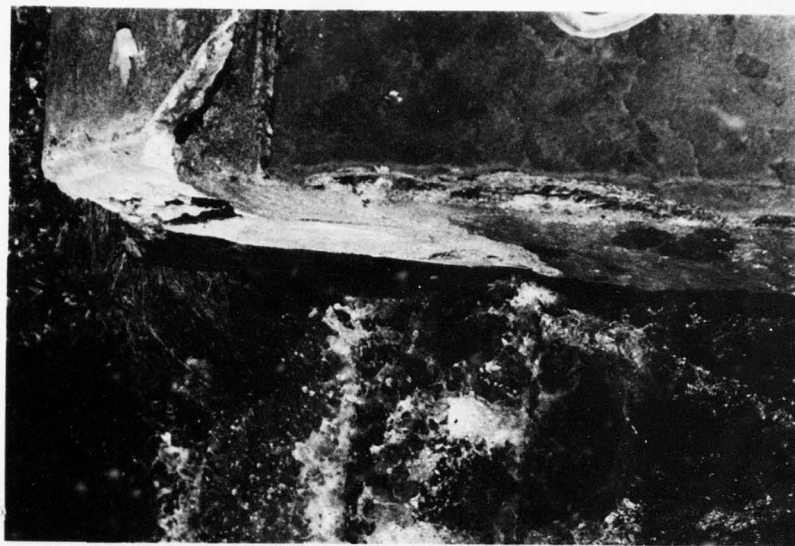
Photo #6
North Spillway Buttress
Looking West and Down at Spillway

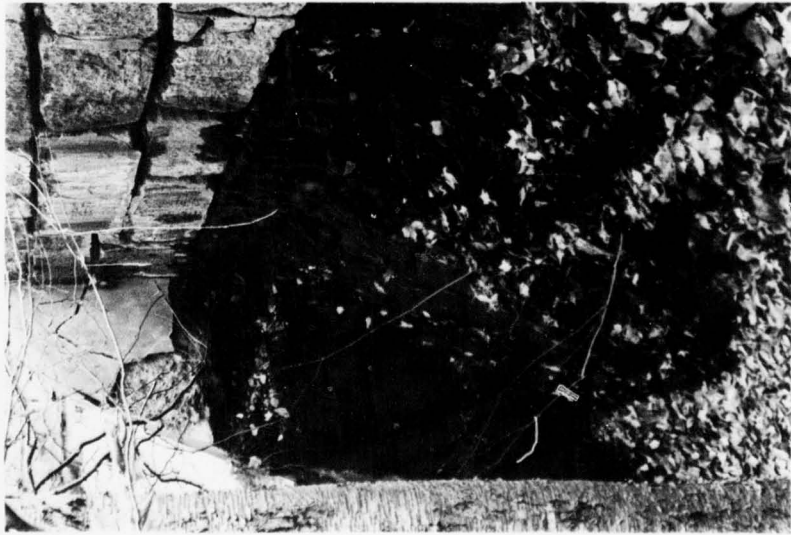
Photo #7
Downstream Face of Masonry Section, South of Spillway
(Looking North) Note Seepage

- f. Water passages, conduits, sluices _____
operational - conduit for facility power
generation is now abandoned
- g. Seepage or Leakage considerable moss growth south of south buttress
on downstream face \approx 2' below water line - seepage observed in this
area (estimated 2-5 gpm) coming thru deteriorated joints in masonry
blocks - principle area of seepage from buttress to 3 feet south.
Additional slight seepage to 10 feet south of buttress

3. Investigations of the observed seepage in the earth embankment and the masonry portion of the dam are required to determine the type and extent of remedial measures warranted. The investigation should include periodic and systematic observations and measurements of the quantity of seepage.

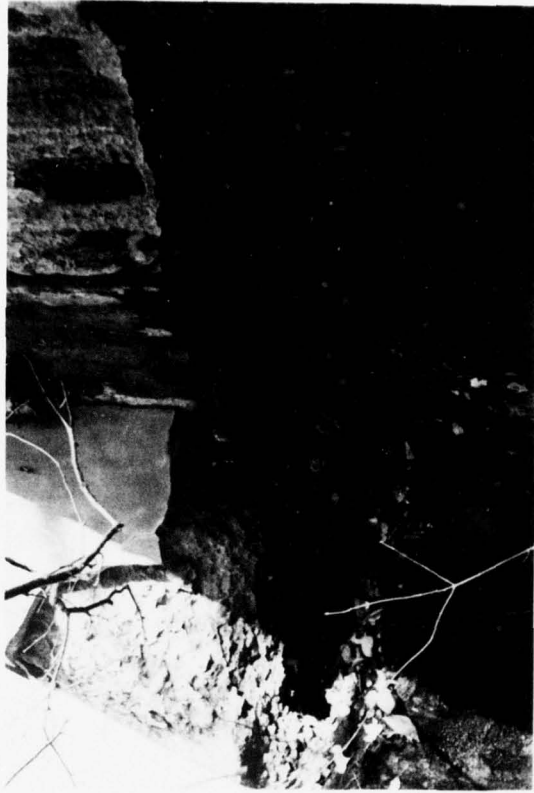
Photo #8
Close up of Seepage Area
and Deteriorated Buttress

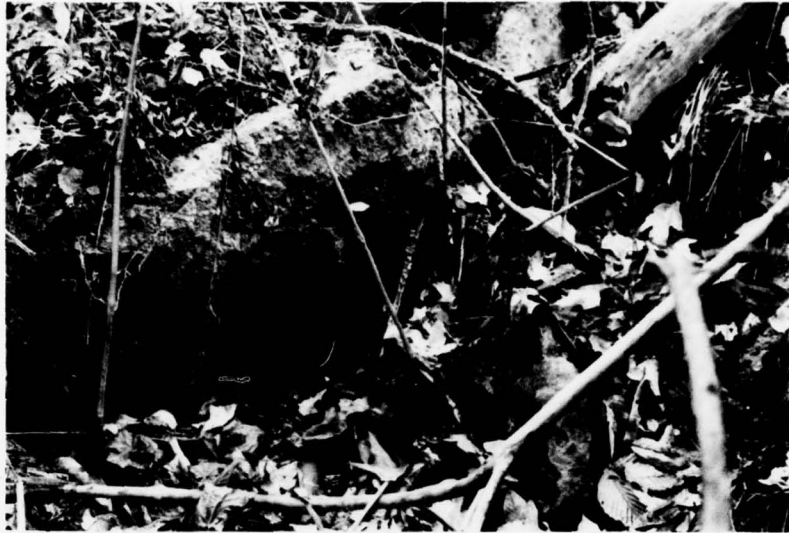
Photo #9

Earth embankment material was placed after the flood of August 1955 (Hurricane Diane) adjacent to the downstream face north of the spillway. Fill was also placed adjacent to the upstream face in 1975 or 1976 to replace that which had settled or eroded over the years. Considerable tree and brush growth was evident on this fill and inspection was difficult. Seepage was observed at 3 locations in the earth embankment adjacent to the outlet conduits on the downstream face. The total combined quantity of flow is estimated to be 5 to 10 gallons per minute (see photograph 9 & 10). No fine particle movement was noted. This flow may be related to the previous precipitation as the three areas were directly below a soft wet area at the top of the embankment.

Seepage Area of Earth Embankment Adjacent to Low Level Outlets
and above Photo #10, Note Seepage at Base of Rock

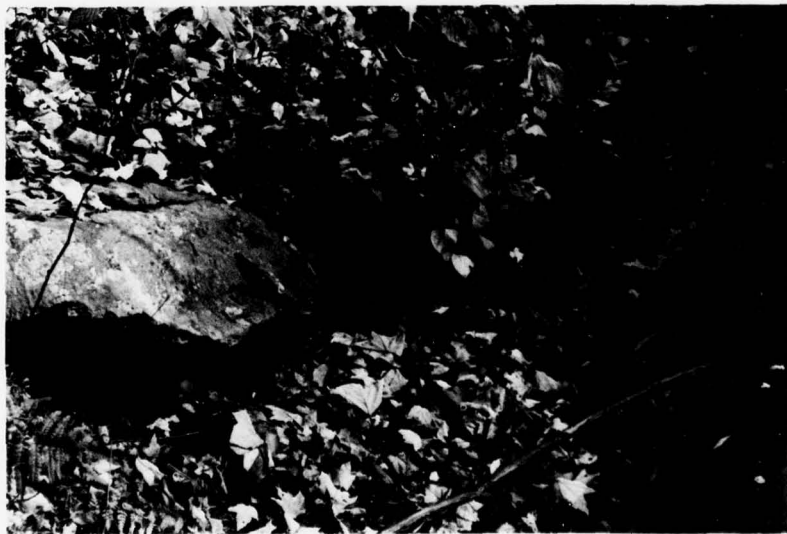
Photo #10

Seepage Area of Earth Embankment Adjacent
to Hydroelectric Supply Conduit and below Photo #9
Note Seepage between Boulders in photo center

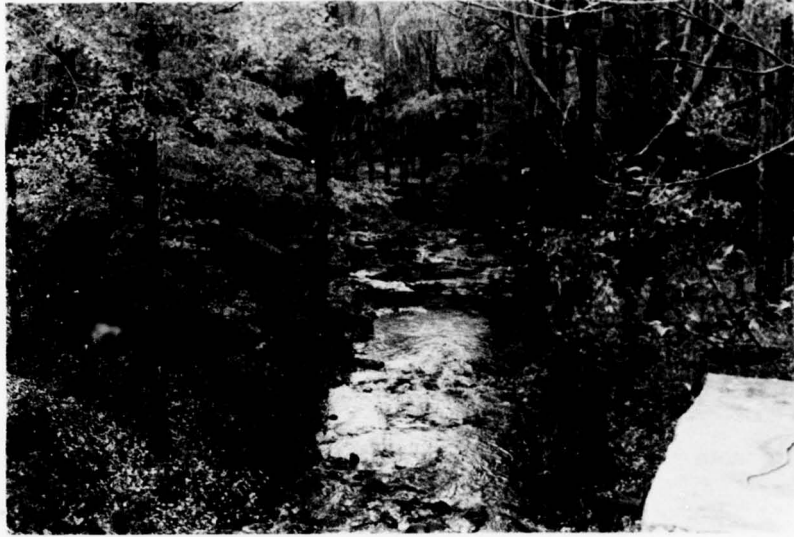
Photo #11

Downstream Channel as Viewed from Spillway
Looking West

d. Condition of Tail race channel PIPRAP ON CHANNEL, CHANNEL FAIRLY
FLAT AND WIDE; RELATIVELY FREE FROM DEBRIS AND
DOESNOT APPEAR TO HAVE ANY POTENTIAL PROBLEM.
Some large trees on banks of channel
