1. REPORT NUMBER		2. GOVT ACCESSION NO.	3. RECIPIENT'S CATALOG NUMBER
4. TITLE (and Subtitle) Phase I Inspection Report New Rochelle Reservoir No. 1 Hutchinson River Basin, Westchester County, New York Inventory No. N.Y. 20		5. TYPE OF REPORT & PERIOD COVERED Phase I Inspection Report National Dam Safety Program

NEW ROCHELLE RESERVOIR No. 1 DAM
OVERVIEW - NORTHEASTERN END

PHASE 1 INSPECTION REPORT
NATIONAL DAM SAFETY PROGRAM
NEW ROCHELLE RESERVOIR No. 1 DAM NY 20
HUTCHINSON RIVER BASIN
WESTCHESTER COUNTY, N.Y.

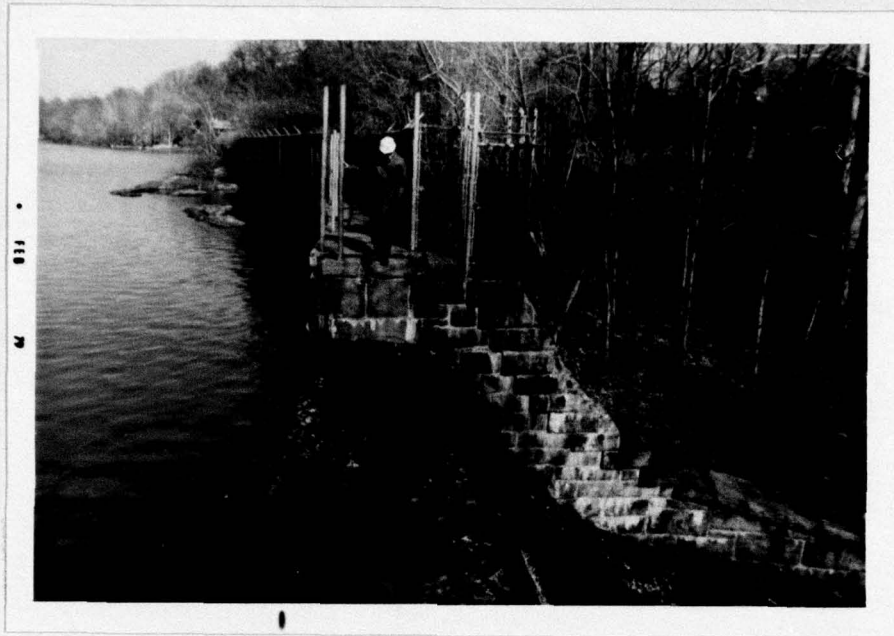
The spillway channel was in satisfactory condition. There was some mortar missing from the joints between blocks near the spillway crest, but generally the spillway was in satisfactory condition.

SPILLWAY CREST

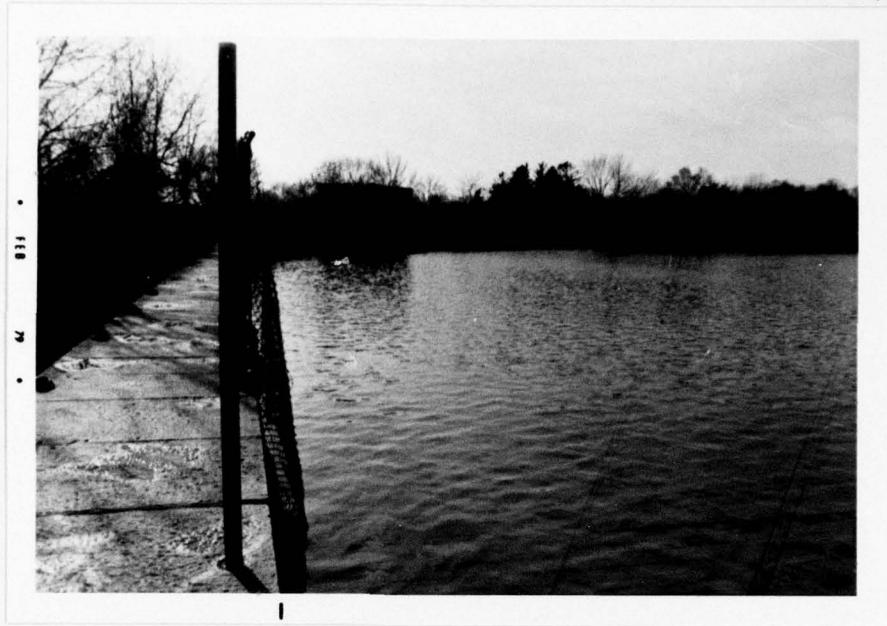
CREST OF NON-OVERFLOW MASONRY SECTION
WITH "GATE HOUSE"

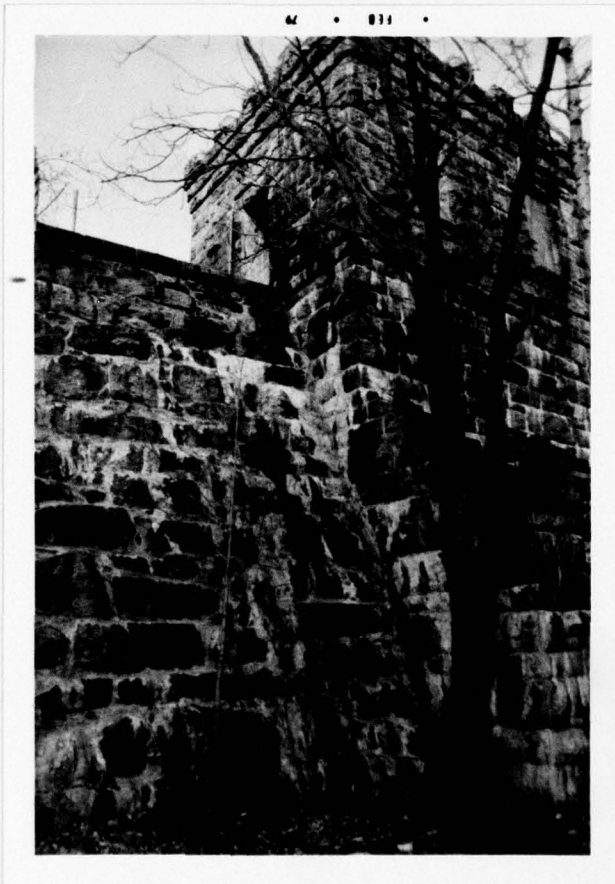
The masonry section appeared to be in satisfactory condition. There were no signs of distress or movement. The stones on the downstream face in one small area near the stone block building were wet from apparent seepage. While several of the blocks were wet, there was no actual flow noted coming through the joints. An inspection of the area immediately downstream of the toe of the masonry revealed no wet areas or soft sections.

"GATE HOUSE" LOOKING UPSTREAM - NOTE
DISCOLORATION ON BLOCKS DUE TO AREA SEEPAGE

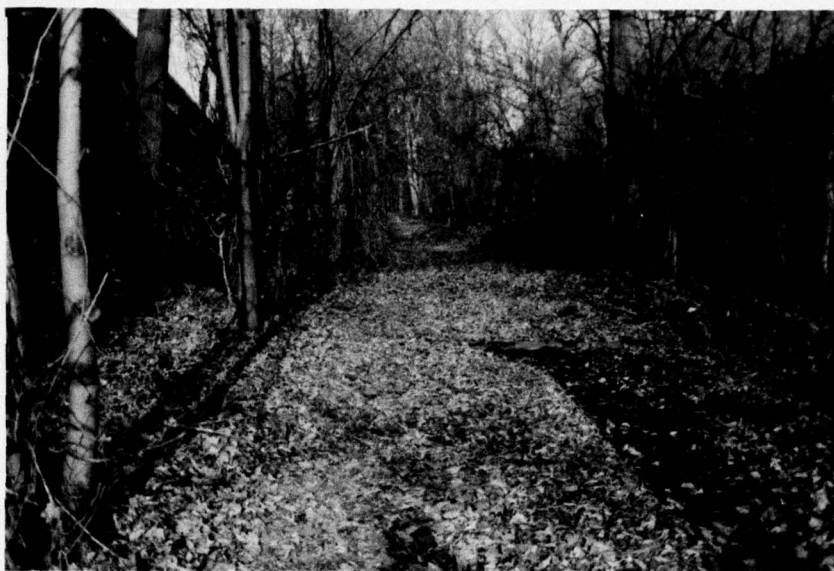
DOWNSTREAM TOE OF MASONRY SECTION
