HEMLOCK LAKE DAM

LIVINGSTON COUNTY, NEW YORK
INVENTORY No. NY 477

PHASE I INSPECTION REPORT NATIONAL DAM SAFETY PROGRAM

SEPTEMBER 1979

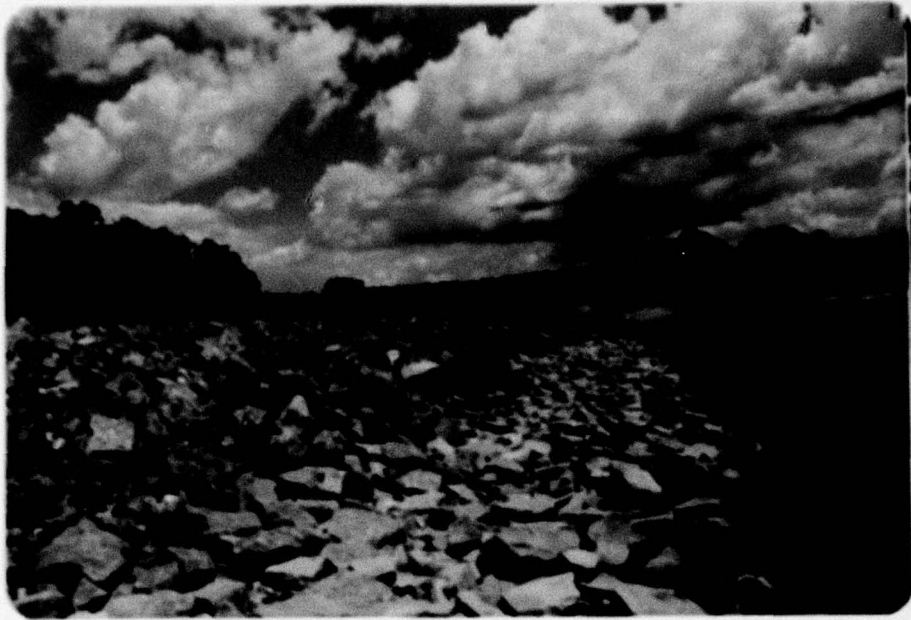
Most of the embankment was grass covered and in good condition. However, visual inspection revealed several minor deficiencies. The most serious of these deficiencies was failure of the riprap on the upstream slope of the embankment, west of the spillway. Several areas on the riprap had been scoured and subsided due to wave action. The worst depression was adjacent to the spillway channel where the slope paving had dropped by as much as 2 feet. The slope had been partially regraded with additional riprap. Other deficiencies observed included several trees growing on the downstream slope of the embankment on the eastern end of the structure and small voids between some of the concrete slabs on the upstream face. There were also larger voids on a number of the slabs where one corner had been removed by wave action leaving triangular voids 1 foot long by 1 foot deep.

Riprap on Western End of Dam -
Gray Stone Placed Due to Damage by Wave Action

- a. The damaged portions of the riprap on the upstream face to the west of the spillway should be repaired. In addition, actions should be taken to prevent the scour problem from occurring in the future.
- b. Triangular voids which exist at the corners of many of the concrete slabs on the upstream slope to the east of the spillway should be repaired.
- c. The deteriorated concrete on the spillway and on the retaining walls for the spillway should be repaired.
- d. The trees which are growing on the downstream slope of the eastern end of the dam should be cut.

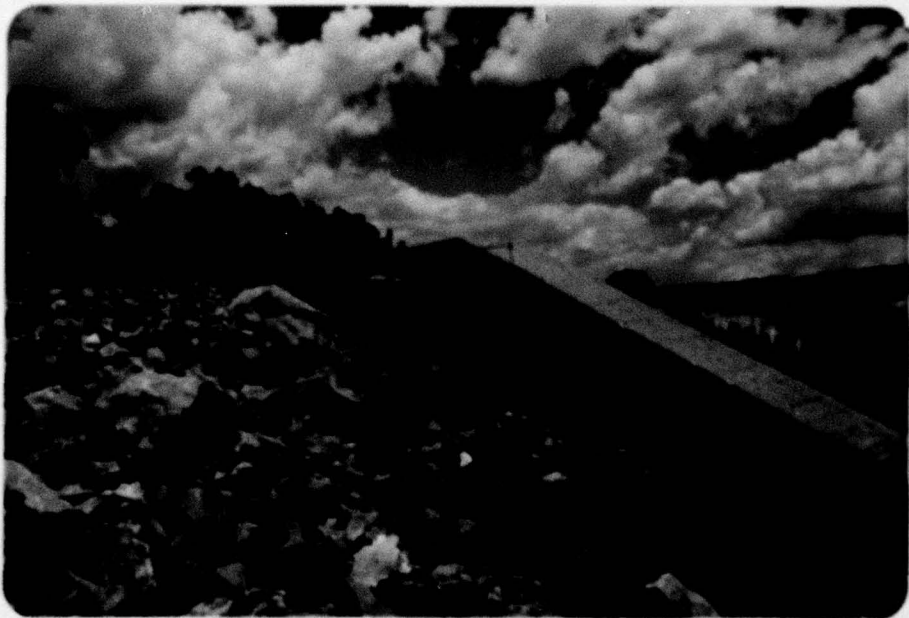
Visual observation of the structure did not reveal any signs of major distress. The upstream slope on the western end of the structure was slightly irregular with depressions which had been caused by wave action.

Depression on West End of Spillway Caused by Wave Action

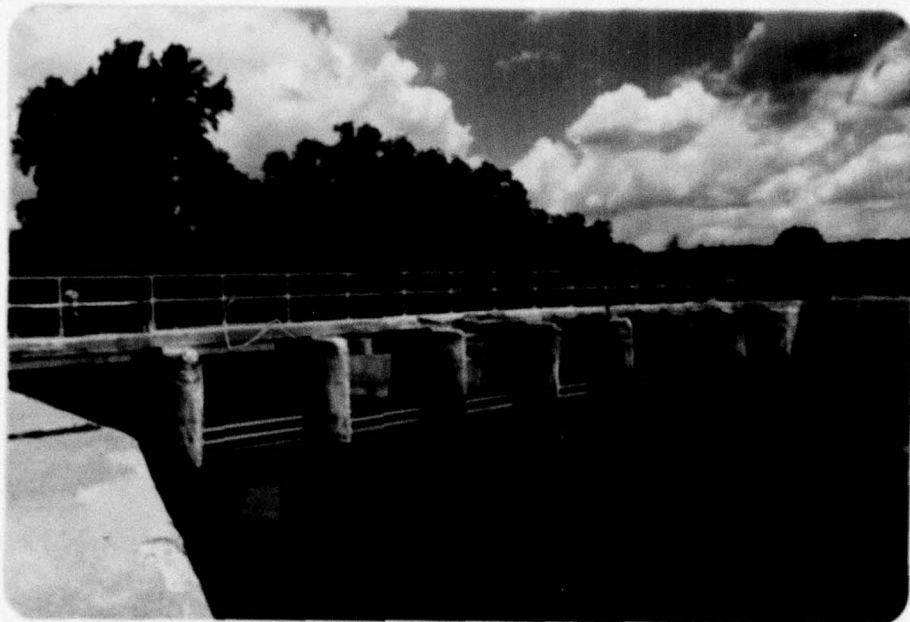
Spillway Section - Channel Stopgates in Place

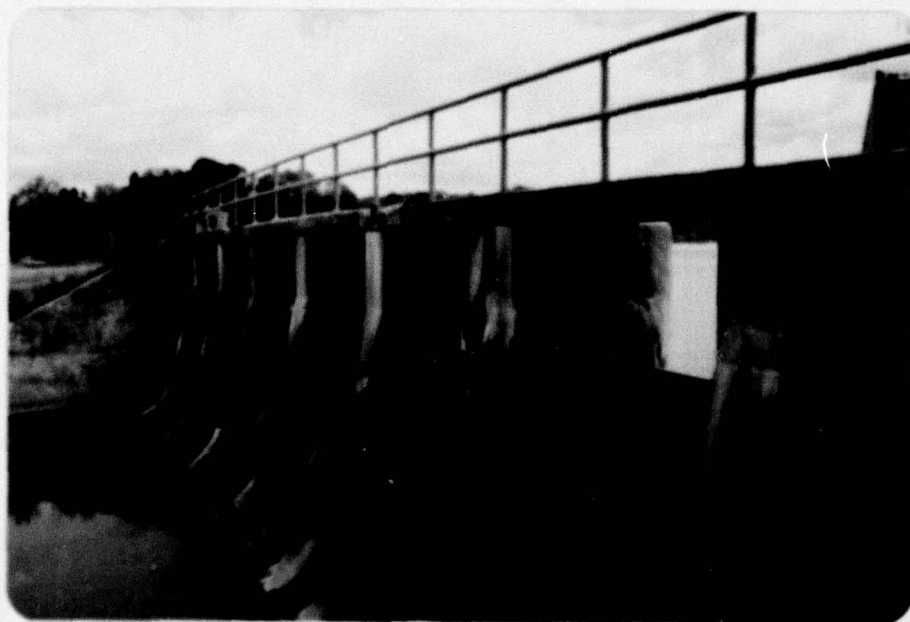
Spillway - Downstream Portion of Ogee Section

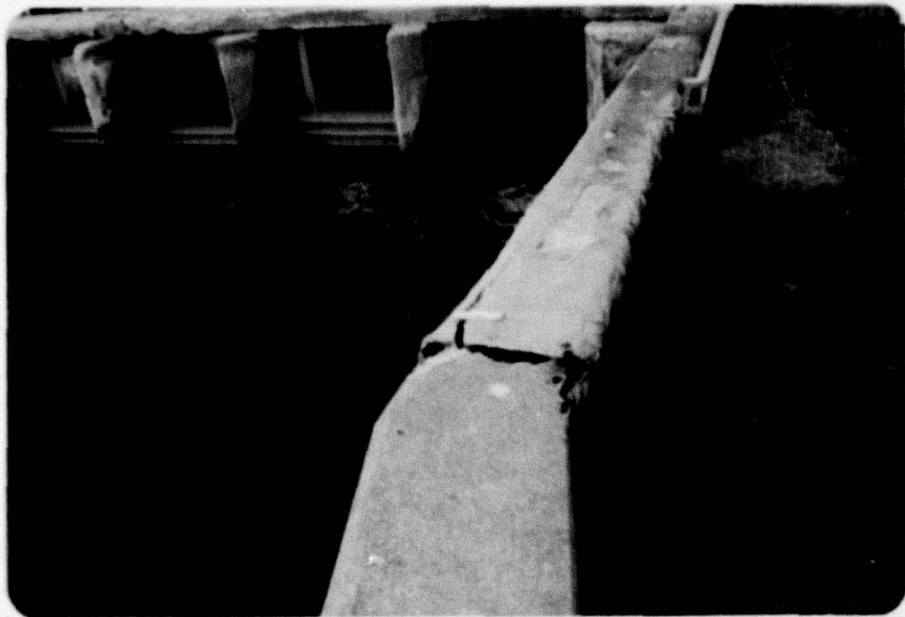
Crack in Patching Material on Wingwall at East End of Spillway

b. Structural Cracking - @ WESTERN CORNER OF EAST WINGWALL; SOME ON FOOTBRIDGE

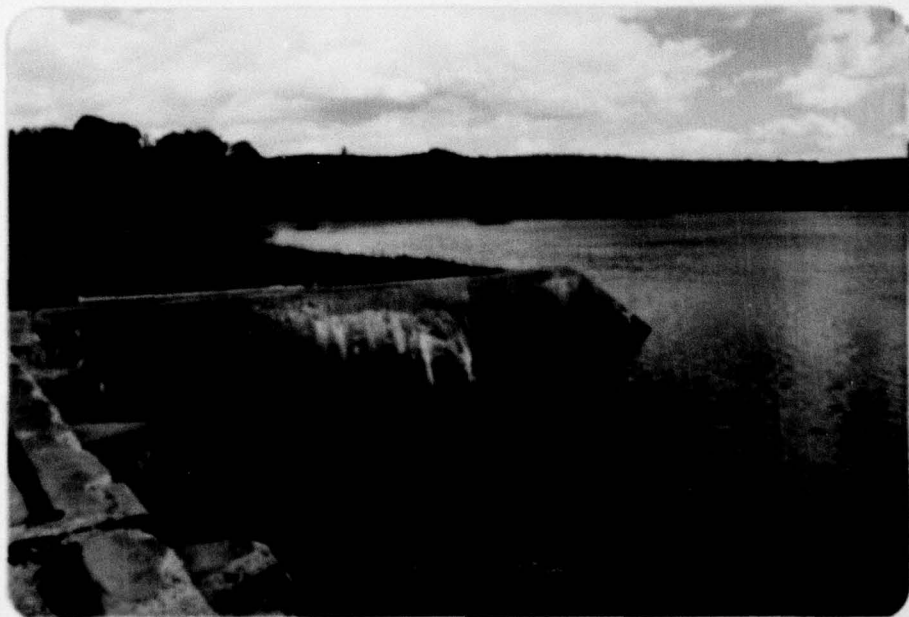
Deterioration of Concrete on Wingwall on East End of Spillway

EASTERN WINGWALL (UPSTREAM) - SOME CONCRETE CRACKING & SPALLING
STPGATES - SATISFACTORY ALL ARE REMOVABLE EITHER BY LIFTING
MECHANISMS OR BY CRANE

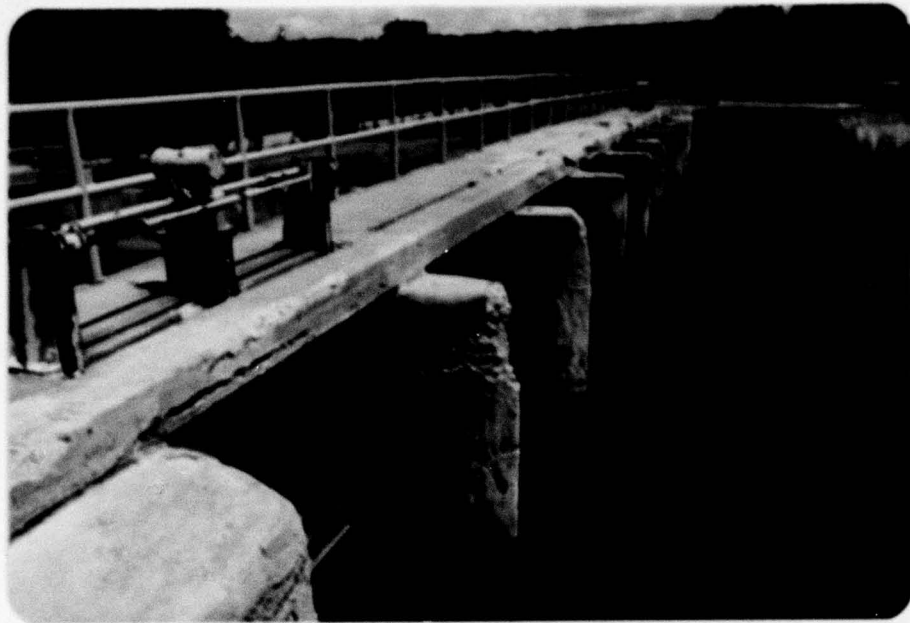
Deteriorated Concrete on Piers and Bridge Deck; also,
Lifting Device Used for Raising Stopgates

a. Concrete Surfaces MINOR SURFACE SPALLING & DETERIORATION ON PIER NOSES, SILLWAY FOOTBRIDGE

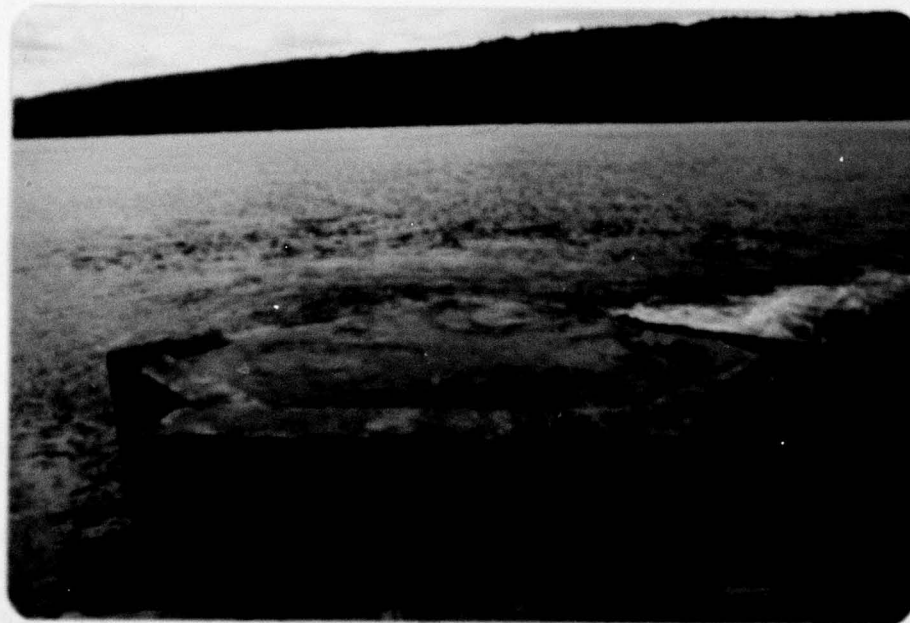
Outlet to Diversion Conduit From the Canadice Outlet

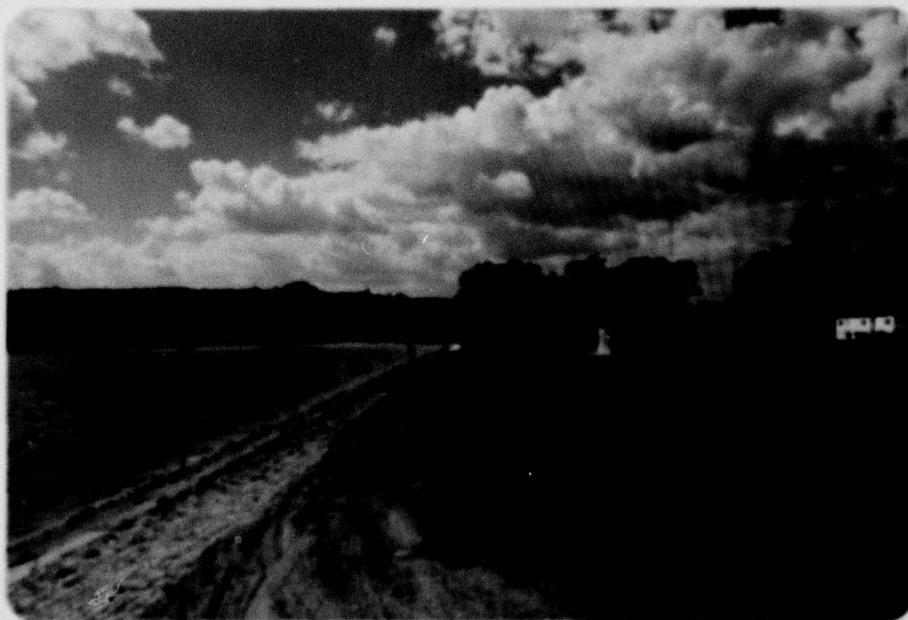
Eastern End of Dam With Building Housing
The Intake to Water Supply System
