DASHVILLE DAM

ULSTER COUNTY, NEW YORK

INVENTORY NO. N.Y. 76

**PHASE I INSPECTION REPORT
NATIONAL DAM SAFETY PROGRAM**

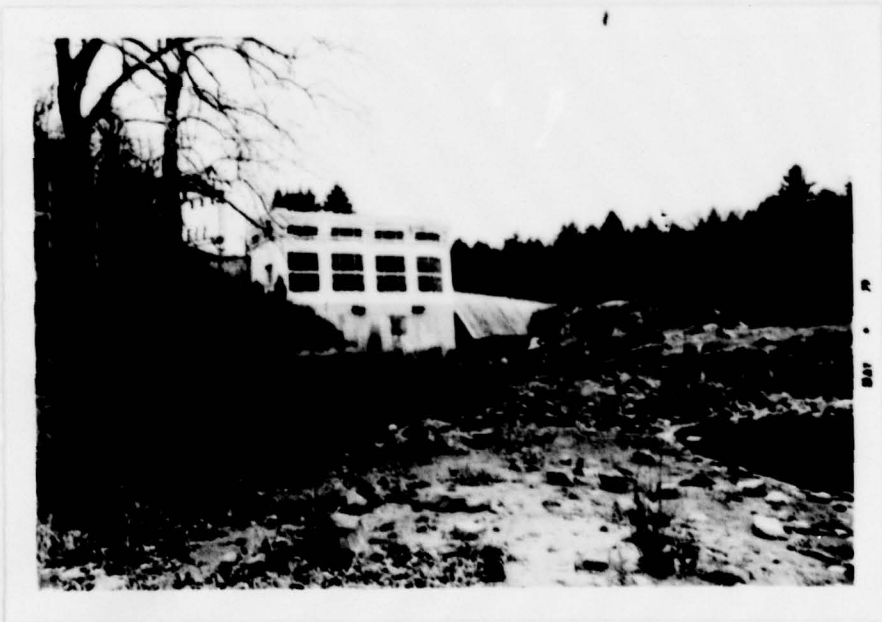
POWER STATION - DOWNSTREAM

Concrete surfaces on the powerhouse were spalling and deteriorated. The intake structure has been repaired several times in the past 50 years. At the time of the inspection, divers were repairing the trash racks.

1. Spalling, surface cracking and separation of the gunite on portions of the downstream face of the dam.
2. The small triangular section of concrete which has been scoured away at the downstream toe.
3. The minor void under the northwest abutment.
4. The spalled concrete surfaces on the powerhouse.

- a) As a result of the detailed structural stability analysis to be completed within one year of the date of this report, remedial measures deemed necessary should be completed within two years of the date of this report.
- b) Ascertain the physical condition and integrity of the mass concrete in the spillway beneath the gunited surfaces, preferably through a coring program.
- c) Correct the minor deficiencies occurring on the concrete surfaces.
- d) Develop and implement a warning system.

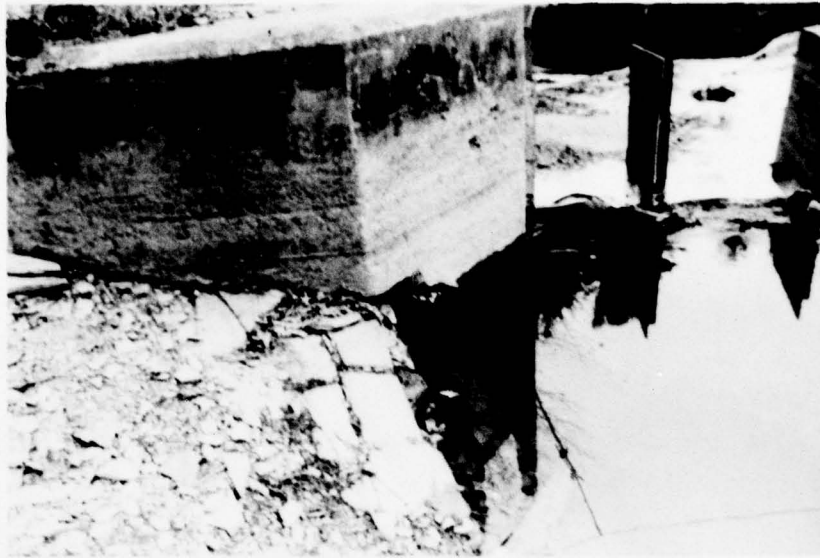
NORTHWEST ABUTMENT - TOP OF DAM

Water flowing over the spillway in the area where the flashboards were opened had scoured some of the backfill from beneath the northwest abutment forming a small void. The abutment is founded on rock, so this hole does not appear to be serious.

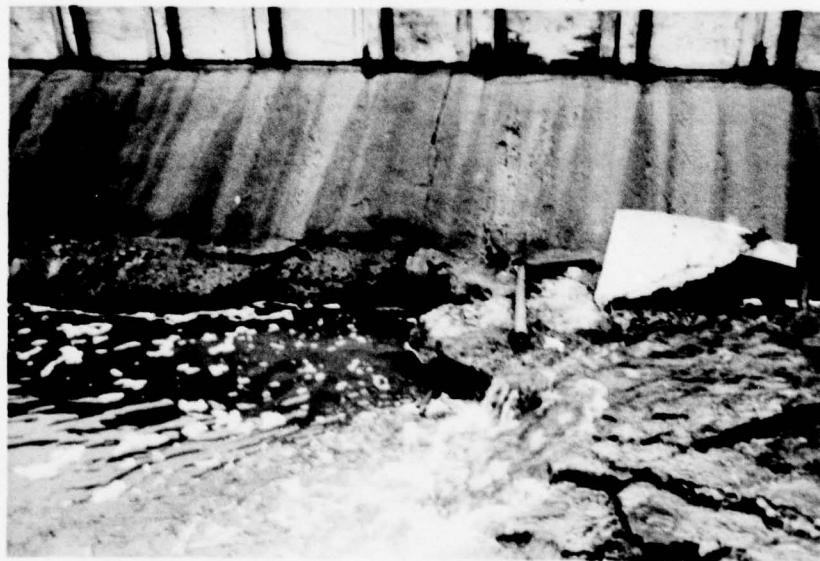
The bedrock at the southeastern abutment was decomposed and fractured. However, the concrete abutment appeared to extend far enough into the rock to provide an adequate cutoff.

EROSION OF BEDROCK @ SPILLWAY

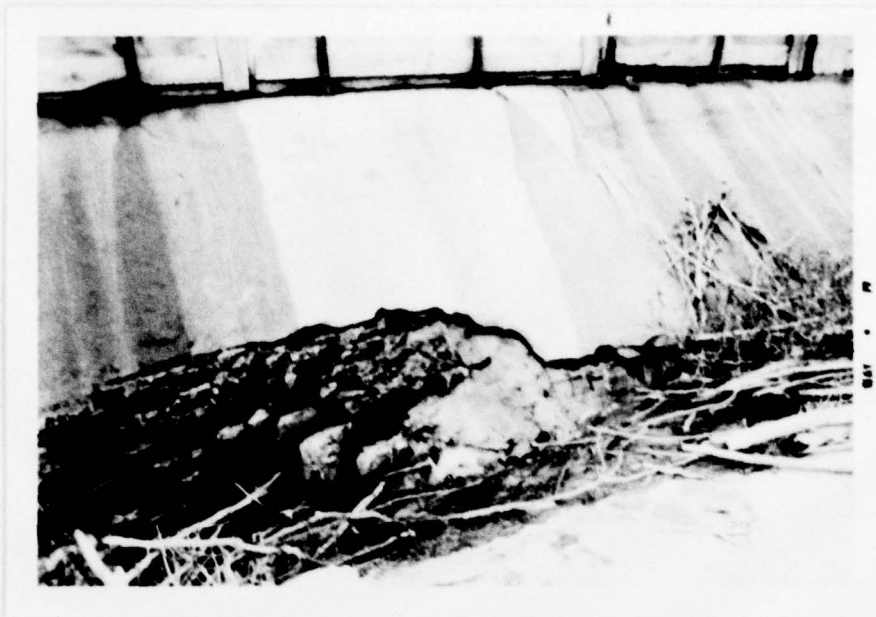
Inspection of the main portion of the dam did not reveal any major deficiencies. There were several small areas of spalling, surface cracking and separation of the gunite near the downstream toe. Small sections of the gunite had been removed, exposing portions of the steel reinforcing mesh. Near the midpoint of the dam, water flowing along the bedrock foundation at the toe had scoured a channel in the concrete. A triangular section approximately 3 inches high and 3 inches deep had been removed.

With the exception of the minor spalling and cracking of the gunite, the downstream face of the dam appeared to be in satisfactory condition. However, since the face had been treated with gunite, the condition of the concrete could not be observed.

CONCRETE SURFACE SPALLING @ SPILLWAY

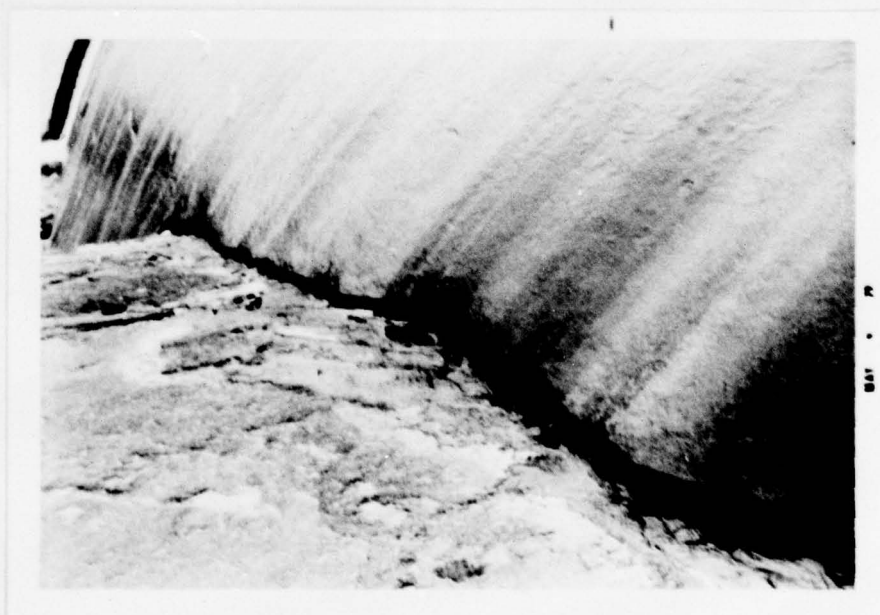
INTERFACE ALONG FOUNDATION AND
NON-OGEE SPILLWAY SECTION

g. Seepage or Leakage NEAR MIDDLE - AREA WHERE WATER FLOWS
UNDER FLASHBOARDS & THEN BENEATH THE GUNITE - IT EXITS
AT THE DOWNSTREAM TOE - ROCK INTERFACE.
