Finch Hollow Watershed Project, Site 1. Inventory Number NY-697
Susquehanna River Basin. Broome County,
New York. Phase 1 Inspection Report,

SUSQUEHANNA RIVER BASIN
FINCH HOLLOW WATERSHED PROJECT - SITE I
NY 697
PHASE I INSPECTION REPORT

PHASE I INSPECTION REPORT
NATIONAL DAM SAFETY PROGRAM
FINCH HOLLOW WATERSHED PROJECT - SITE I
I.D. No. NY 697
DEC #96A-3852
SUSQUEHANNA RIVER BASIN
BROOME COUNTY, NEW YORK

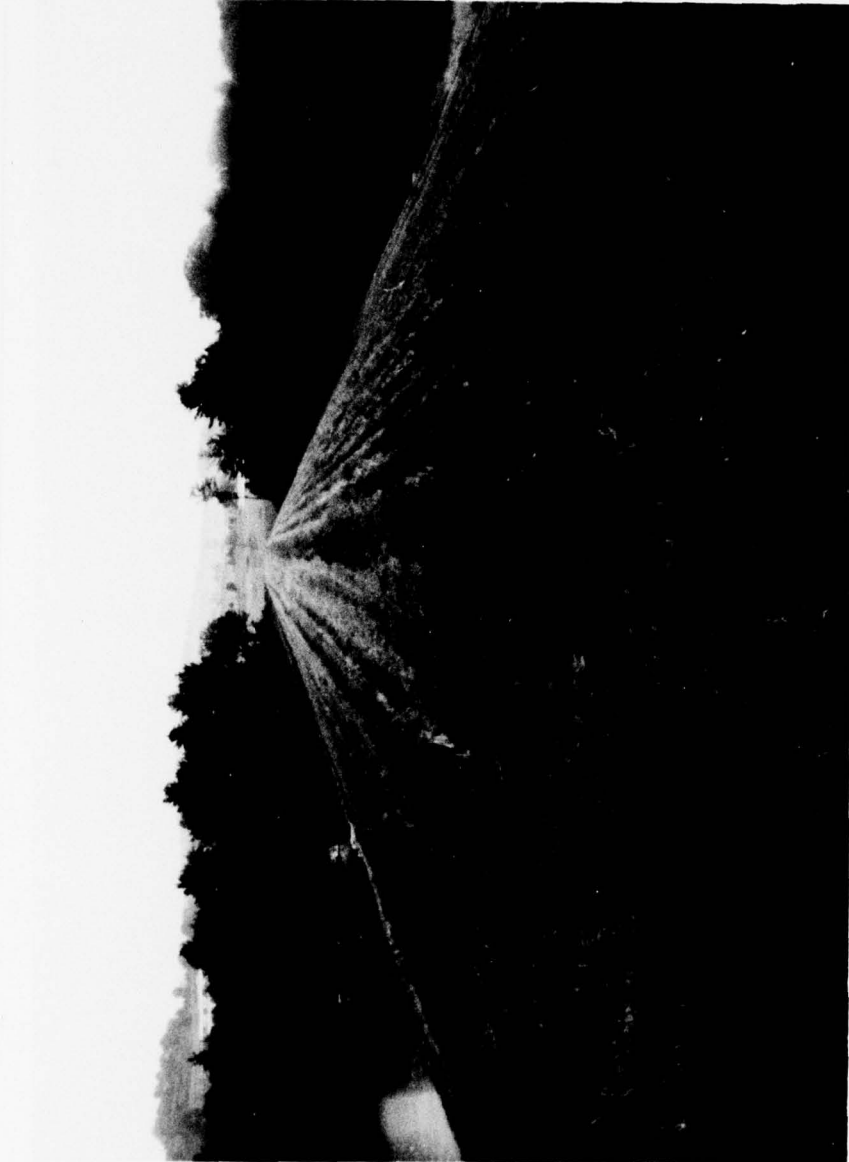
Overview of Finch Hollow Site 1 Dam
Photo #1

No signs of distress were observed in the earth embankment and no evidence of seepage, misalignment, sloughing, subsidence, depressions, surface cracking, or undesirable growth were noted in connection with the embankment. Riprap was in place on the upstream slope in the vicinity of the normal pool level for wave protection. (See photos #1, 2, & 12)

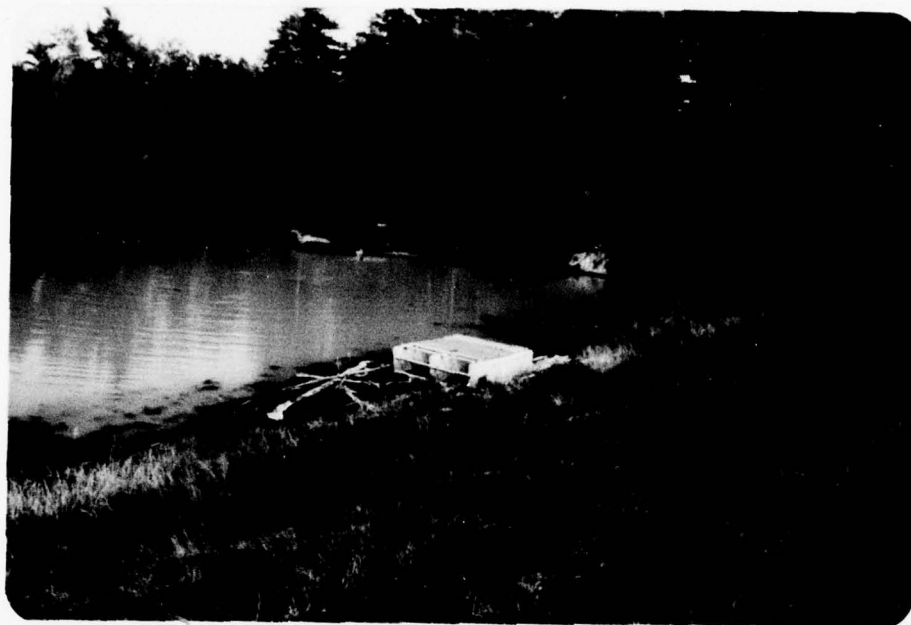
Upstream Face of Dam
Photo #2

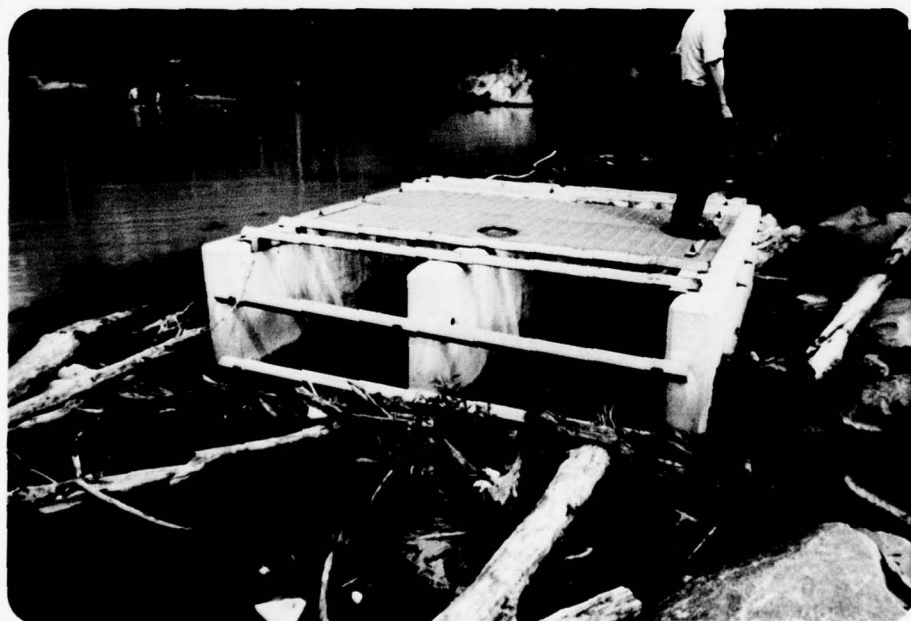
1. The riser top grating is loose and the bolting units require repair. (See photo #5);
2. Considerable debris is surrounding the intake of the principal spillway. This debris should be removed with periodic removals conducted in the future. (See photos #3 & 4).

Right Side of Principal Spillway Riser
Photo #3

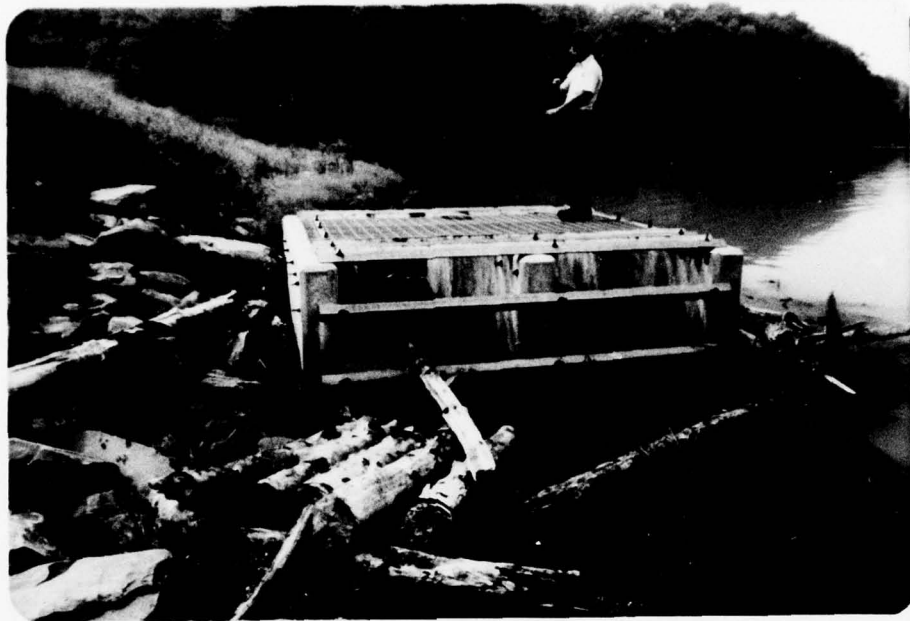
Left Side of Principal Spillway Riser
Photo #4

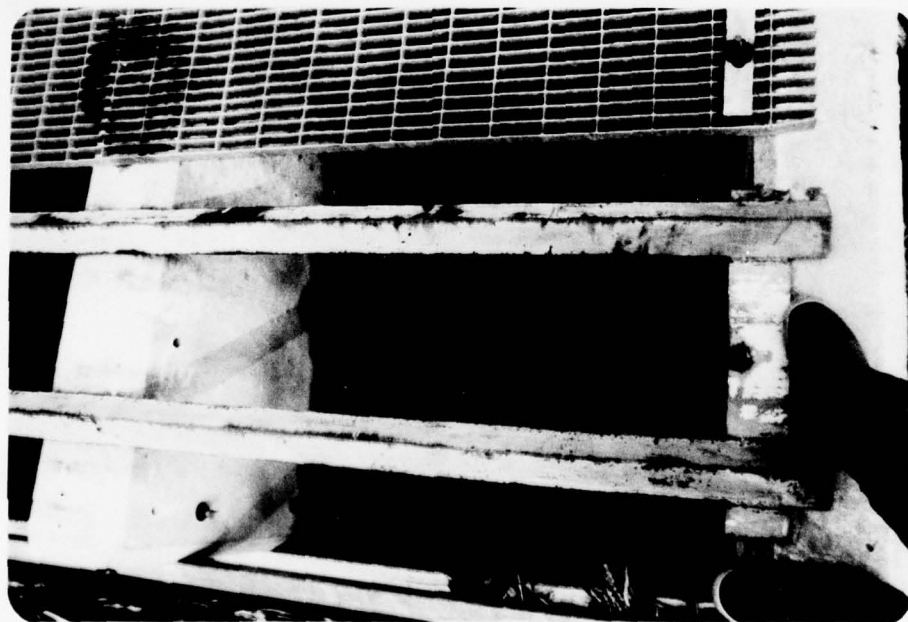
Grating Atop Riser
Not Missing Bolting Unit Near Boot
Photo #5

b. Principle Spillway structurally good
grate on right side on top of riser is loose
bolting units require repair

1. Remove the tree growth at the entrance and exit of the auxiliary spillway channel to permit the unimpeded flow of discharge water;
2. Repair the bolting units of the principal spillway riser grating;
3. Remove the debris surrounding the principal spillway riser intake. Provide a program of periodic inspection and maintenance of the dam and appurtenances, including operation and lubrication of the slide gate mechanism. Document this information for future reference;

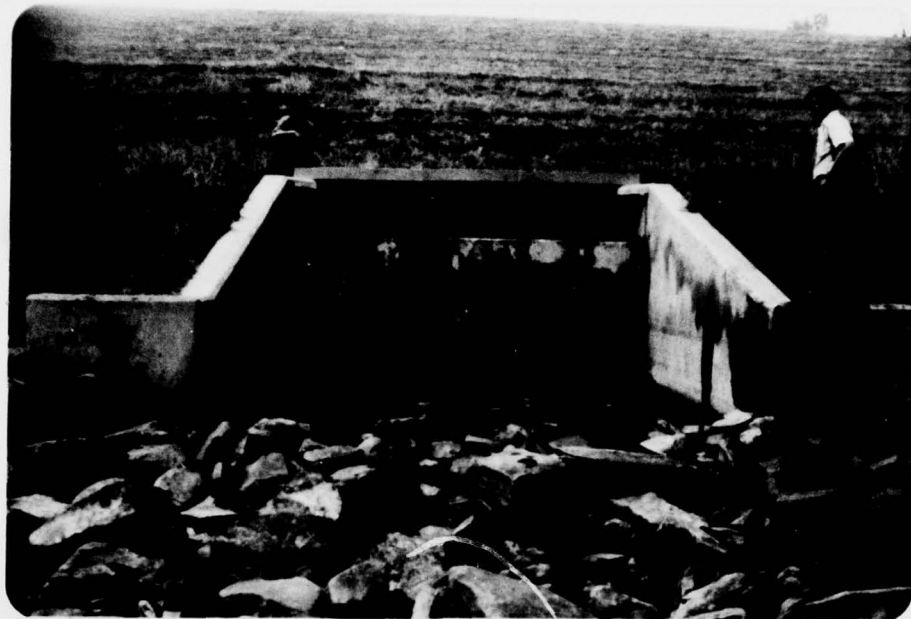
The principal spillway consists of a vertical drop inlet structure, a reinforced concrete pipe through the embankment; an impact basin at the toe of the embankment, and an outlet channel. (See photos #3, 4, 6, 7, & 11). These components appear to be in satisfactory condition with the following exceptions:

Impact Basin
Photo #6

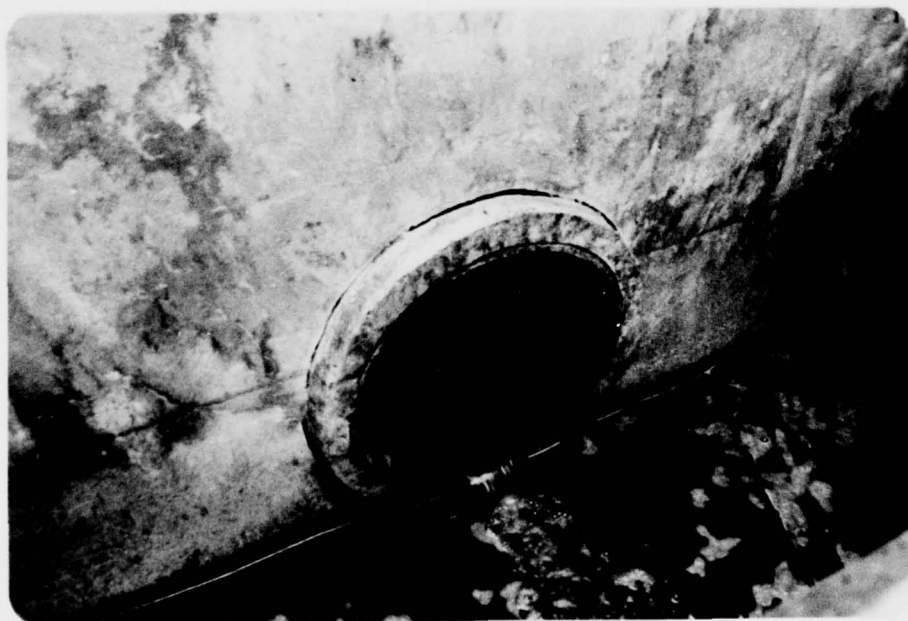
Outlet of 36" Concrete Pipe in Impact Basin
Photo #7

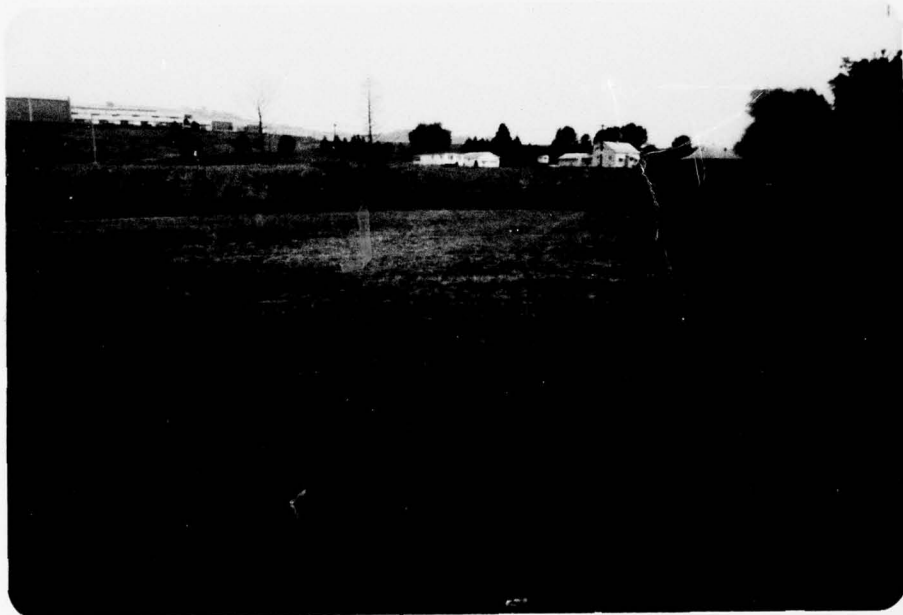
The vegetated auxiliary spillway (earth cut section) is located beyond the left (east) abutment of the embankment (See photos #8, 9, & 10). The channel is in good condition, however, the following problem areas were noted:

Level Section of Auxiliary Spillway
Photo #9

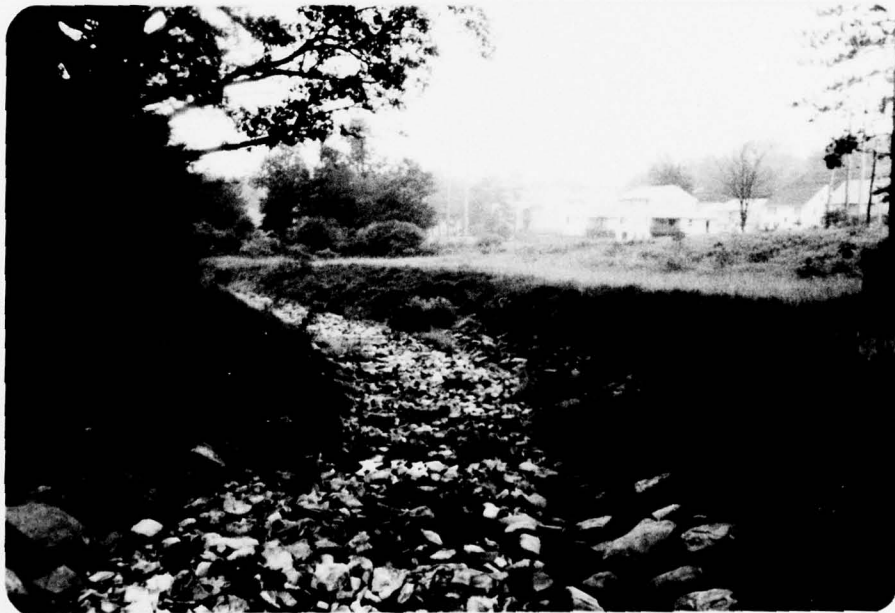
Downstream Channel Below Impact Basin
Photo #11

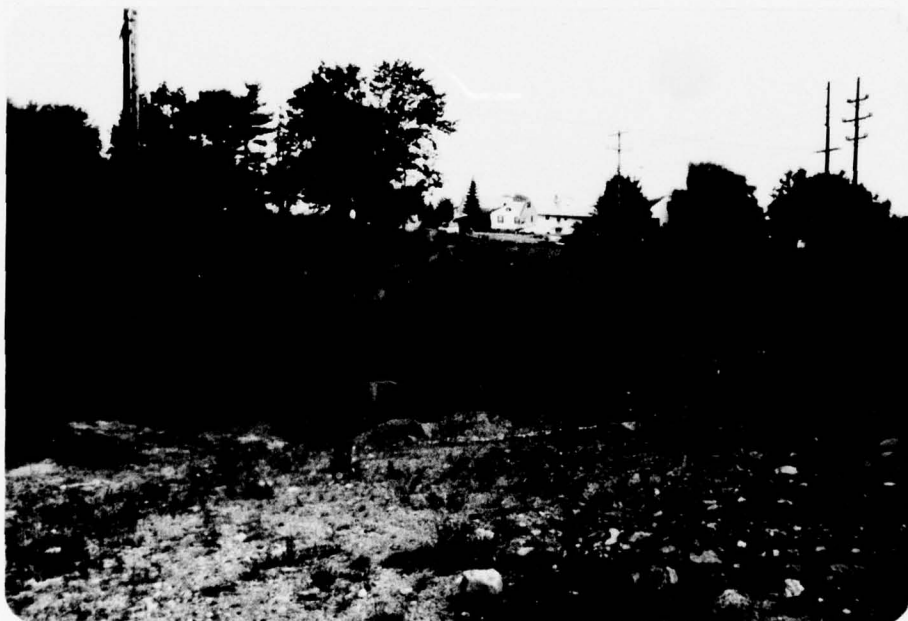
Highway Embankment Below Dam
Photo #13

- a. Condition (debris, etc.) very little
highway embankment & box culvert
see notes below
- b. Slopes good condition
- c. Approximate number of homes 20 homes near base of dam
on right side of downstream channel, highway embankment
below homes with small box culvert to carry flow from dam
if dam failure occurred flow would back up behind this
- 8) Miscellaneous embankment and flooding of these homes would
occur, particularly if highway embankment culvert
was clogged w/debris

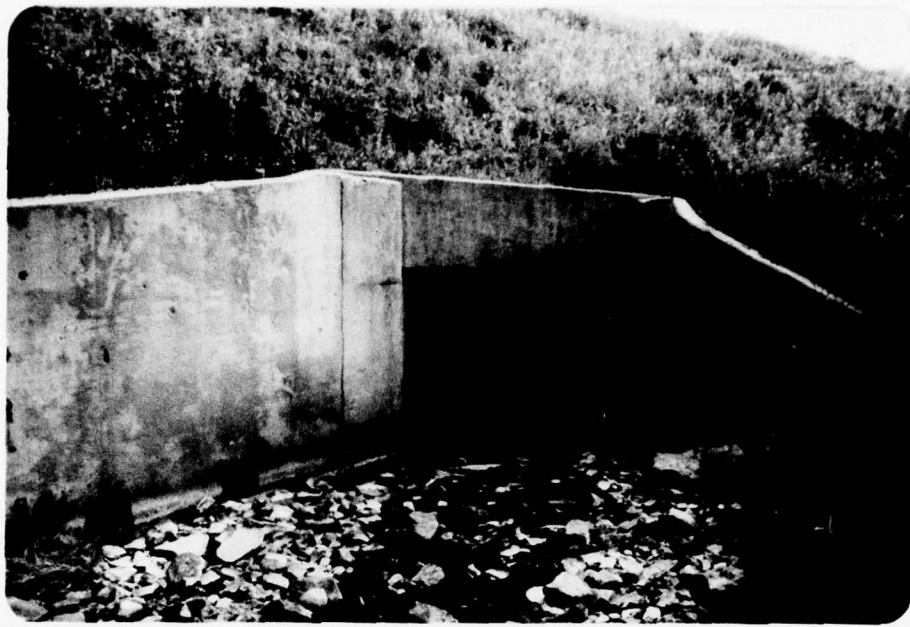
Box Culvert Beneath Highway Embankment
Photo #14

- a. Results of the highway embankment box culvert investigation will determine the type and extent of remedial measures required.
- b. Remove the tree growth at the entrance and exit of the auxiliary spillway channel to provide for unobstructed passage of flow.
- c. Repair the bolting units of the grating at the top of the principal spillway riser.
- d. Remove the debris which surrounds the intake of the principal spillway riser. Provide a program of periodic inspection and maintenance of the dam and appurtenances, including operation and lubrication of the slide gate mechanism. Document this information for future reference.
- e. Develop an emergency action plan for notification of downstream residents and the proper authorities in the event of heavy auxiliary spillway discharge.
