SEPTEMBER 1979

Name Of Dam: TOMS CREEK DAM
Location: WISE COUNTY, VIRGINIA
Inventory Number: VA. NO. 19510

PHASE I INSPECTION REPORT

NATIONAL DAM SAFETY PROGRAM

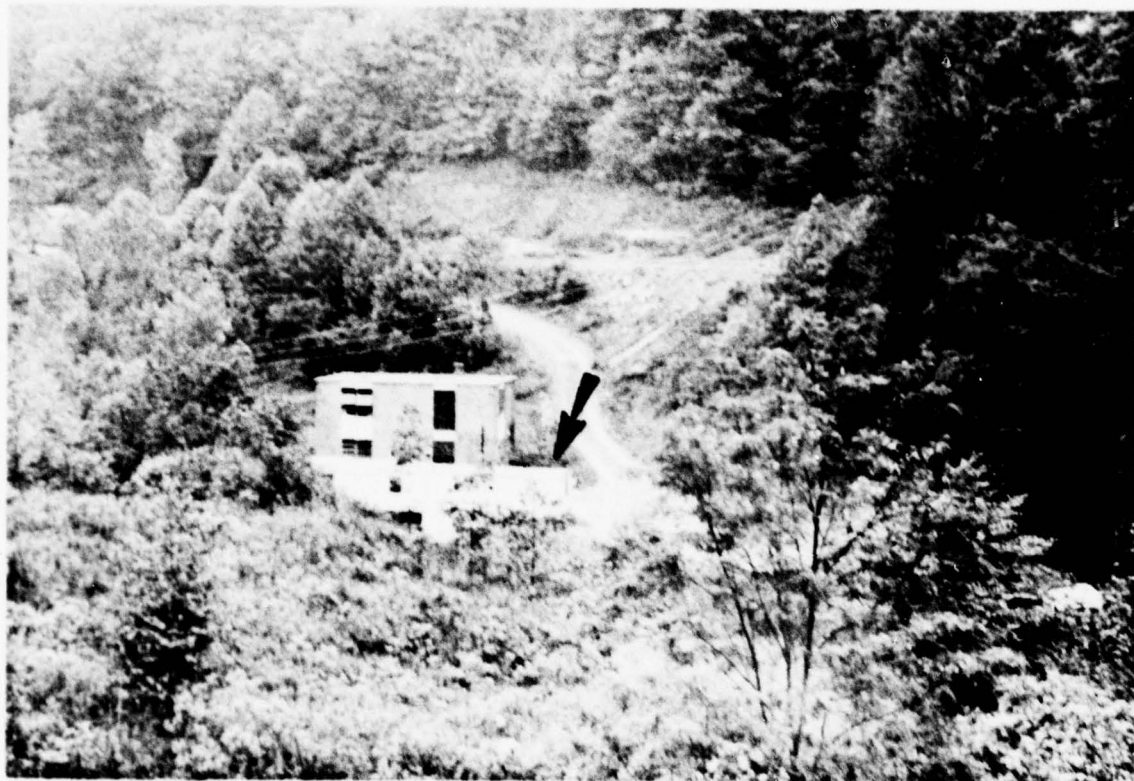
1.2.4 Hazard Classification: The dam is located in a rural area; however, based upon the location of a home and water filtration plant approximately 300 ft downstream (See Photo 1, Appendix II), and the industrial development and several homes within 2 miles downstream of the dam, the dam is assigned a "significant" hazard classification. The hazard classification used to categorize a dam is a function of location only and has nothing to do with its stability or probability of failure.

WATER TREATMENT PLANT DOWNSTREAM
(NOTE CARETAKER'S HOME, ARROW)

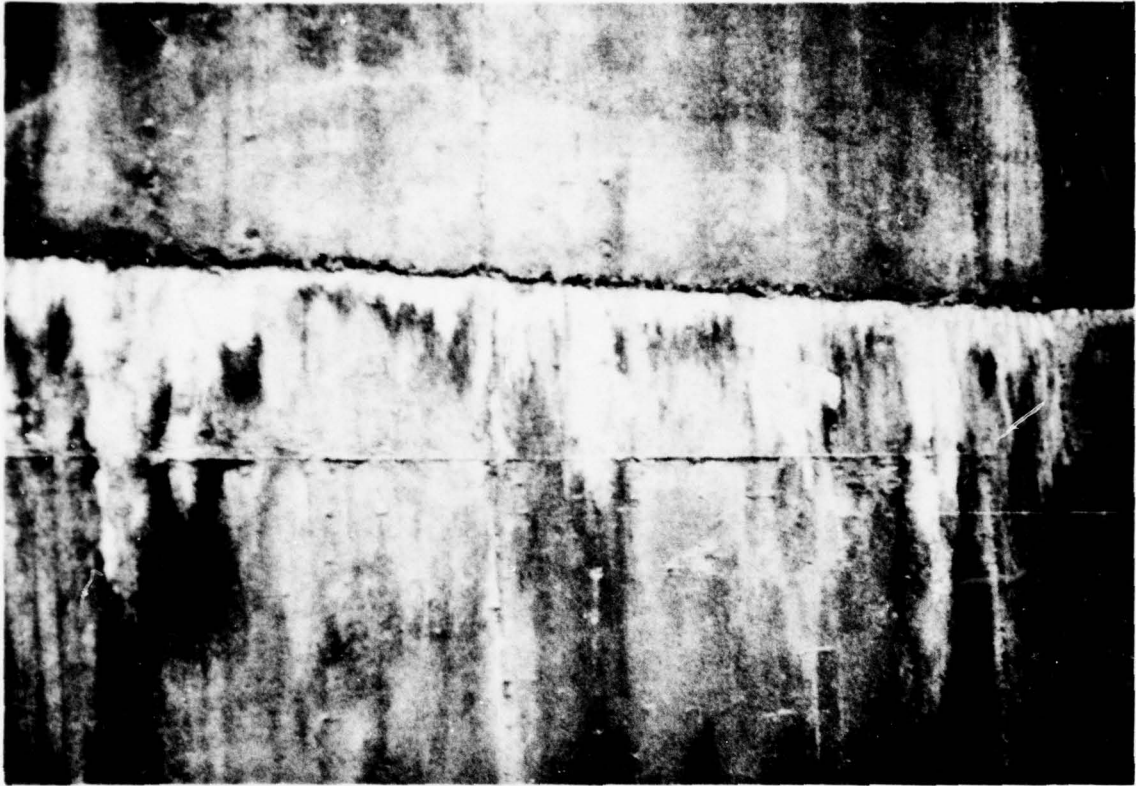
VIEW OF COLD JOINT

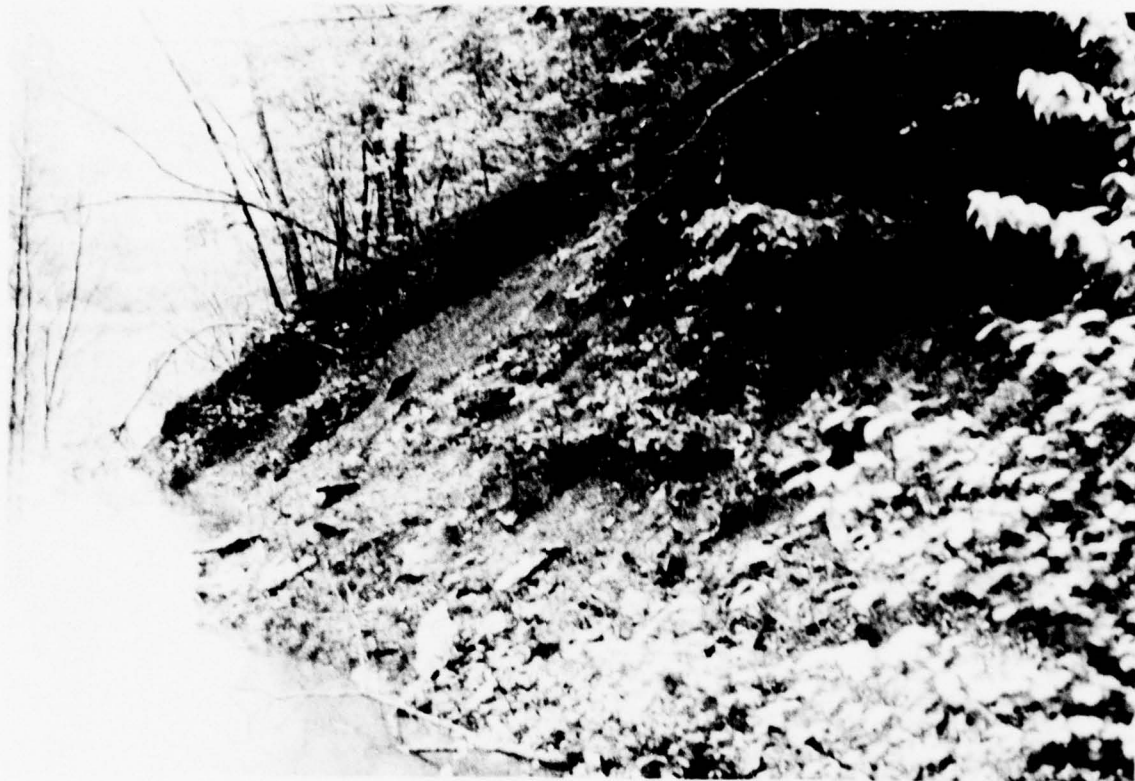
SLOUGHING ABOVE LEFT ABUTMENT
