Name Of Dam: GENT BROTHERS DAM  
Location: RUSSELL COUNTY, VIRGINIA  
Inventory Number: VA. NO. 16706

# PHASE I INSPECTION REPORT

## NATIONAL DAM SAFETY PROGRAM

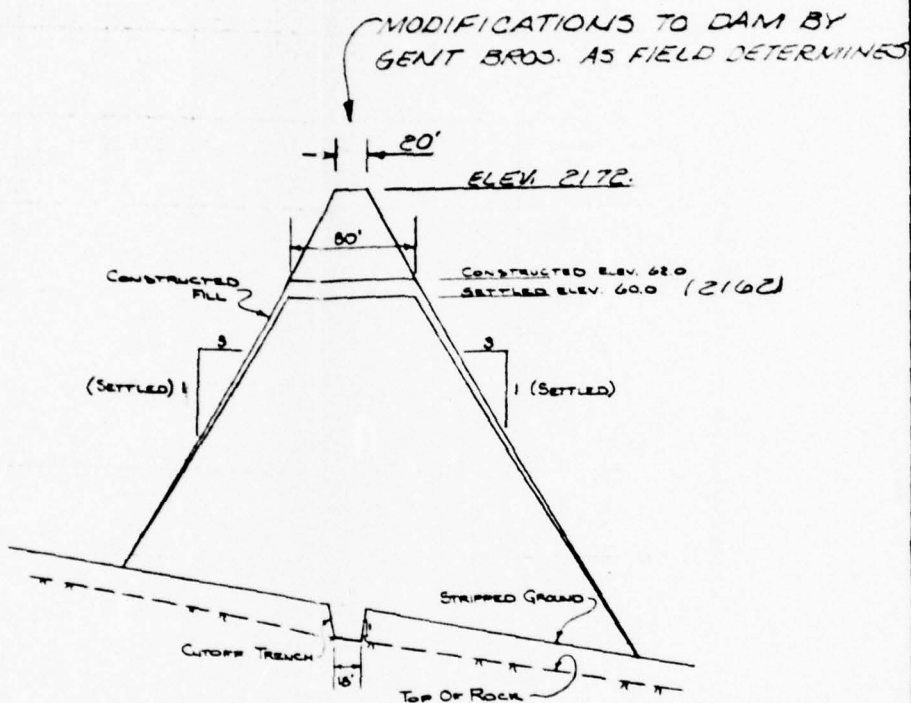
PLATE No. 2

The downstream embankment slope meets the requirements recommended by the U. S. Bureau of Reclamation; however, the upstream slope is slightly steeper than recommended when subject to rapid drawdown. Since no undue settlement, cracking or seepage was noted at the time of inspection, it appears that the embankment is adequate for normal pool level with water at elevation 2165 M.S.L. Since the rapid drawdown stability is in question, the water level in the dam should not be lowered at a rate exceeding 6 inches per day. If this is not acceptable, a geotechnical engineering study is recommended in order to evaluate in detail the actual stability of the dam for the rapid drawdown condition.

TYPICAL SECTION OF EMBANKMENT

7.2 Recommendations and Remedial Measures: An accurate check on stability could not be made since sufficient design data, calculations and construction records were not available. Since only the rapid drawdown stability condition appears to be in question, the lake level should not be lowered at a rate exceeding 6 inches per day. If this is not acceptable, the Owner should provide a geotechnical engineering study which evaluates in detail the actual stability condition of the dam.

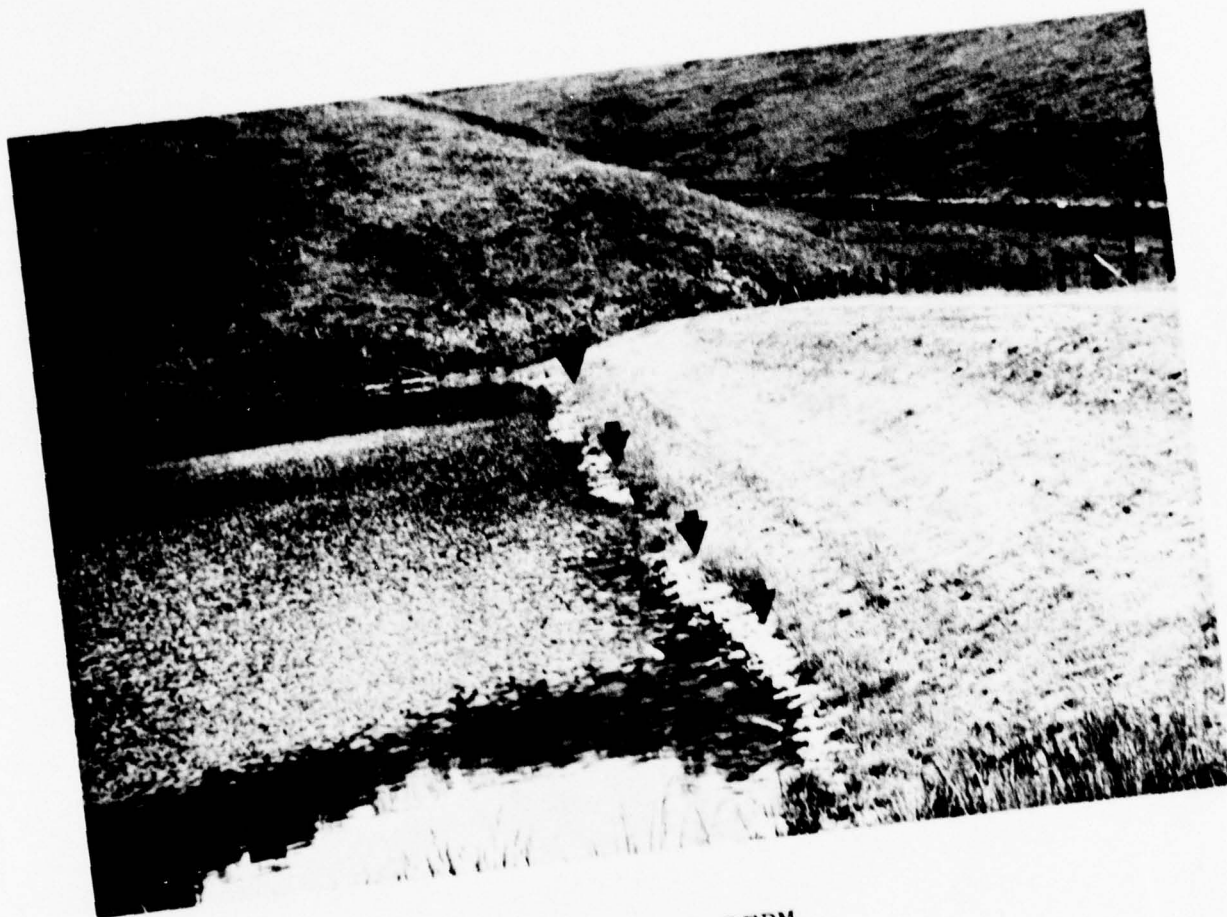
VIEW ACROSS UPSTREAM FACE OF BERM  
(Note Intake and Rip Rap)

1.5 Riprap: Showed no displacement or washing; appeared to be in proper alignment and in good condition. Blocks of rock ranged from 0.5 to 3 ft<sup>±</sup> in length and were reportedly hand placed.

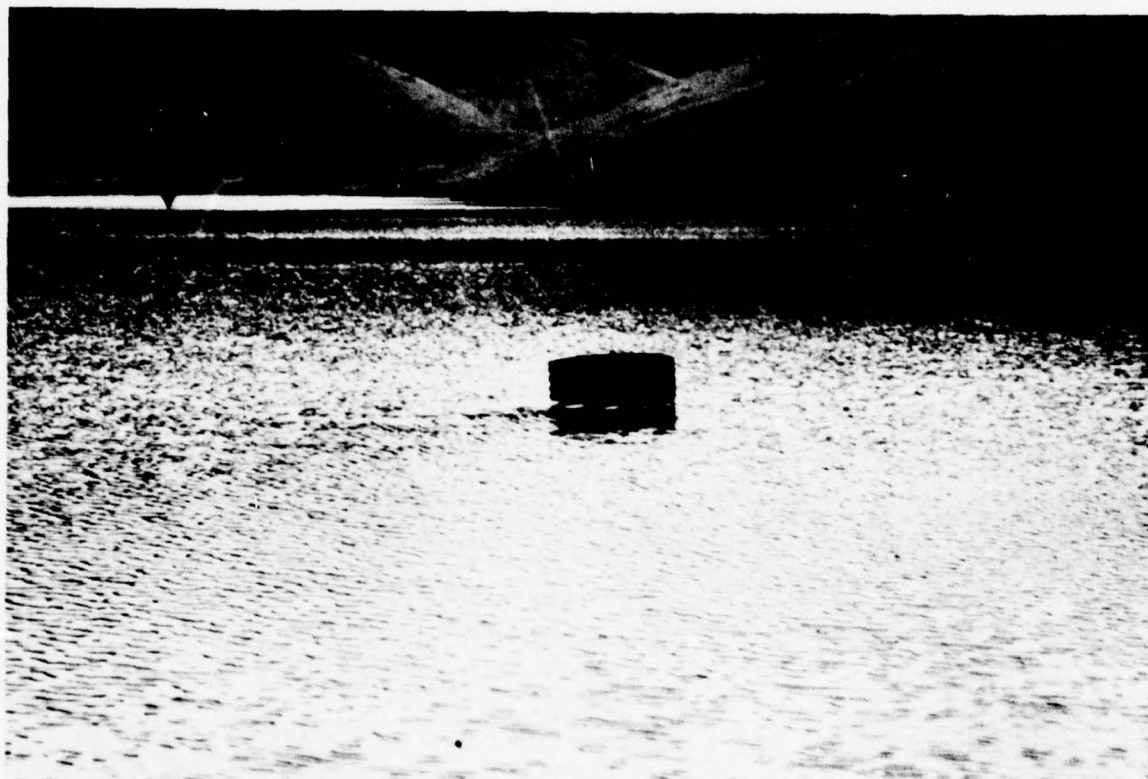
The principal spillway intake and discharge pipe are in good condition. No debris was noted on the inlet. The 8"

gate was reportedly in operating condition. The principal spillway is an 18" bituminous coated CMP with a 24" CMP riser. The emergency spillway was in good condition.

VIEW OF RISER INTAKE  
(Note 8" Gate Location with Arrow. Also, Headwater Spring  
Locations in Background at Location of Cattle)
