Name Of Dam: HUNTING CAMP DAM
Location: BLAND COUNTY, VIRGINIA
Inventory Number: VA. NO. 02101

PHASE I INSPECTION REPORT

NATIONAL DAM SAFETY PROGRAM

BY
SCHNABEL ENGINEERING ASSOCIATES, P.C./
J. K. TIMMONS AND ASSOCIATES, INC.

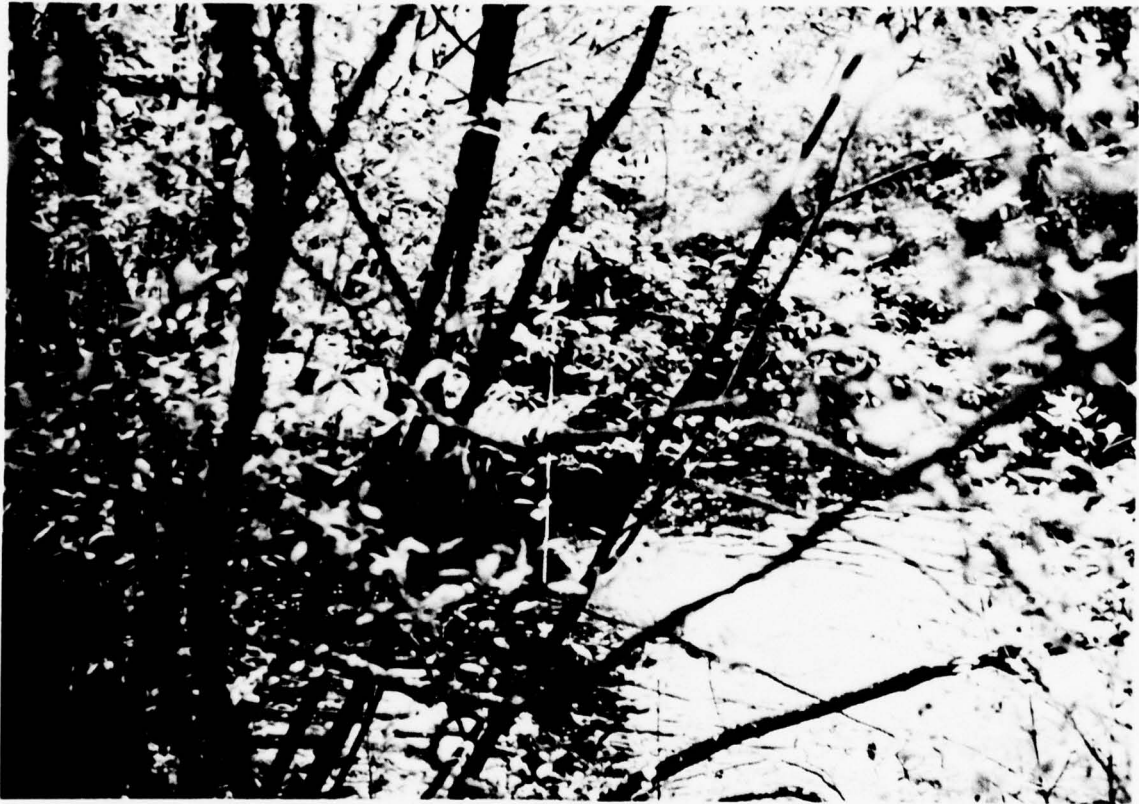
CLOSE-UP OF OUTLET PIPE

2.1 Outlet Conduit: 30 inch CMP. Some corrosion but not significant.

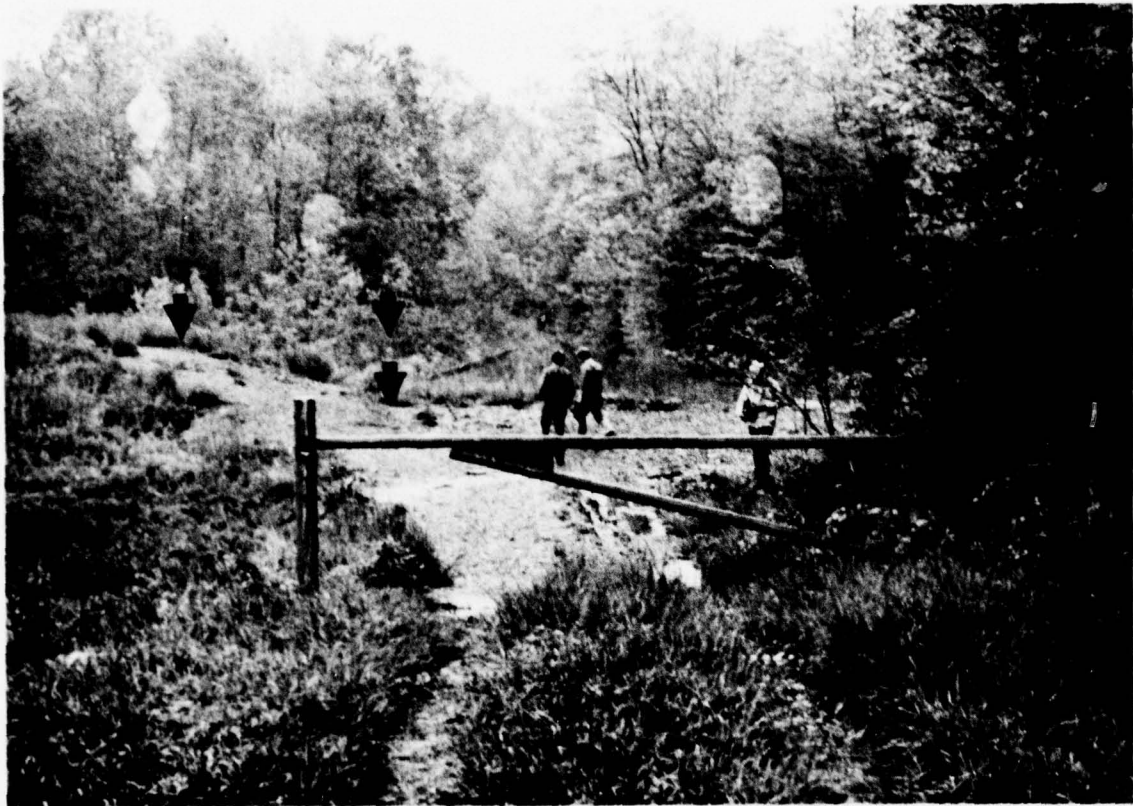
There are two trapezoidal channels; one located on each abutment, used for emergency spillways. They both empty into broad wooded floodplain-type areas. Erosion had occurred in 1977 to the right spillway, but has since been repaired and stabilized.

SPILLWAY IN RIGHT ABUTMENT
(Outlined with Arrows)

3.2 Discharge Channel: Erosion on right secondary spillway, but repaired.

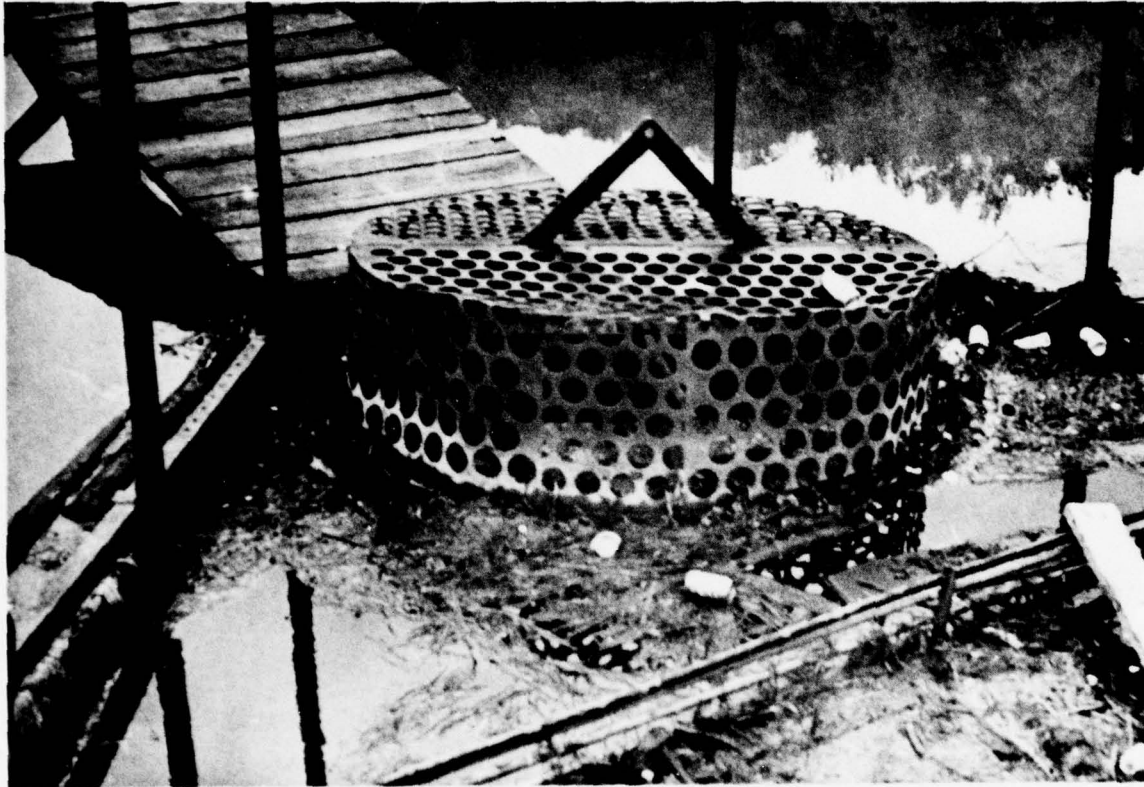
The principal spillway has a 42 inch CMP riser with a 30 inch CMP outlet pipe. The intake is in good condition. No spalling or cracking was observed. A small amount of debris was noted in the trash rack. The 12 inch gate is reportedly operational.

CLOSE-UP DEBRIS RACK AT 42" INTAKE

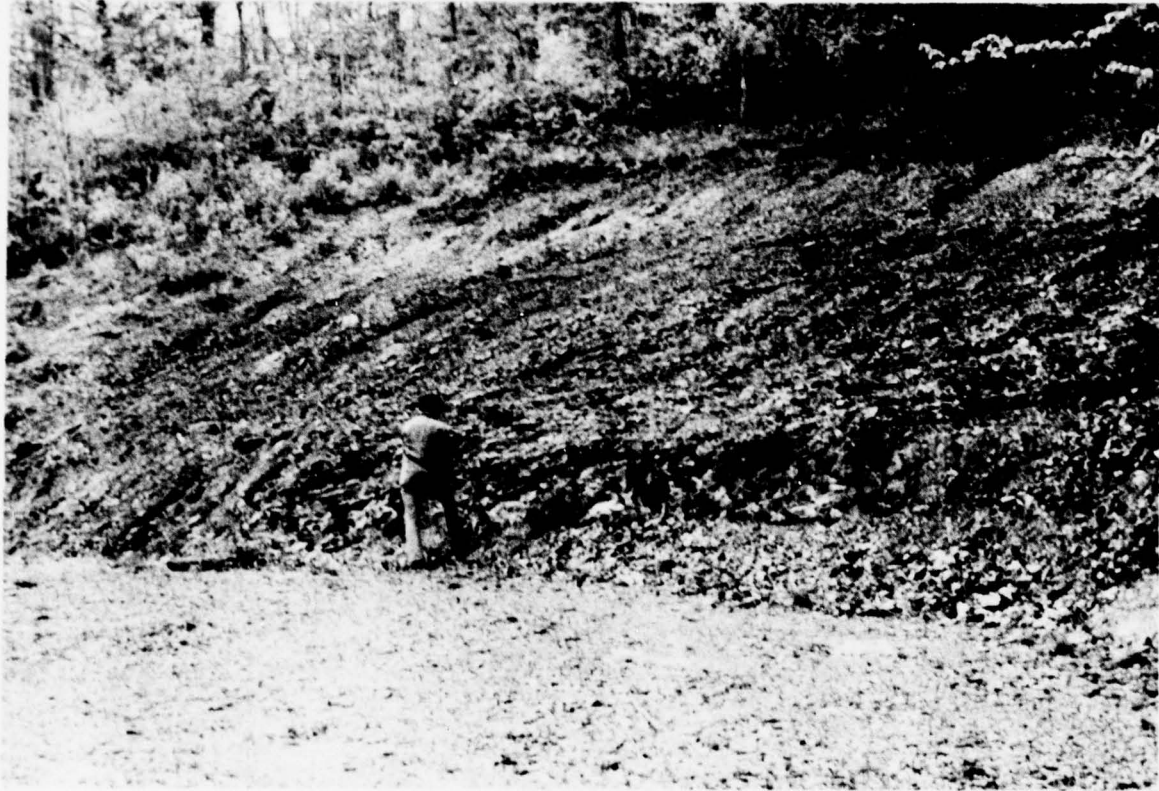
VIEW OF BORROW AREA FOR REPAIR OF SPILLWAY

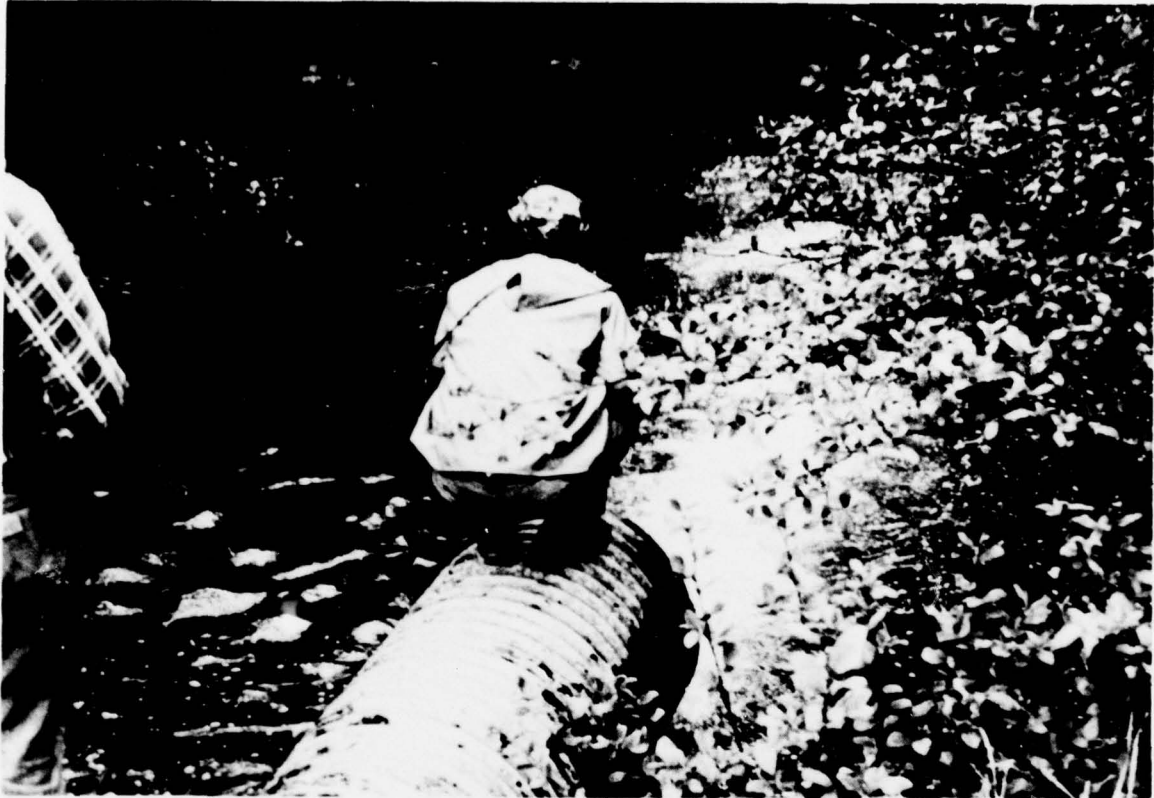
VIEW OF OUTLET STRUCTURE LOOKING DOWNSTREAM

2.3 Outlet Structure: In good condition.

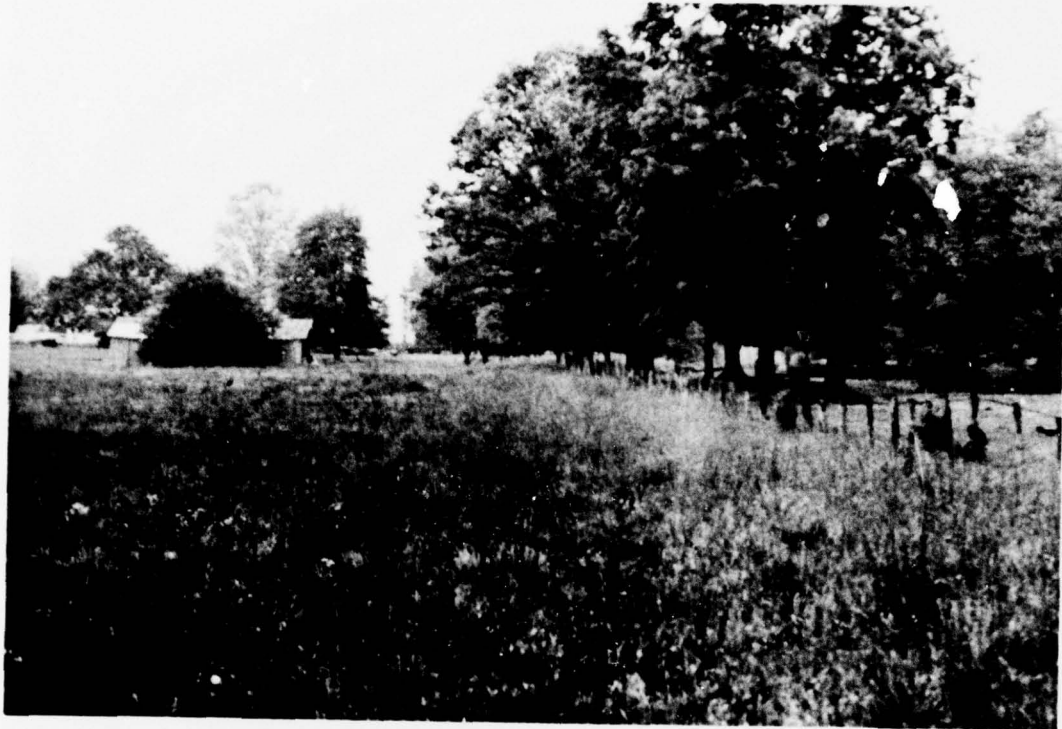
Four homes were observed approximately 2500± ft downstream. They appear to be approximately 10 to 15 ft above creek bed. (El 2320 M.S.L.). The bridge at Suiter, Virginia, for Rt. 615, is at a lower elevation than the homes.

VIEW OF DOWNSTREAM FLOODPLAIN
