Name Of Dam: CHERRYSTONE NO. 1
Location: PITTSYLVANIA COUNTY, VIRGINIA
Inventory Number: VA. NO. 14302

PHASE I INSPECTION REPORT

NATIONAL DAM SAFETY PROGRAM

SCHNABEL ENGINEERING ASSOCIATES, P.C./
J. K. TIMMONS AND ASSOCIATES, INC.

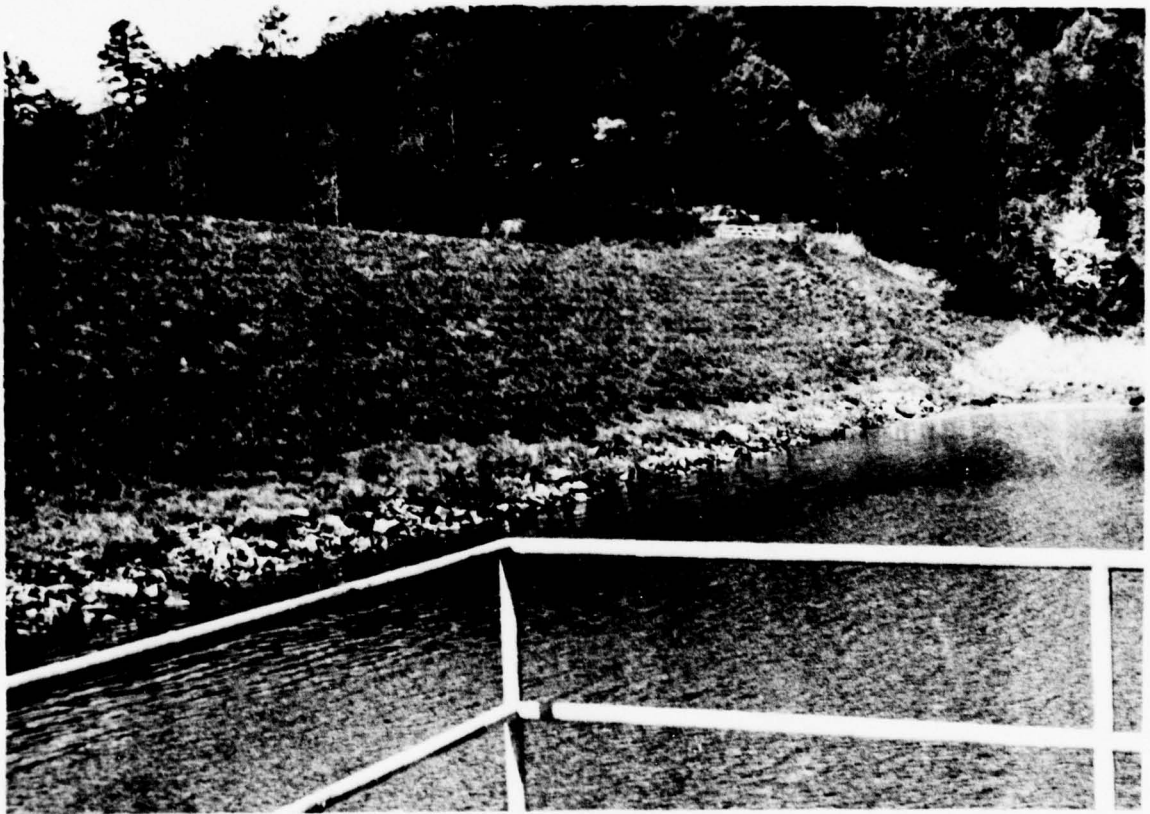
UPSTREAM FACE OF EARTHEN IMPOUNDMENT
Photo #1

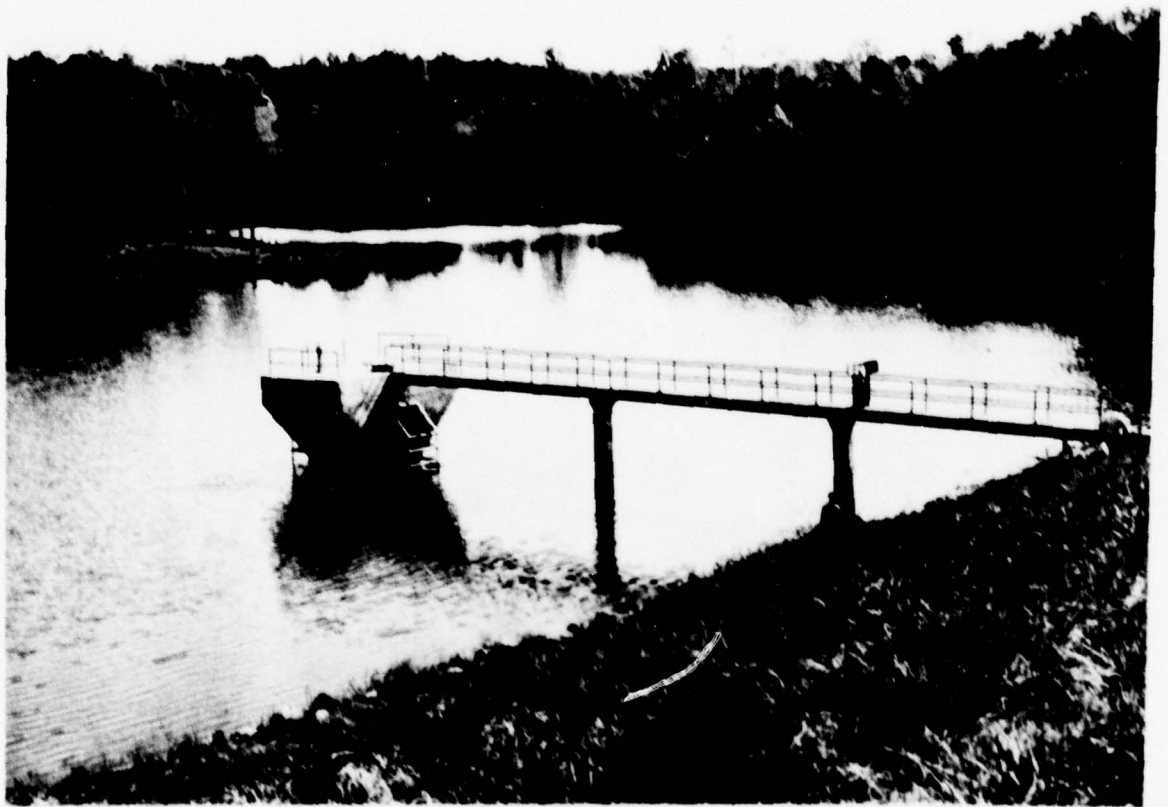
The intake is in good conditions. No spalling or cracking was observed. A small amount of debris was noted in the trash rack. The manhole cover is missing from the structure. The gates **have** not been operated since 1972. The energy dissipator was in good condition and functioning properly.

INTAKE STRUCTURE AND CATWALK
Photo #2

4.1 Intake Structure: The structure was in good condition. No top on the manhole. Small amount of debris in inlets. Gates were operable in 1972.

7.2.4 Replace manhole on principal spillway inlet structure.

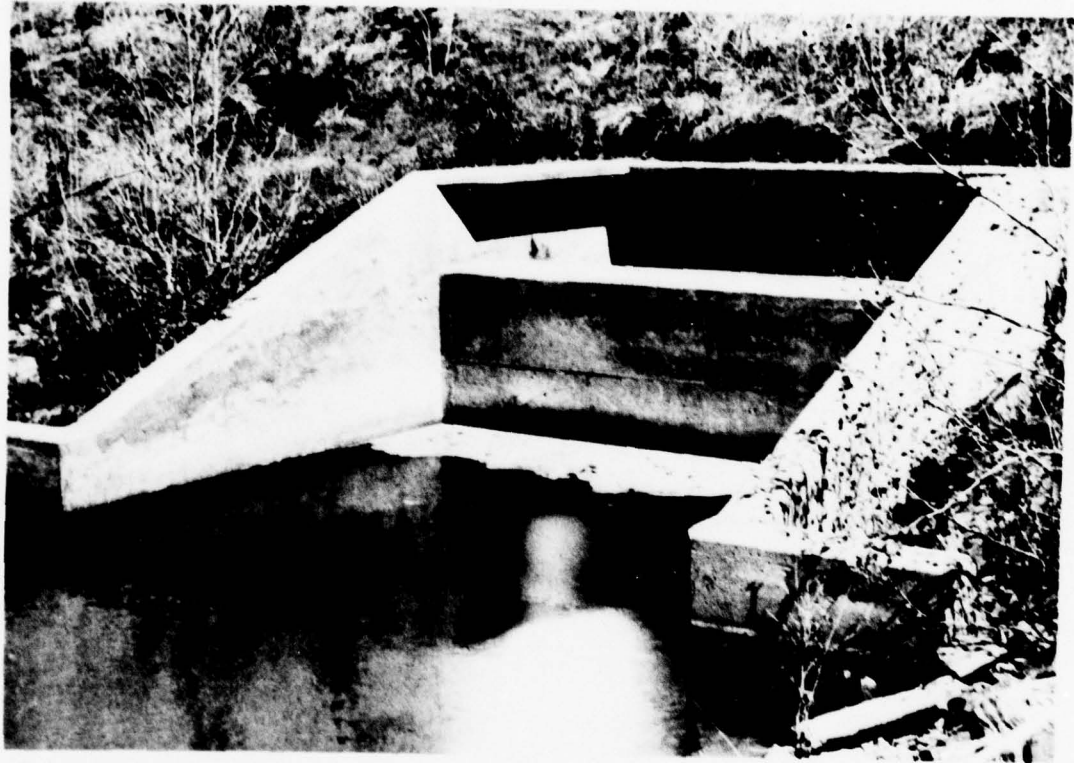
Photo #4

OUTLET ENERGY DISSIPATOR
Note: Outlet Channel Flow

4.2 Outlet Structure: 42". In good condition. Half-full. The energy dissipator was in excellent condition.

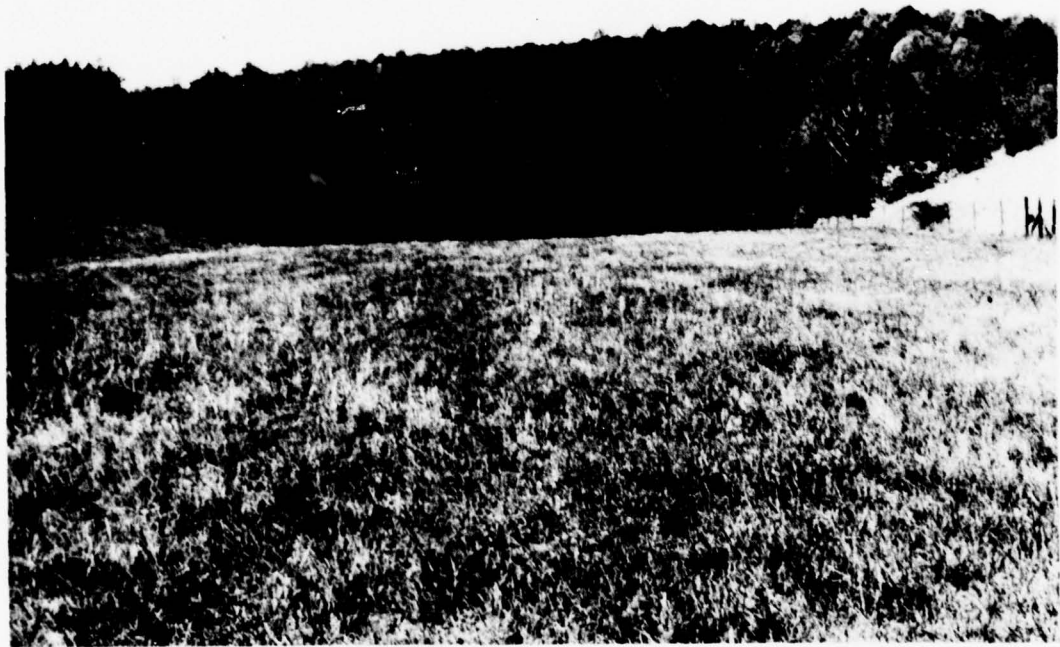
Photo #5

VIEW EMERGENCY SPILLWAY

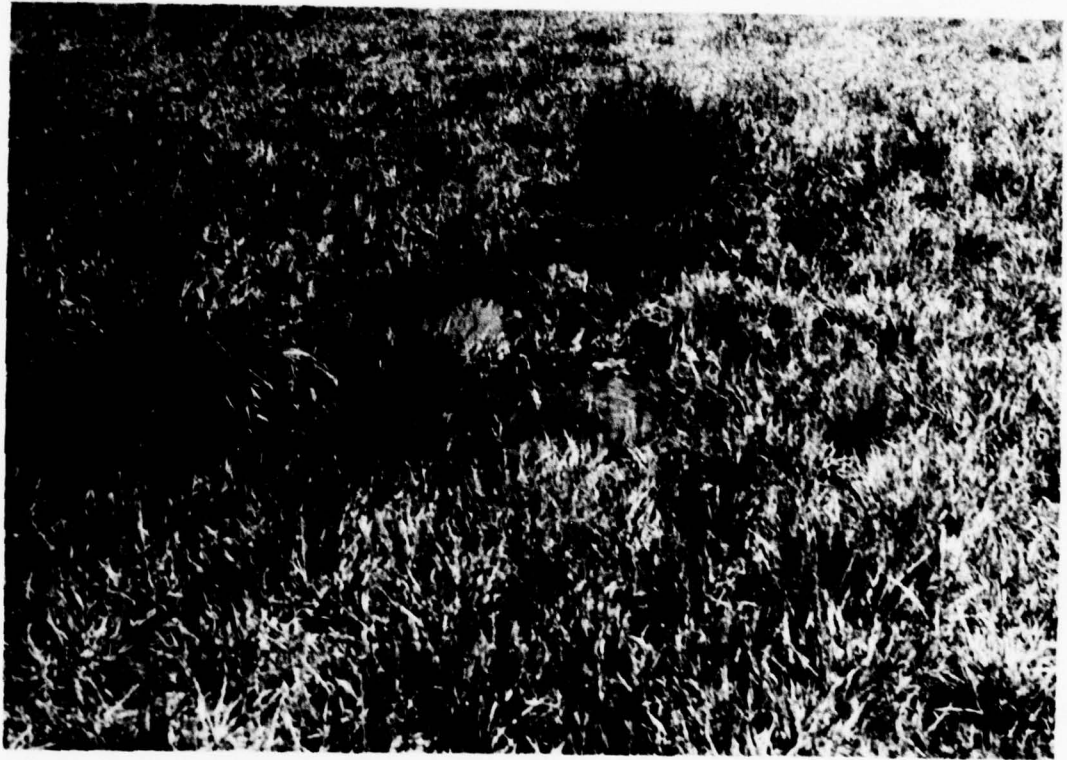
The moisture observed below the downstream toe of the embankment is not considered to be related to seepage through the dam.

WET SPOT NOTED DOWNSTREAM OF LEFT ABUTMENT
Photo #6

1.7 Seepage: The toe or basal 15 ft[±] downstream embankment slope was moist; however, no seepage was observed. There appears to be considerable ponded water just below the downstream toe of the embankment to the right of the principal spillway outlet. This area is fed by water from a spring located below the right abutment embankment interface. Cattails fan and marsh grass are present. This type of vegetation is indicative of long term poorly drained areas. The left
