Name Of Dam: MIDDLETON DAM
Location: LEE COUNTY, VIRGINIA
Inventory Number: VA. NO. 10501

PHASE I INSPECTION REPORT

NATIONAL DAM SAFETY PROGRAM

BY
SCHNABEL ENGINEERING ASSOCIATES, P.C./
J. K. TIMMONS AND ASSOCIATES, INC.

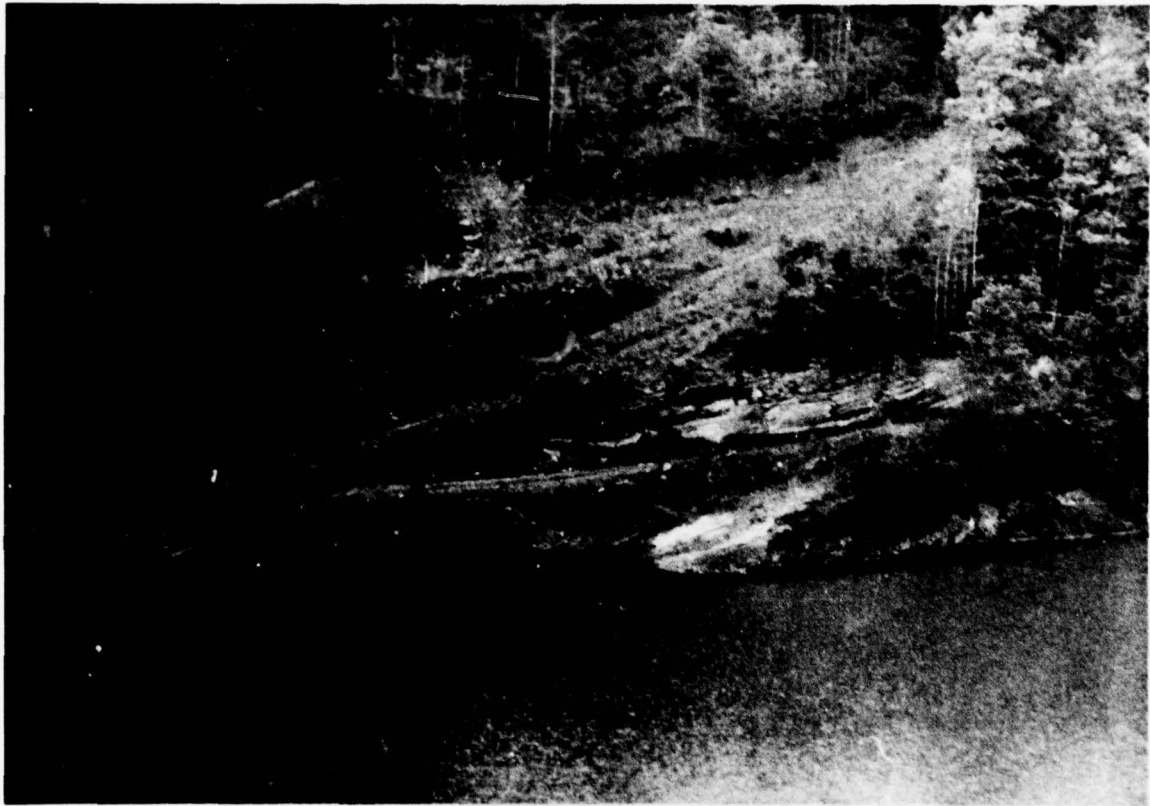
VIEW OF CUT AT RIGHT ABUTMENT

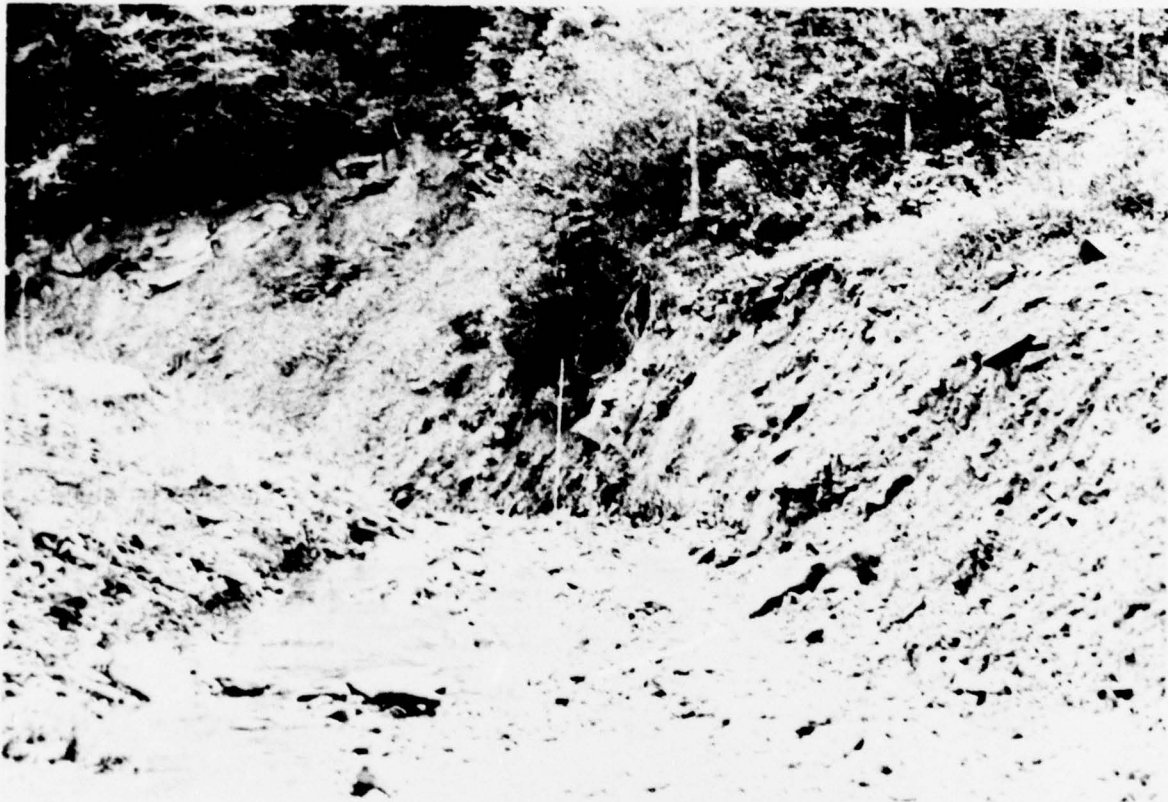
The emergency spillway is located at the right abutment. The left side of the emergency spillway is at a slope of 1.5:1 and in fill. The right side of the spillway is at a 1:1 slope and is in cut. Previous erosion reported by the owner had been repaired.

PHOTOGRAPH EMERGENCY SPILLWAY

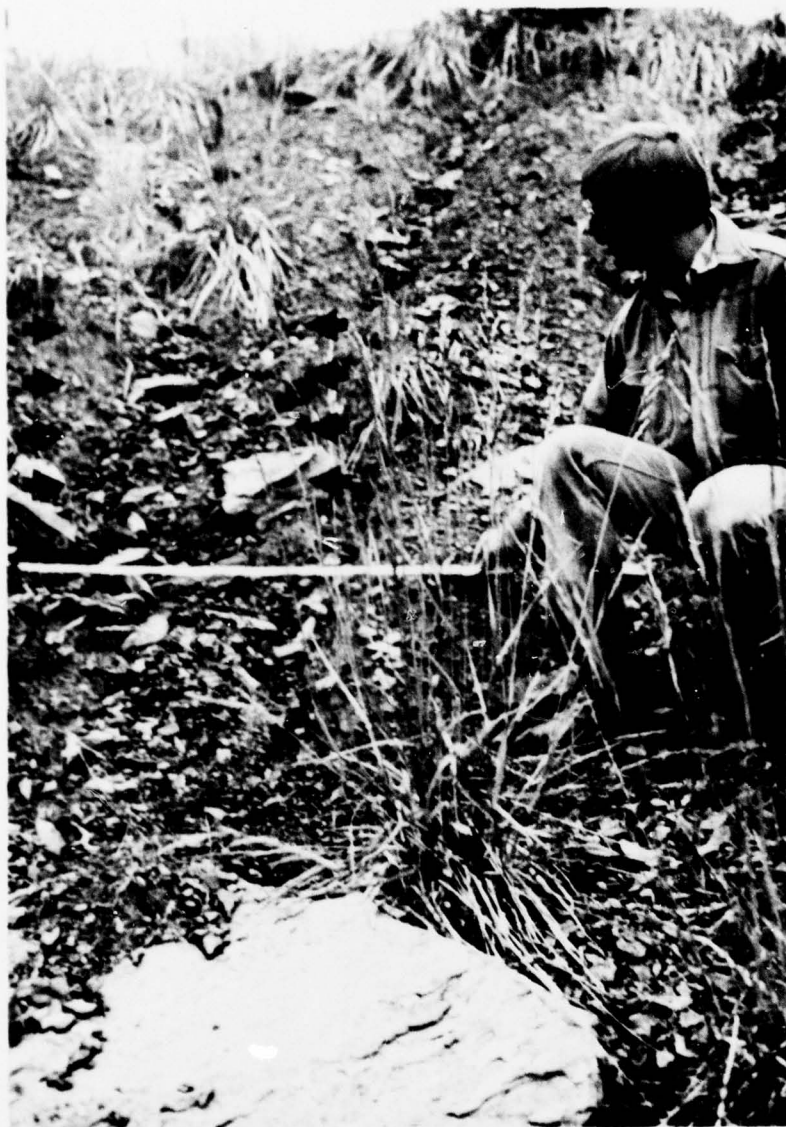
3.1.2 Dam and Spillway: The slopes of the dam had sparse vegetation, and a few trees were observed. Shallow eroded areas exist across much of the embankment as shown on photograph on Page II-4 of Appendix II. Field measurements indicate slopes are 1:1 on the upstream face and 1.8:1 on the downstream face. The dam appeared to be constructed from shale material. The surficial rock fill has a matrix which was visually classified sandy silt or clayey silt (ML) to silty sand (SM), according to Unified Soil Classification System. This material includes occasional blocks of shale up to 3 ft[±] in length. A sample of clay similar to that used during construction was examined and it was visually classified as a silty clay (CL). Seepage was noted along the downstream toe of the dam approximately 55 ft left of the emergency spillway. The dam was constructed by excavating the side slopes and pushing the cut material into a ravine, as reported by the owner/contractor, Mr. Steve Middleton.

3.2 Evaluation: Overall, the dam was in fair condition at the time of inspection. However, some remedial measures are required. The embankment is sparsely vegetated and is subject to erosion during heavy runoff. Erosion should be controlled by reseeding with a vegetative material which can grow on the shale slopes. The outlet pipe should be uncovered to allow a free flowing condition. The iron-staining associated with the seepage observed along the downstream toe could be derived from the iron-bearing shaly residual soils. It is not known whether this seepage represents a spring or is related to seepage through the dam. It should be monitored at least quarterly to detect any increase in flow rate which may cause piping within the embankment. The presence of several large boulders on the embankment slopes indicates that oversize material was included in the embankment fill.

EROSION ON DOWNSTREAM FACE

7.3.2 The embankment should be reseeded in order to minimize surface erosion by runoff and should be mowed at least twice per year.

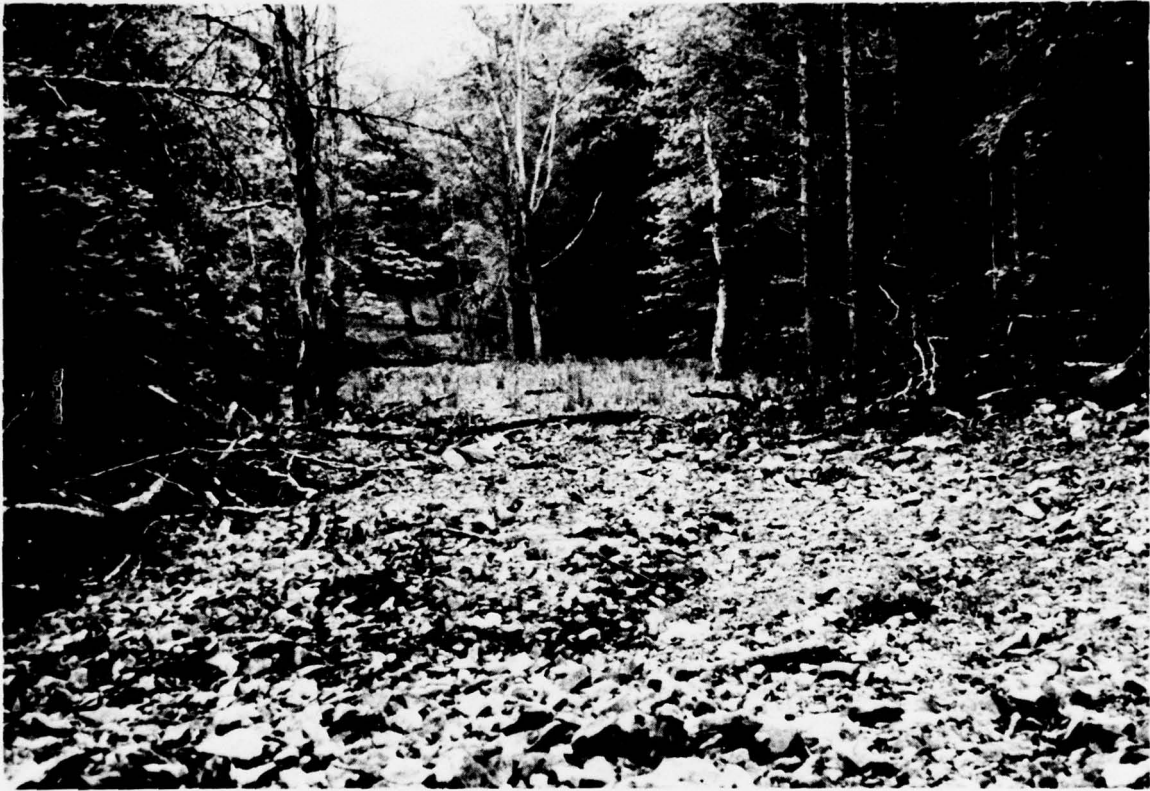
VIEW LOOKING DOWNSTREAM FROM EARTHEN BERM

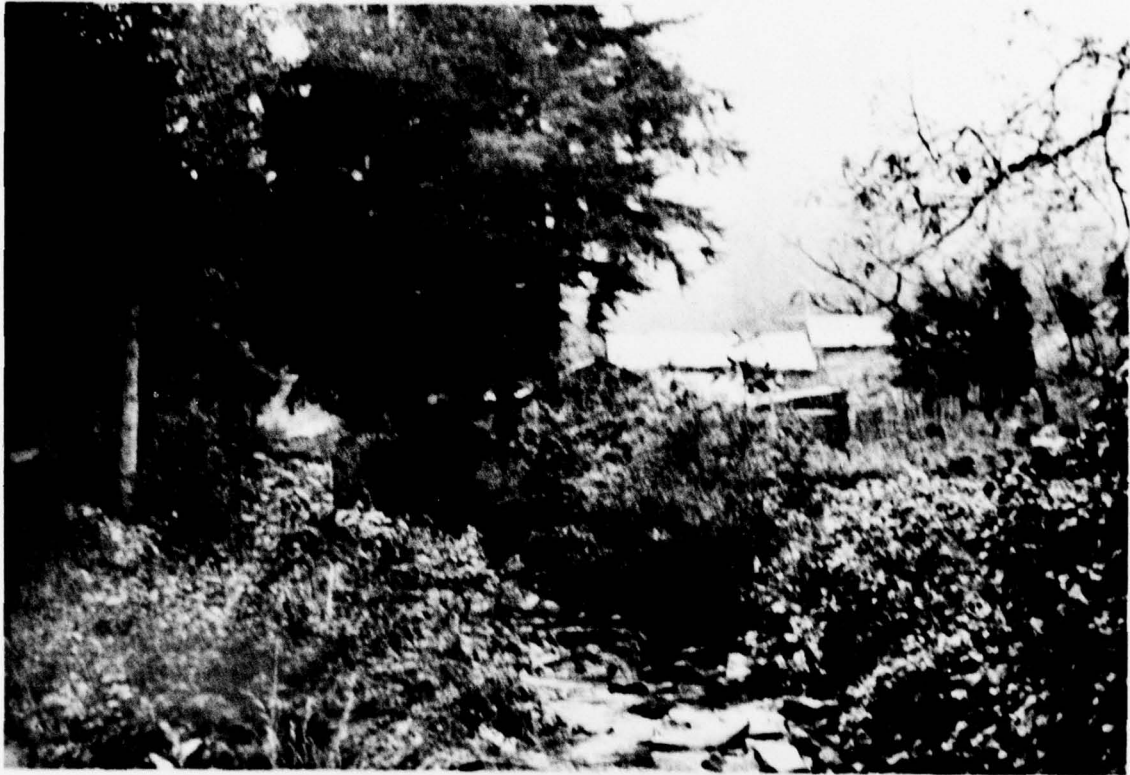
HOMES IN DOWNSTREAM FLOODPLAIN

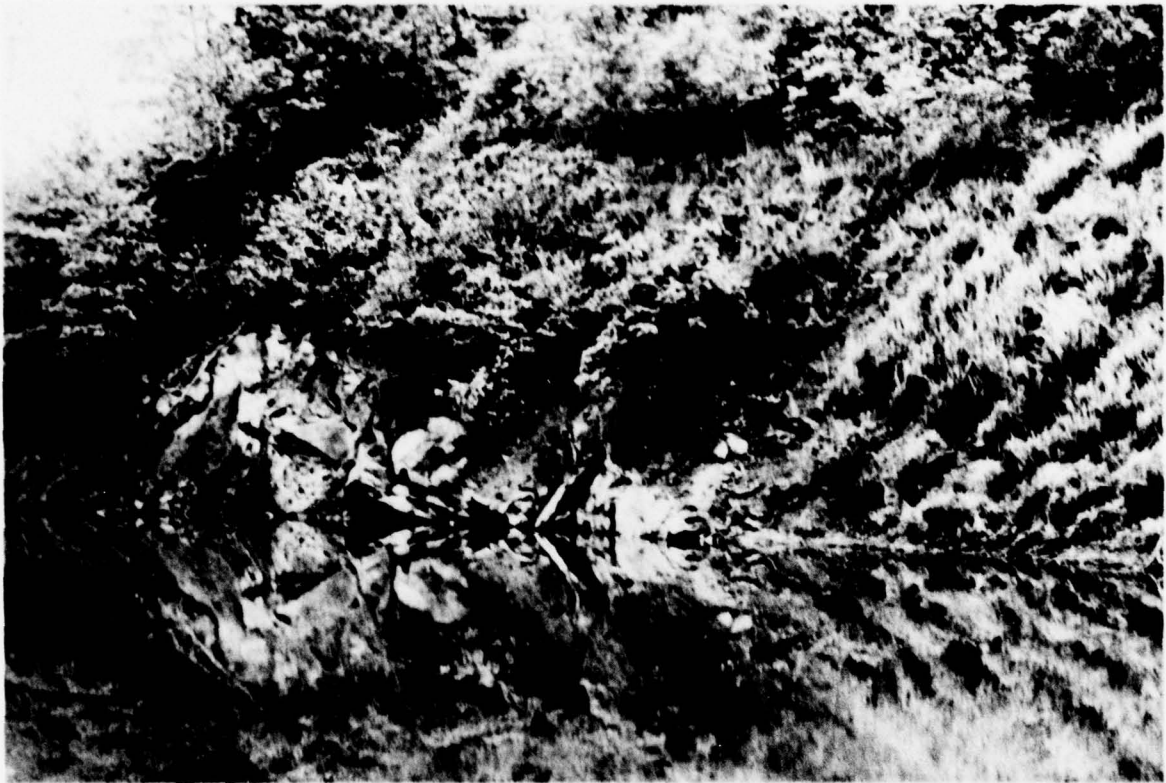
VERTICAL SLOPE AT LEFT ABUTMENT
